United States Department of the Interior

Subject: 2010 Annual Monitoring Report for Cachuma BO

This report presents the data and summarizes the results of monitoring southern steelhead and water quality conditions in the LSYR below Bradbury Dam during Water Year 2010 (WY, 10/1/09 - 9/30/10). The report also incorporates references to observations and fish population trends for the period from WY2001 through WY2010 for comparative purposes. Fish monitoring during WY2010 suggests that management actions undertaken by the Bureau of Reclamation (USBR or Reclamation) on the Lower Santa Ynez River (LSYR) continue to positively influence trends in numbers of southern steelhead (*Oncorhynchus mykiss, O. mykiss*) in the basin.

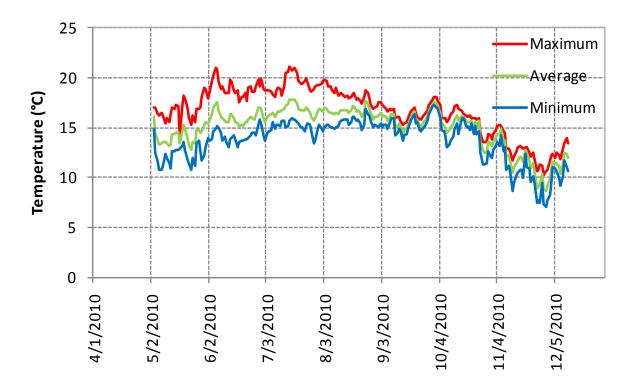
Figure 15: 2010 Thermograph maximum, average, and minimum daily values for the Quiota Creek (QC-2.71) temperature unit.

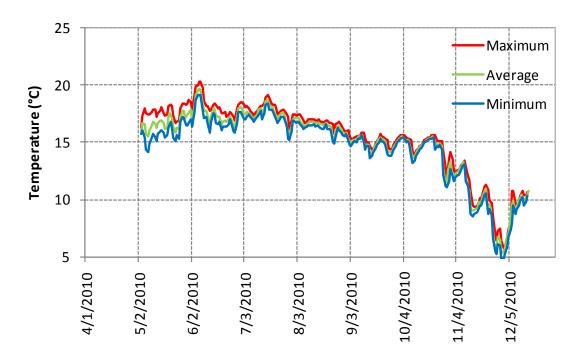
Figure 17: 2010 Thermograph maximum, average, and minimum daily values for El Jaro Creek (EJC-3.80), 50-feet upstream of the confluence with Salsipuedes Creek.

Recorded water temperatures were some of the coolest water temperatures observed in the El Jaro/Salsipuedes Creek drainage and remained below 20.5 °C throughout the period, possibly due to groundwater upwelling in the area (Figure 17). The 24-hour difference between maximum and minimum temperatures ranged from 0.5 °C to 3.2 °C for the entire deployment period.

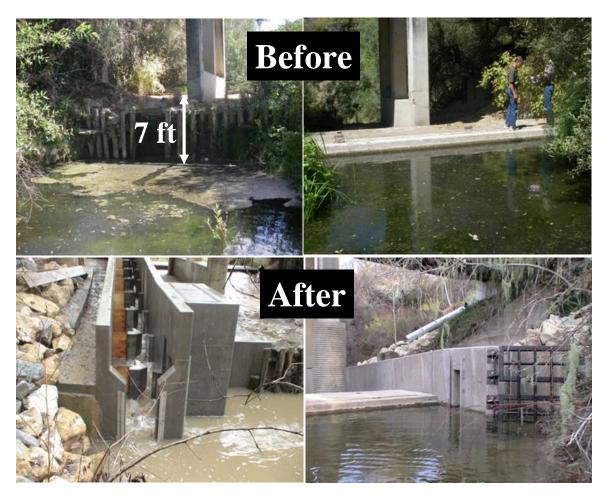
Figure 64: Fish passage and habitat restoration in the fall of 2008 at Rancho San Julian on El Jaro Creek.

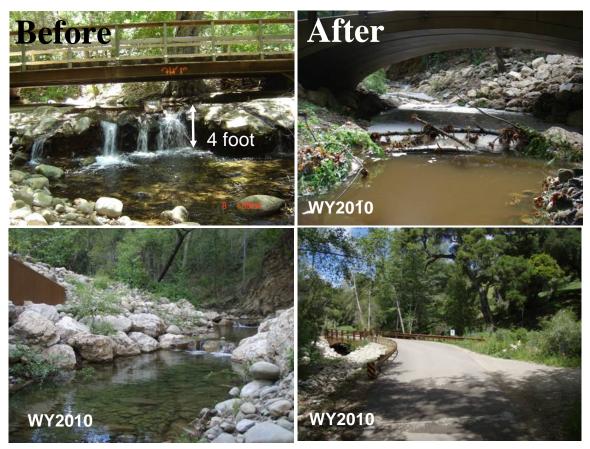
Figure 65: Fish passage and habitat restoration in the fall of 2008 at Refugio Road on Quiota Creek Crossing 6.
