WY2022 ANNUAL MONITORING SUMMARY

THE BIOLOGICAL OPINION FOR THE OPERATION AND MAINTENANCE OF THE CACHUMA PROJECT ON THE SANTA YNEZ RIVER IN SANTA BARBARA COUNTY, CALIFORNIA

**CACHUMA OPERATION AND MAINTENANCE BOARD
FISHERIES DIVISION**

JUNE 9, 2023

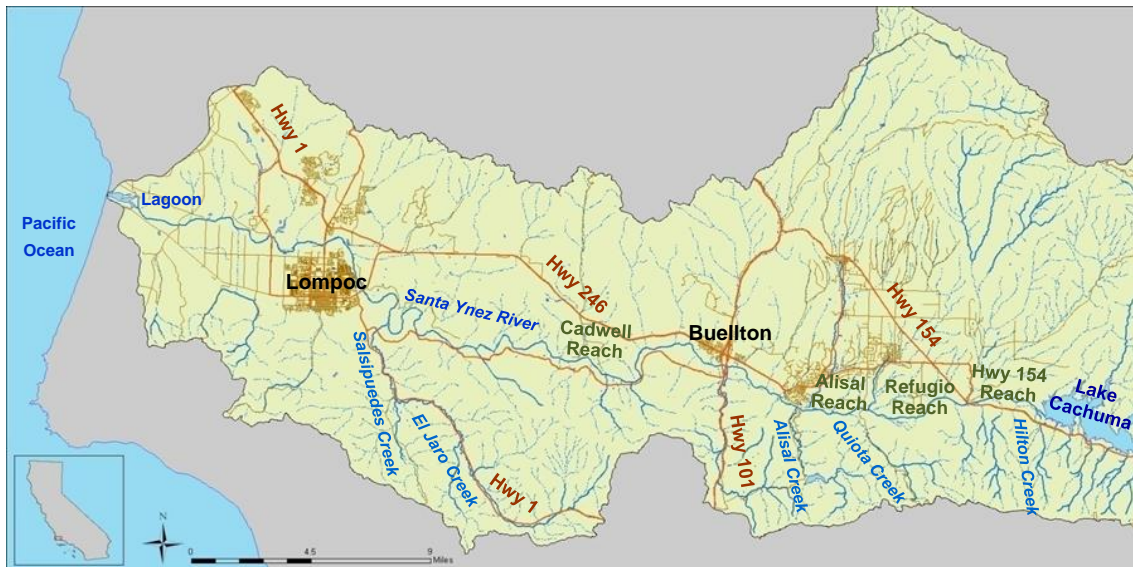
Figure ES-1: LSYR from Bradbury Dam and Lake Cachuma to the Pacific Ocean west of Lompoc, showing tributary creeks and management reaches of interest for the LSYR Fish Monitoring Program.

The monitoring tasks completed in WY2022 were performed below Bradbury Dam in the LSYR watershed and in Lake Cachuma, which is approximately half the drainage area (450 square miles) and stream distance (48 miles) to the ocean compared to the entire watershed. The area is within the Southern California Steelhead Distinct Population Segment (DPS) and the Monte Arido Highland Biogeographic Population Group (BPG) in the Southern Steelhead Recovery Planning Area (NMFS, 2012). Monitoring focused on three management reaches (Highway 154, Refugio, and Alisal reaches) and the Cadwell Reach on the LSYR mainstem, and tributaries (Hilton, Quiota, El Jaro, and Salspuedes creeks) known to support suitable habitat for *O. mykiss* (Figure ES-1).

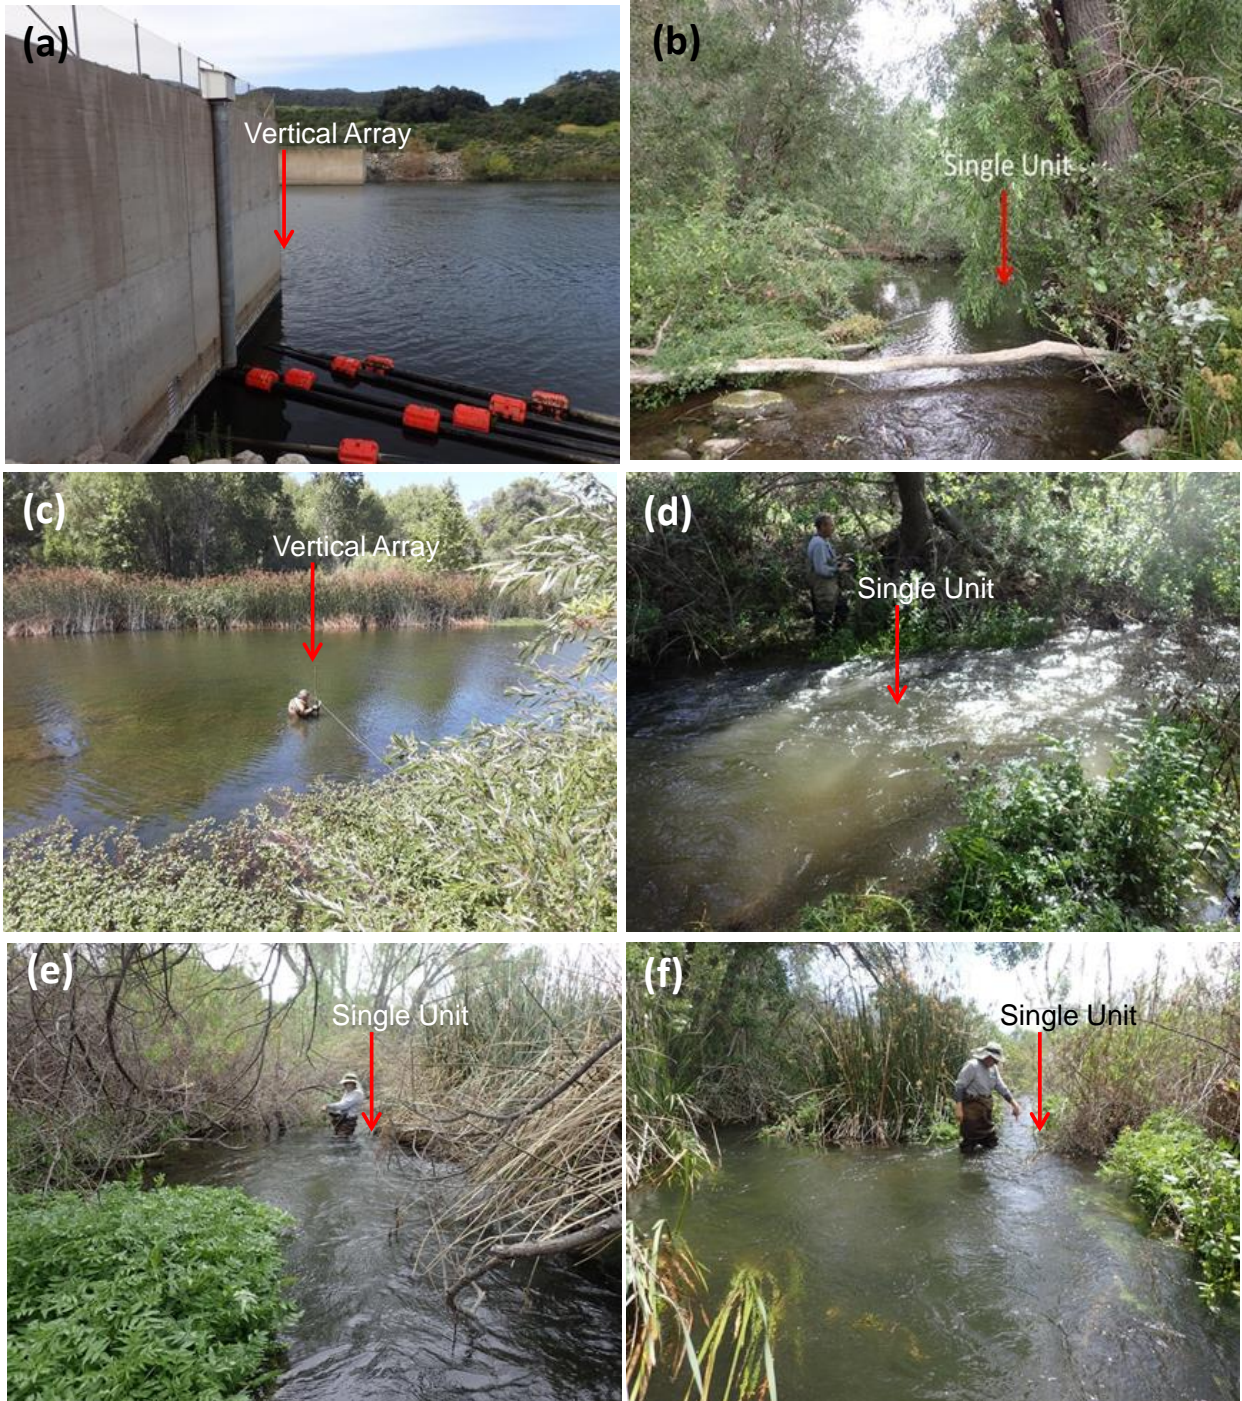
Figure 6: 2022 LSYR mainstem temperature unit deployment locations at: (a) LSYR-0.01, (b) LSYR-0.25, (c) LSYR-0.51, (d) LSYR-0.68, (e) LSYR-1.09, and (f) LSYR-1.54.

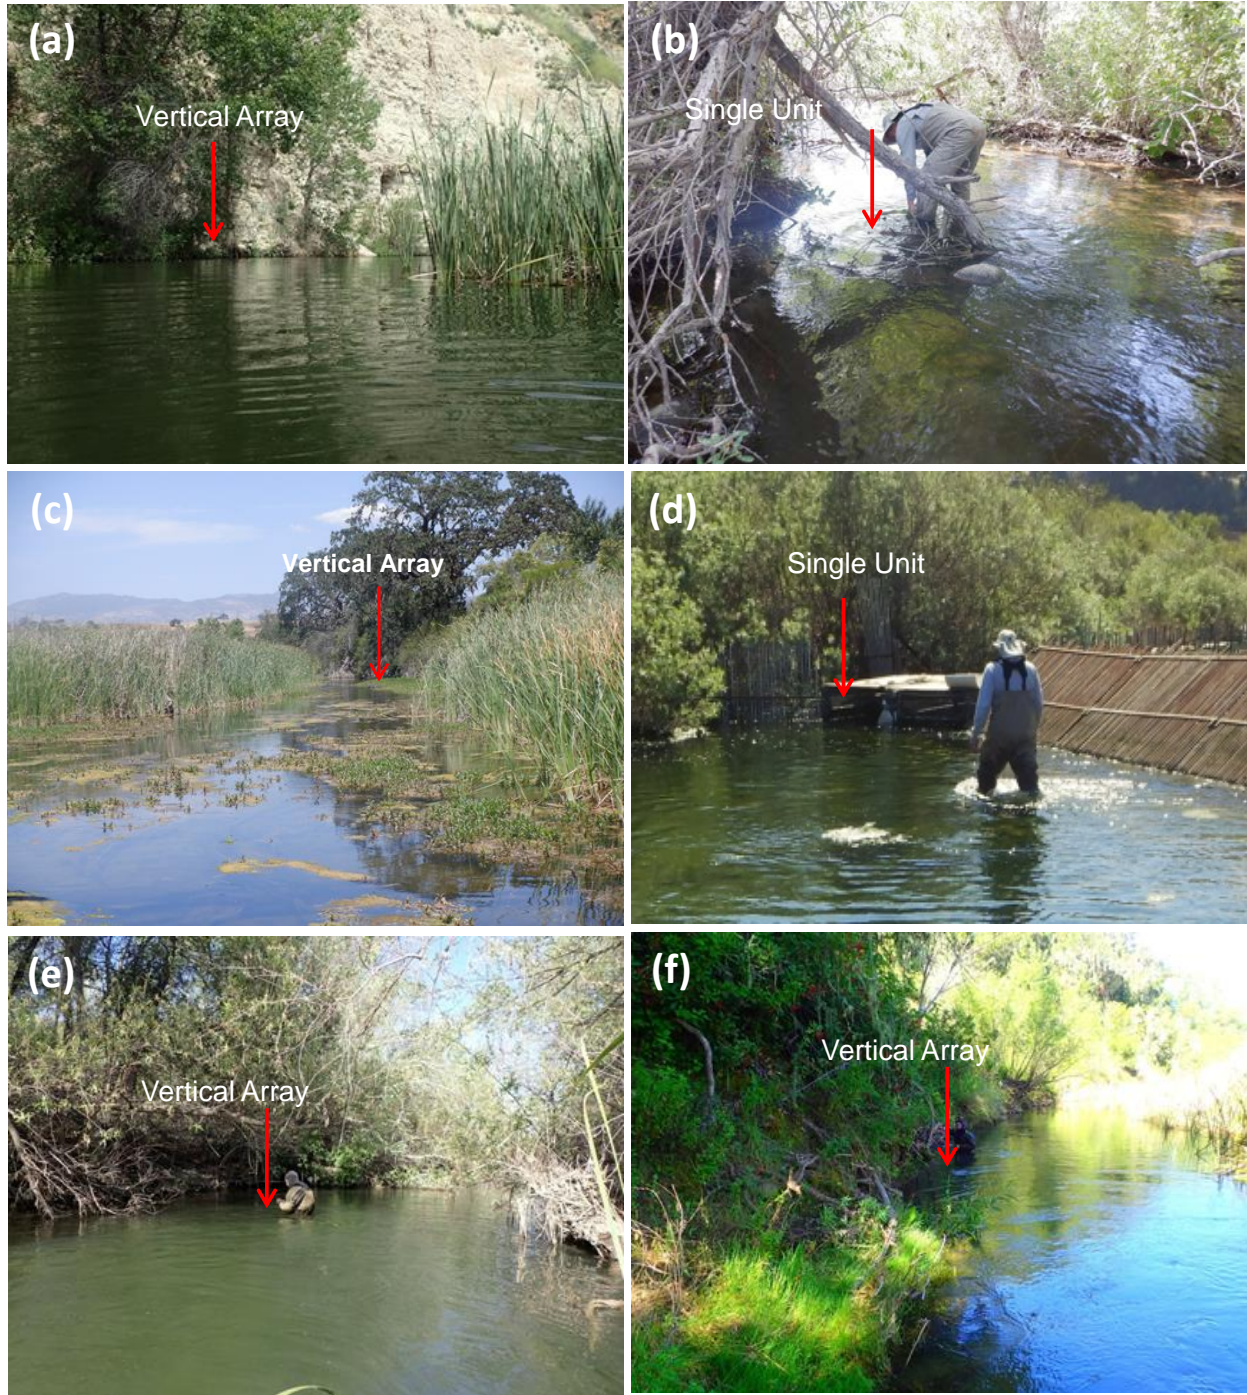
Figure 7: 2022 LSYR mainstem temperature unit deployment locations at: (a) LSYR-1.71, (b) LSYR-2.77, (c) LSYR-4.95, (d) LSYR-6.08, (e) LSYR-7.65, and (f) LSYR-8.7.

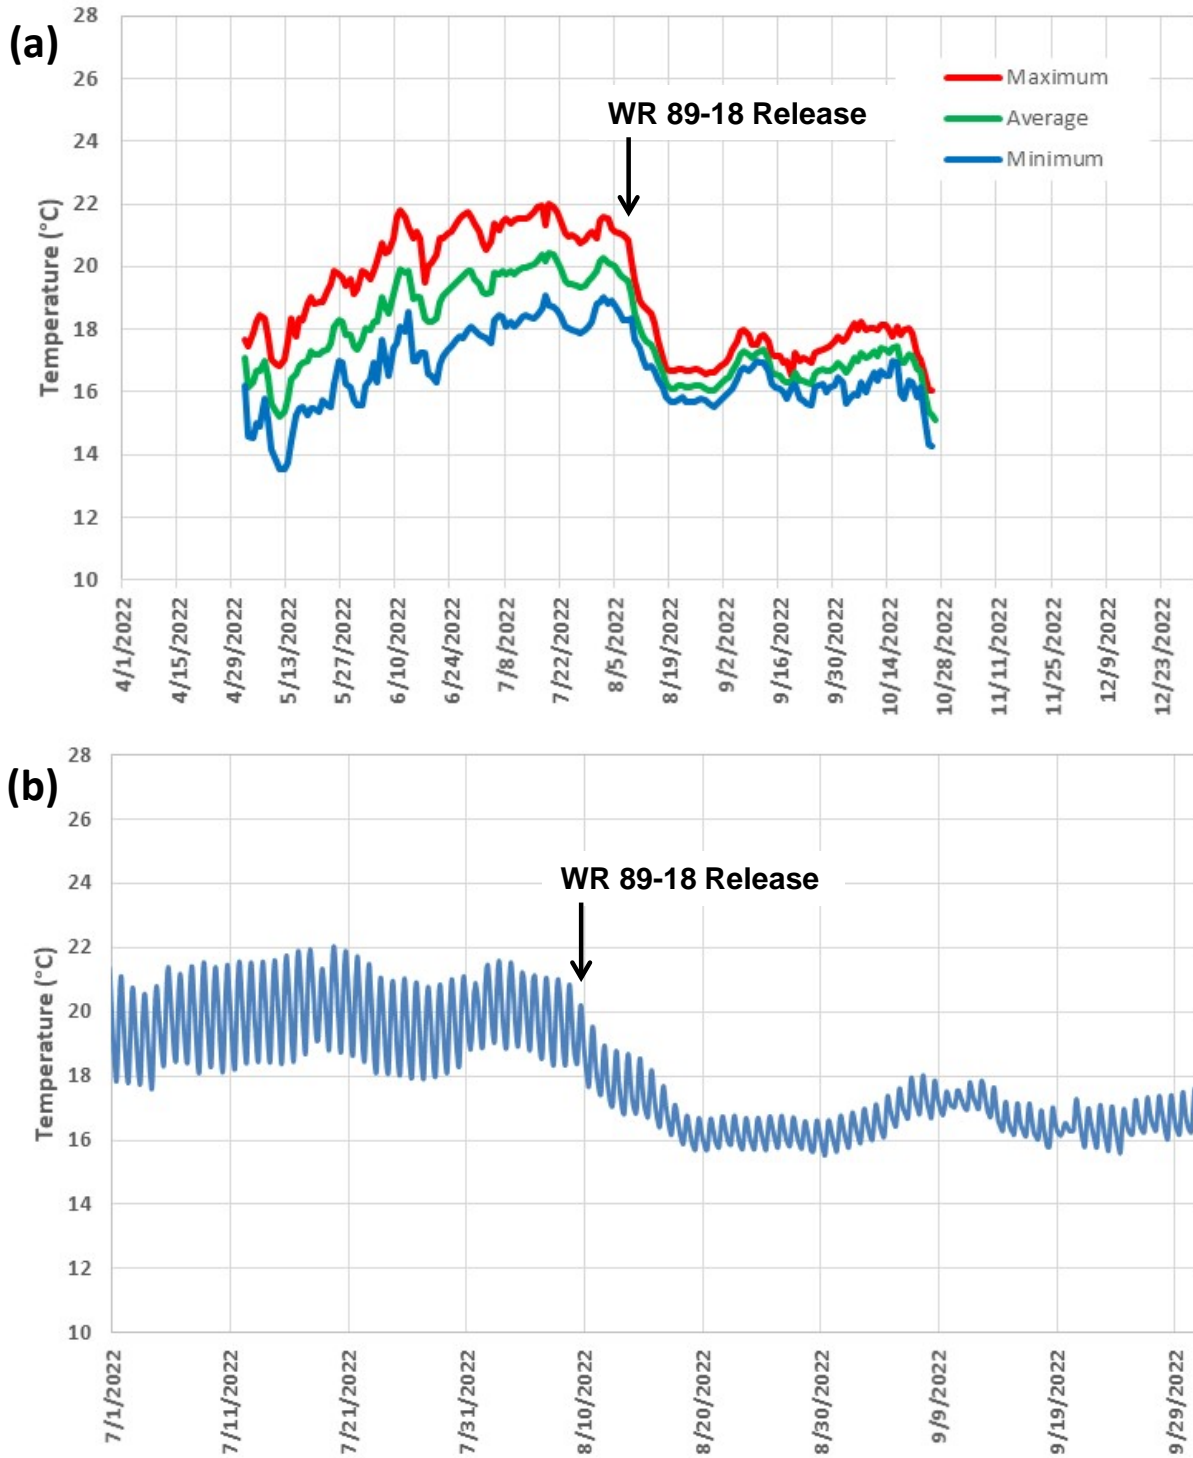
Figure 18: 2022 Reclamation property boundary at LSYSR-0.68 (downstream of the Long Pool) bottom (2 feet) thermograph for (a) daily maximum, average, and minimum values and (b) hourly data from 7/1/22 through 10/1/22.

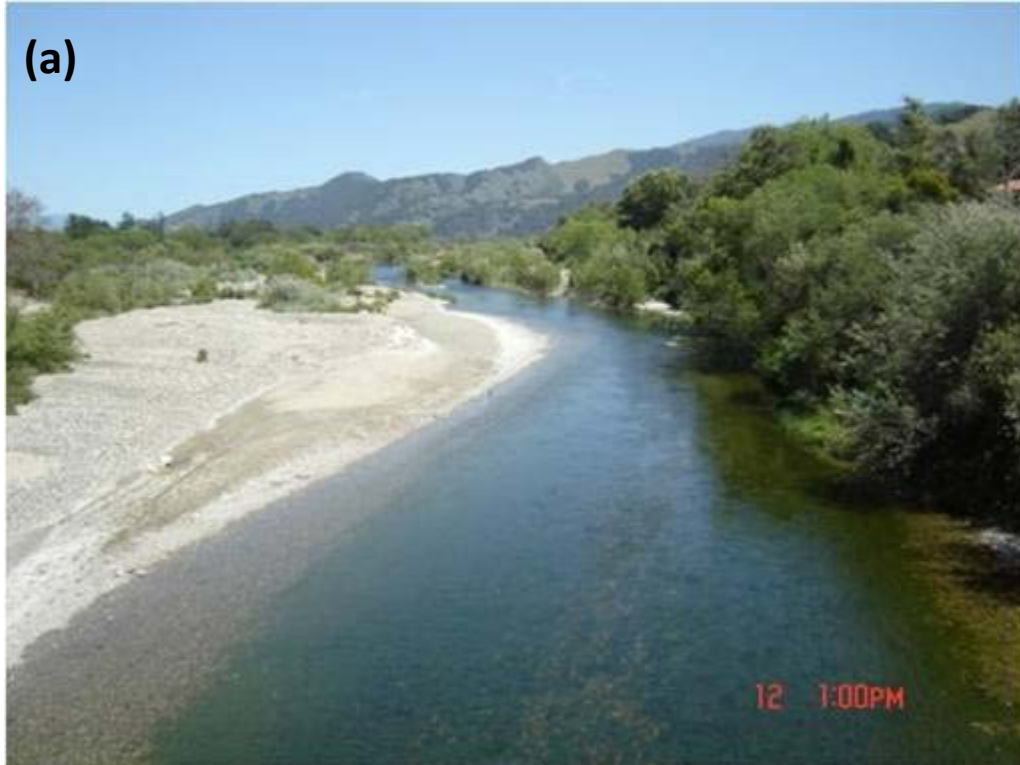
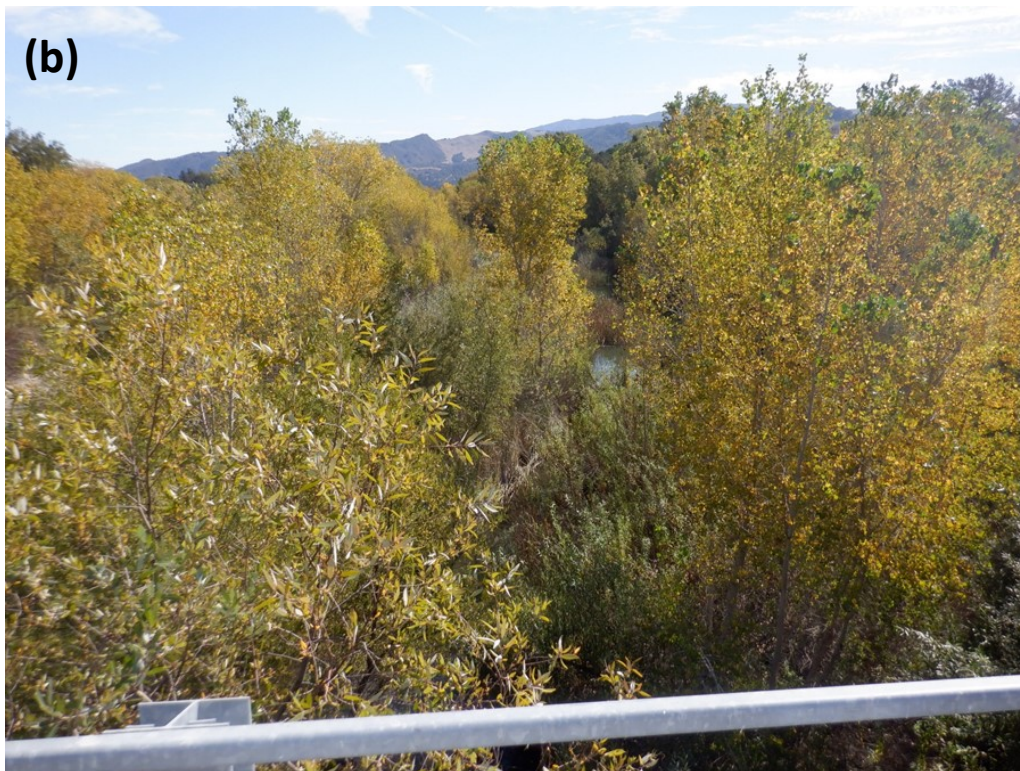
Figure 57: Photo points (M-6) collected at Highway 154 Bridge looking downstream in (a) September 2005 and (b) October 2022.

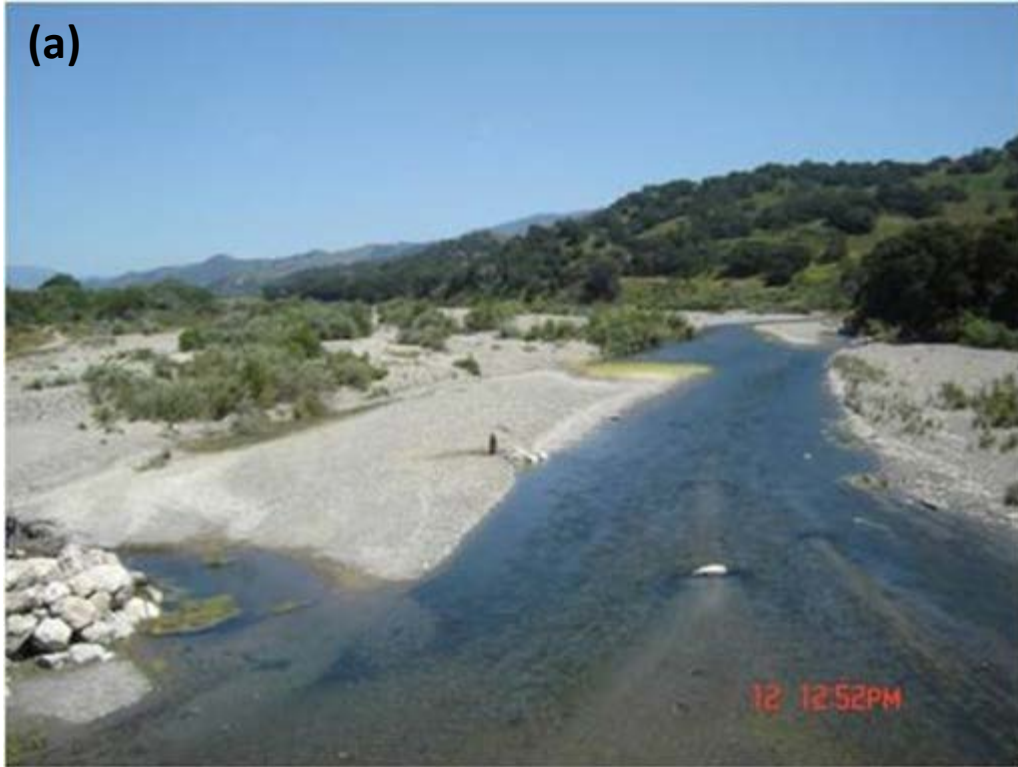
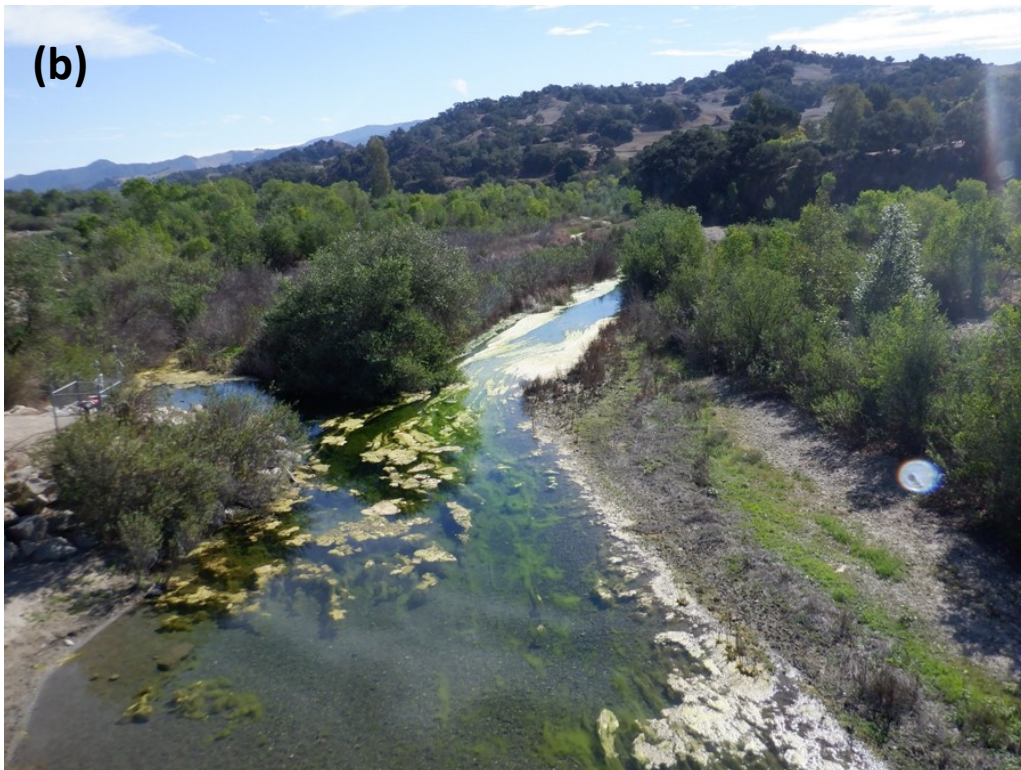
Figure 58: Photo point (M-12) collected at Refugio Bridge looking upstream in (a) May 2005, and (b) October 2022.

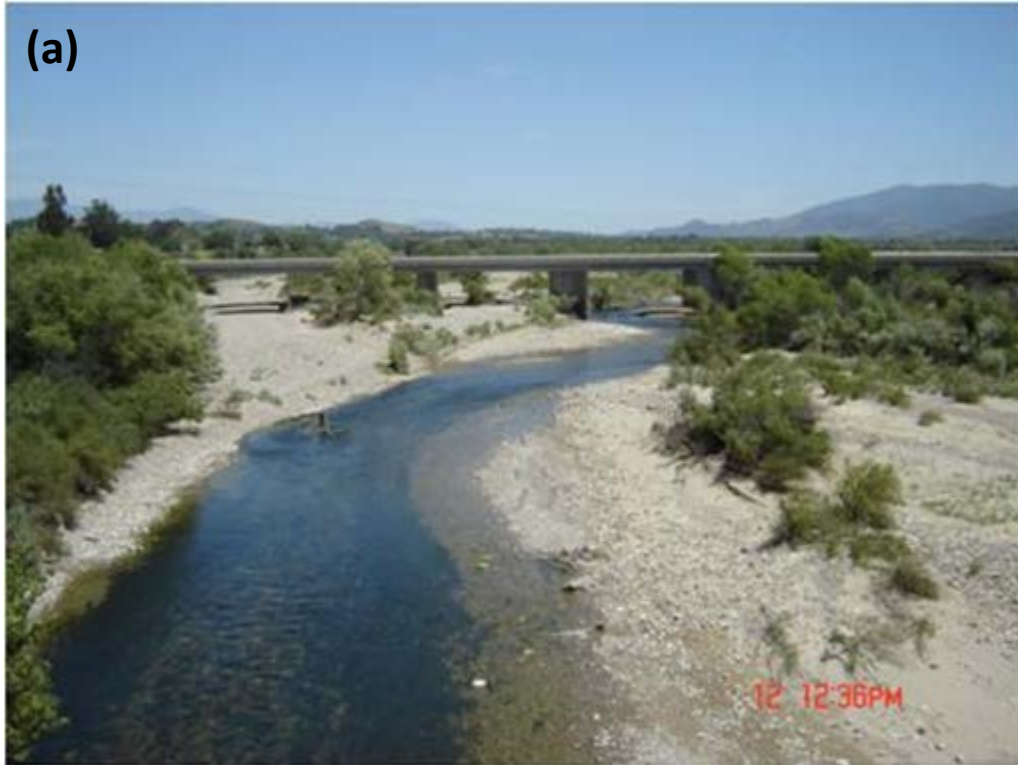
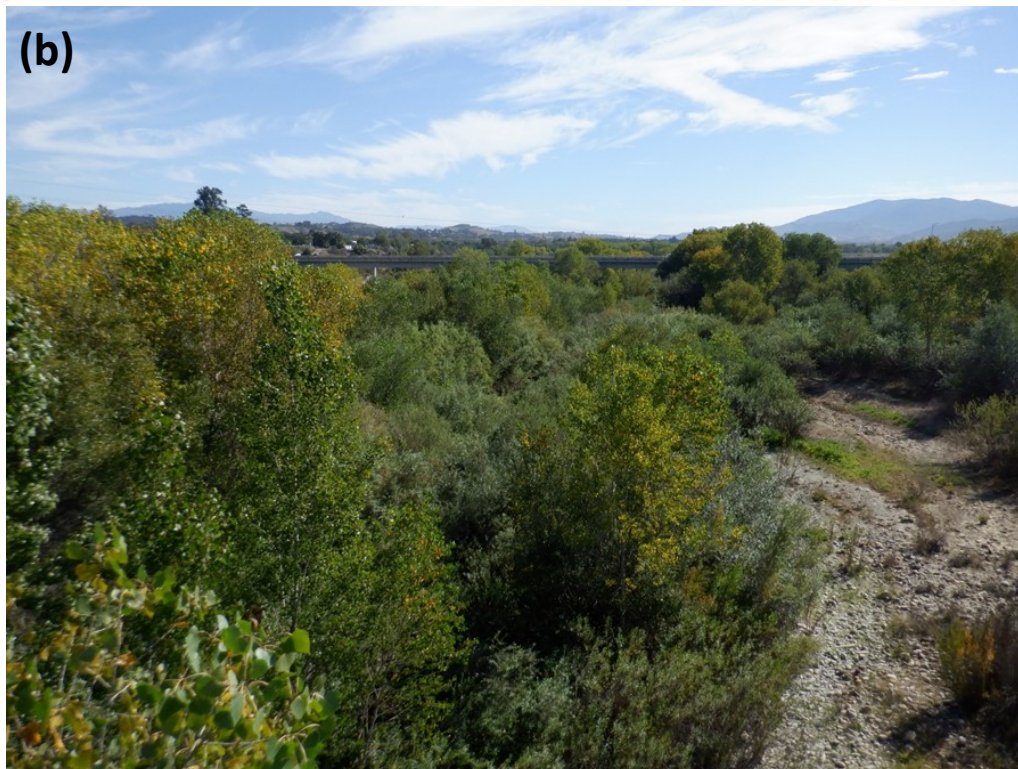
Figure 59: Photo point (M-14) collected at Alisal Bridge looking upstream in a) May 2005, and b) October 2022.

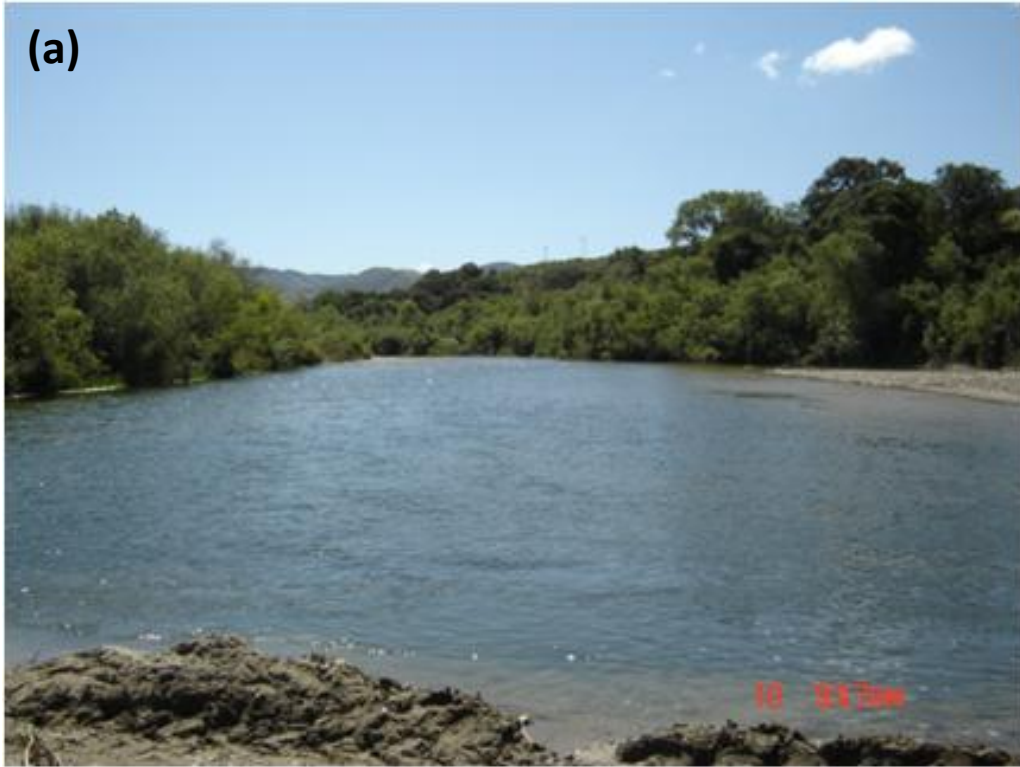
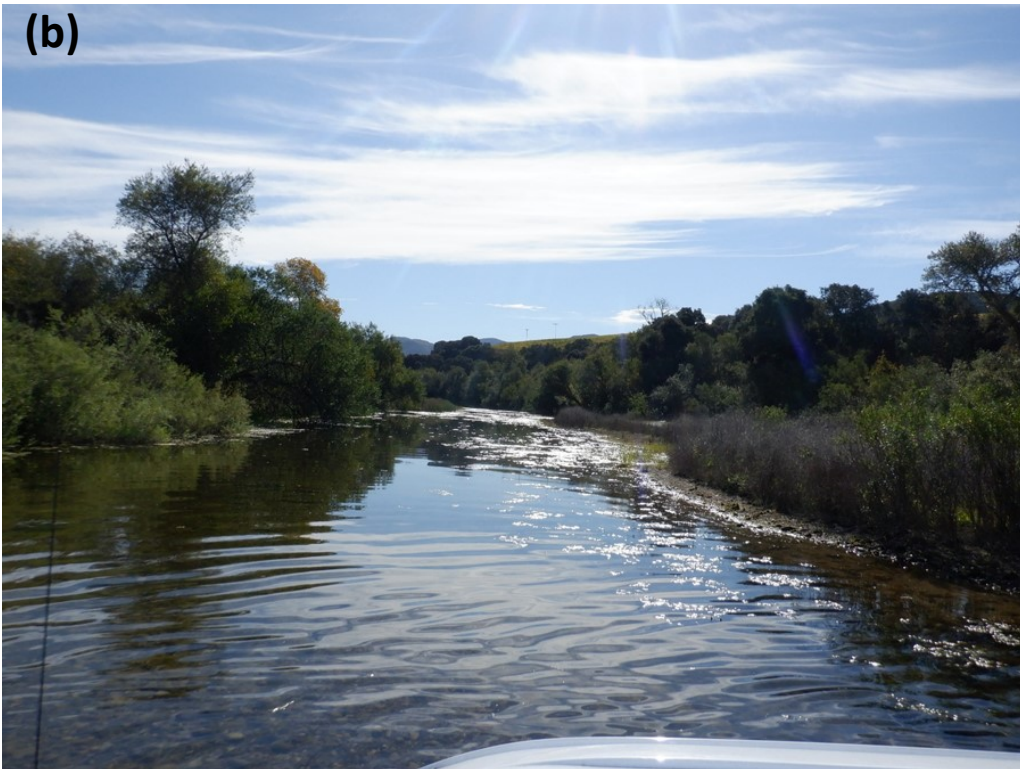
Figure 60: Photo point (M-19) collected at Avenue of the Flags Bridge looking upstream in (a) May 2005, and (b) October 2022.

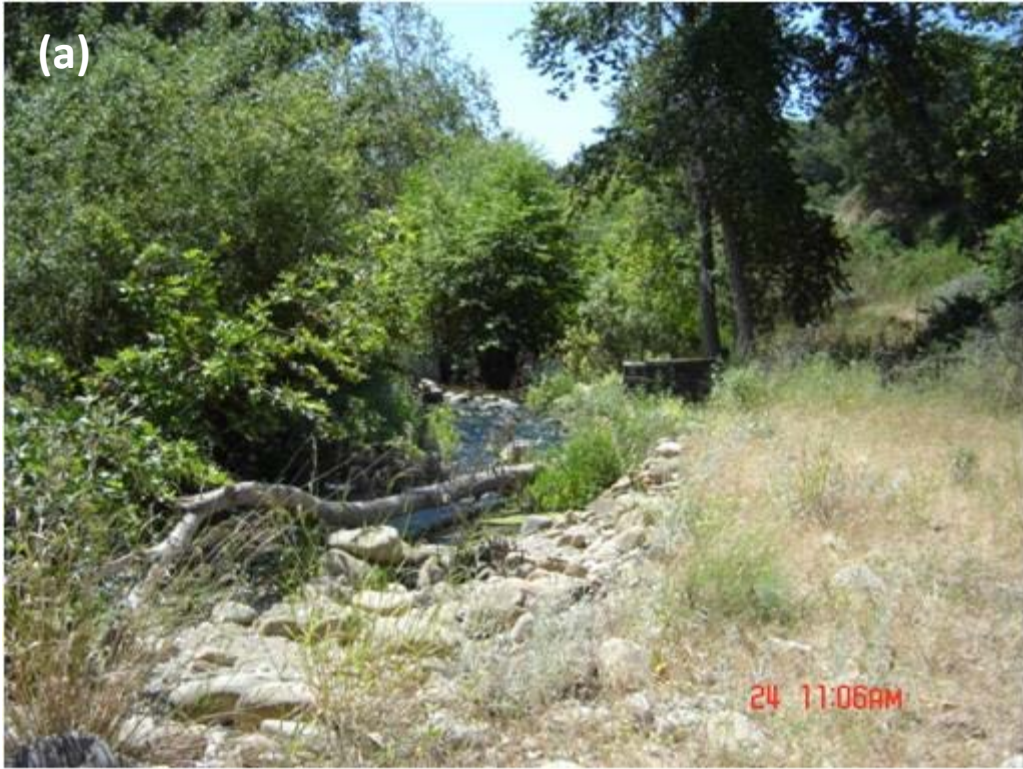
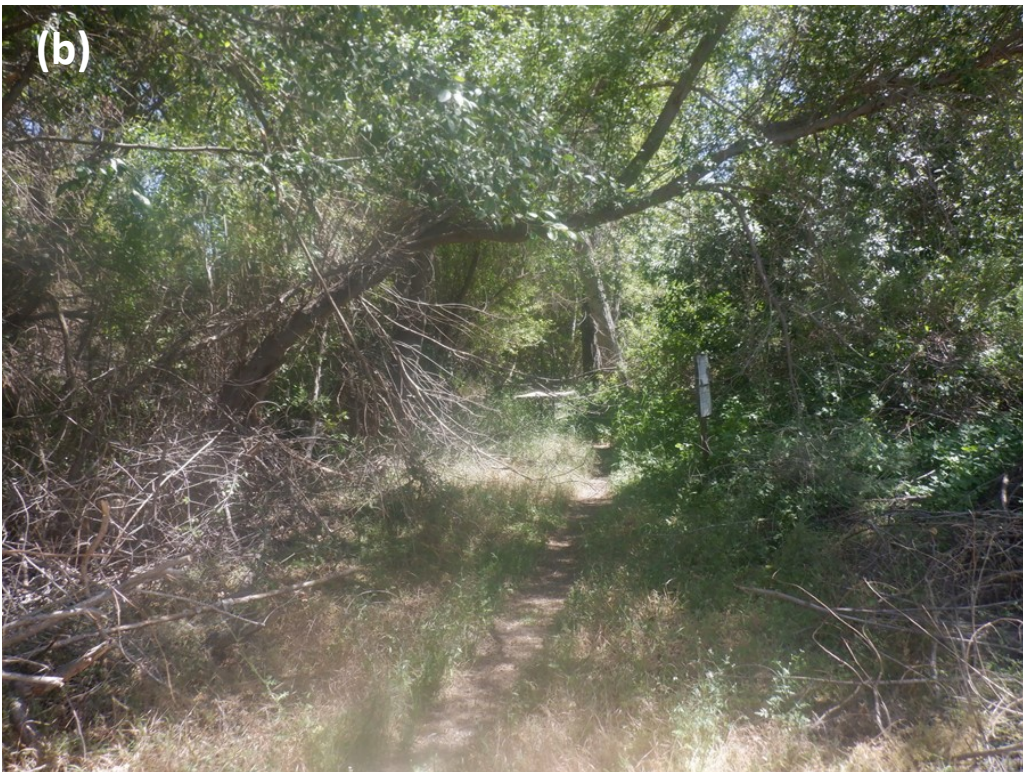
Figure 61: Photo point (M-21) collected at Sweeney Road Crossing looking upstream in (a) May 2005, and (b) October 2022.

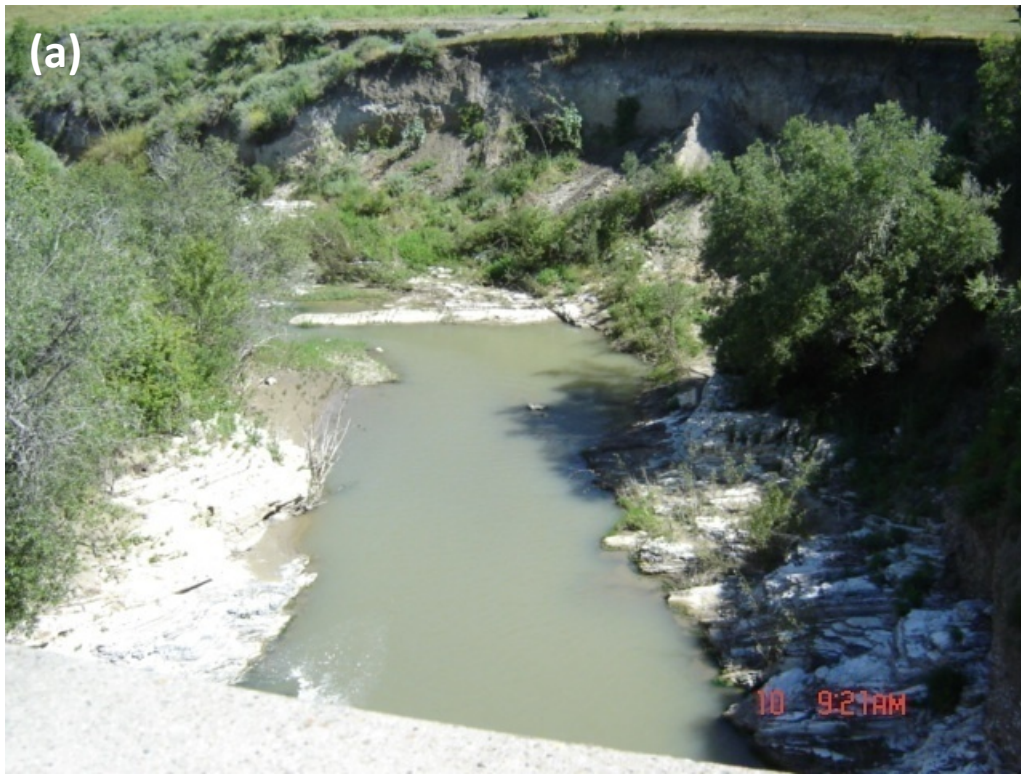
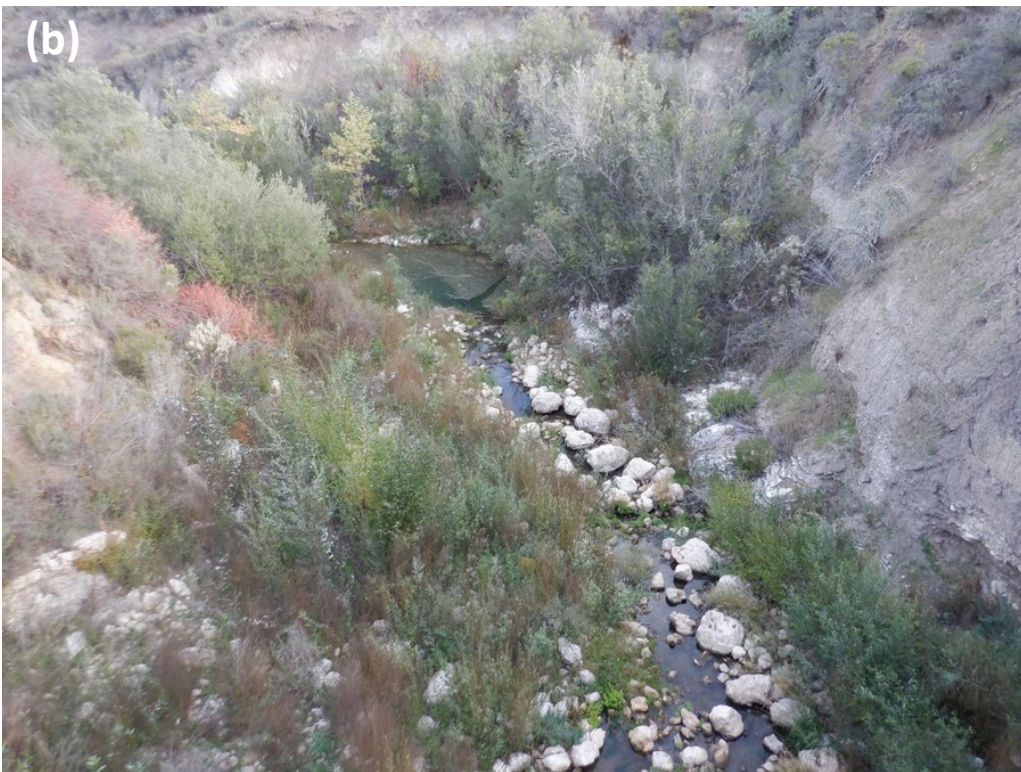
Figure 65: Photo point (T-39) collected at Salsipuedes Creek at Hwy 1 Bridge in May 2005 and (b) October 2022 (Post CalTrans Hwy 1 Bridge Replacement Project).

Figure 65: Photo point (T-39) collected at Salsipuedes Creek at Hwy 1 Bridge in May 2005 and (b) October 2022 (Post CalTrans Hwy 1 Bridge Replacement Project).

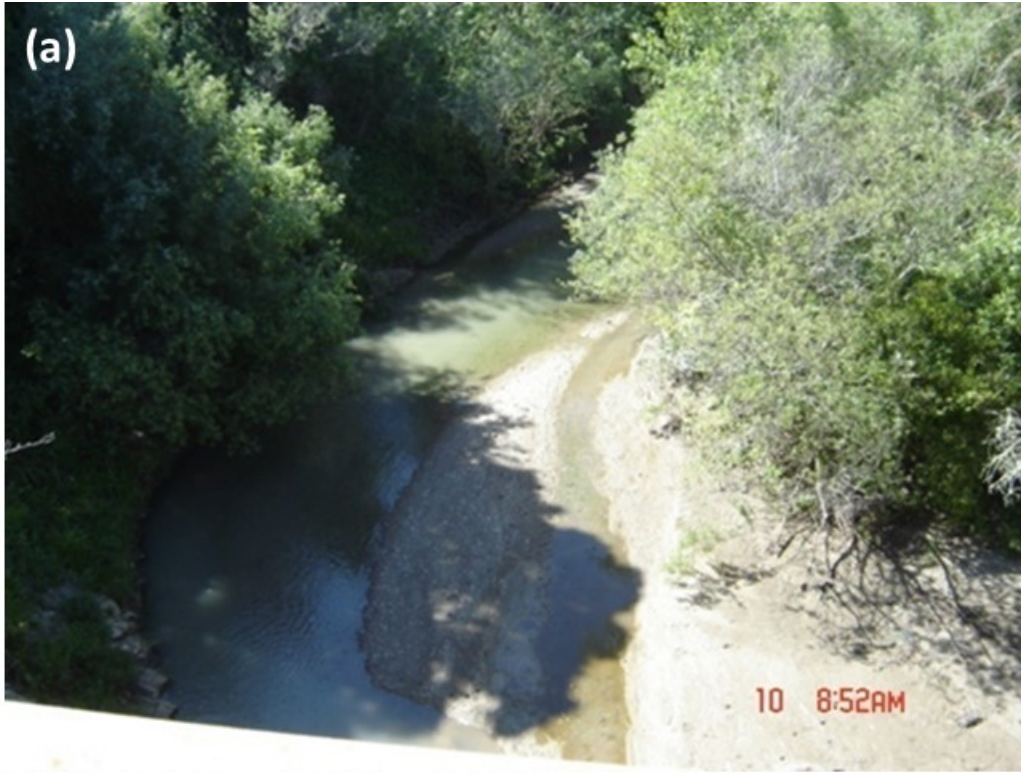
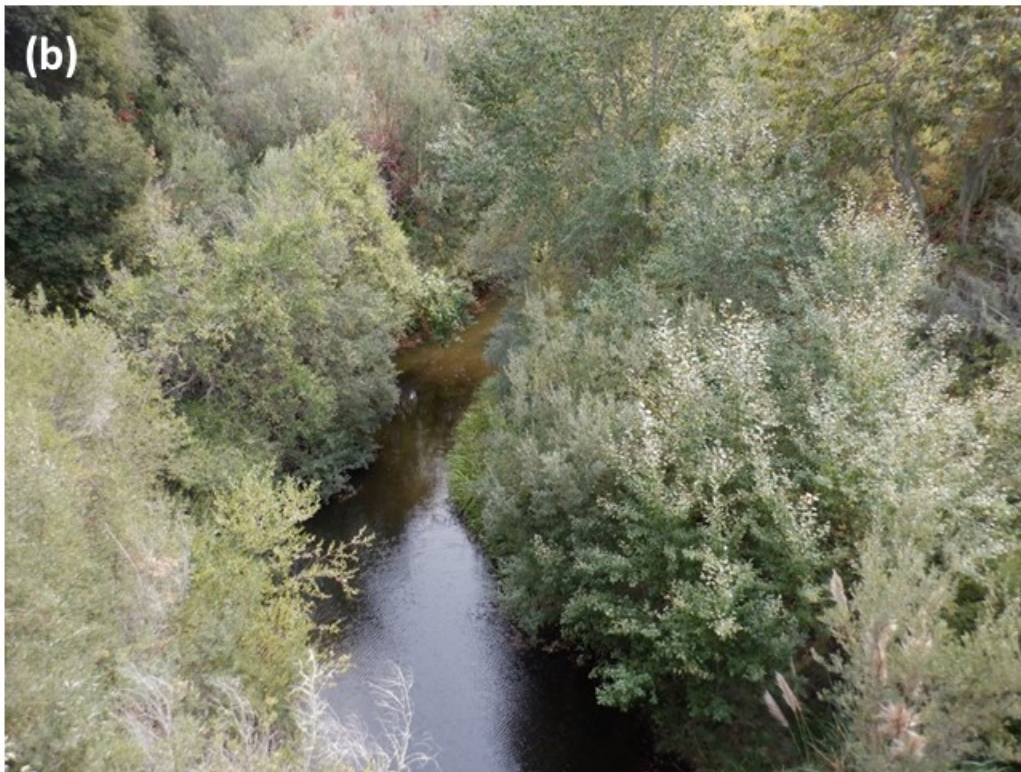
Figure 66: Photo point (T-42) collected at Salsipuedes Creek at Jalama Road Bridge in May 2005 and (b) October 2022.

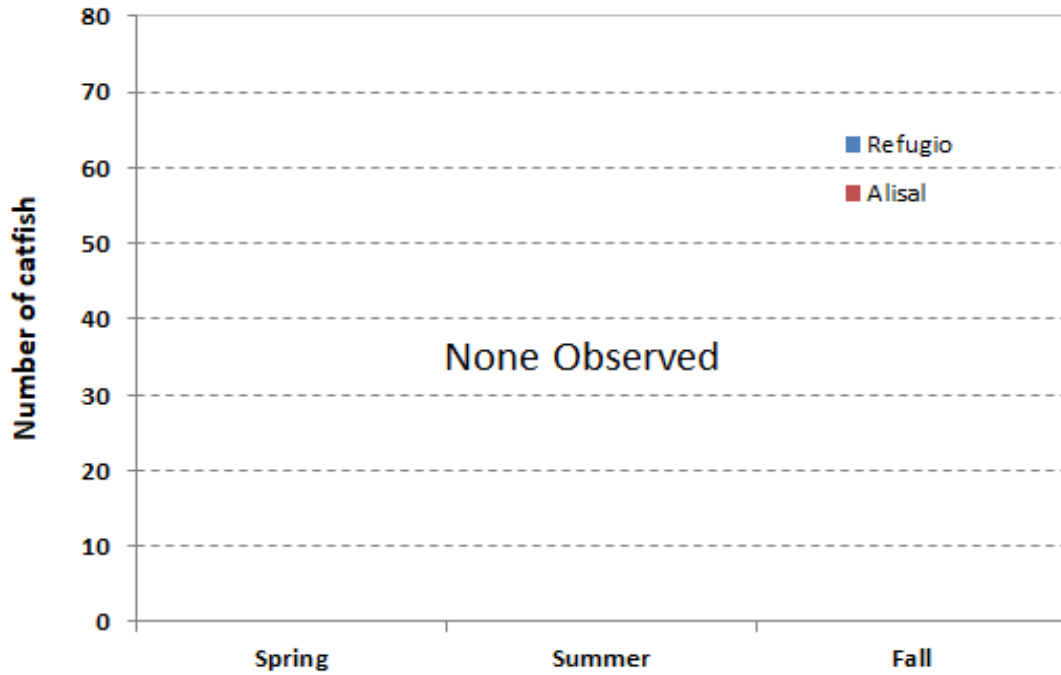
Figure 86: Count of warm water predators, (a) catfish and (b) carp, observed in Refugio and Alisal reaches during the spring, summer, and fall snorkel surveys in 2022.

Figure 86: Count of warm water predators, (a) catfish and (b) carp, observed in Refugio and Alisal reaches during the spring, summer, and fall snorkel surveys in 2022.

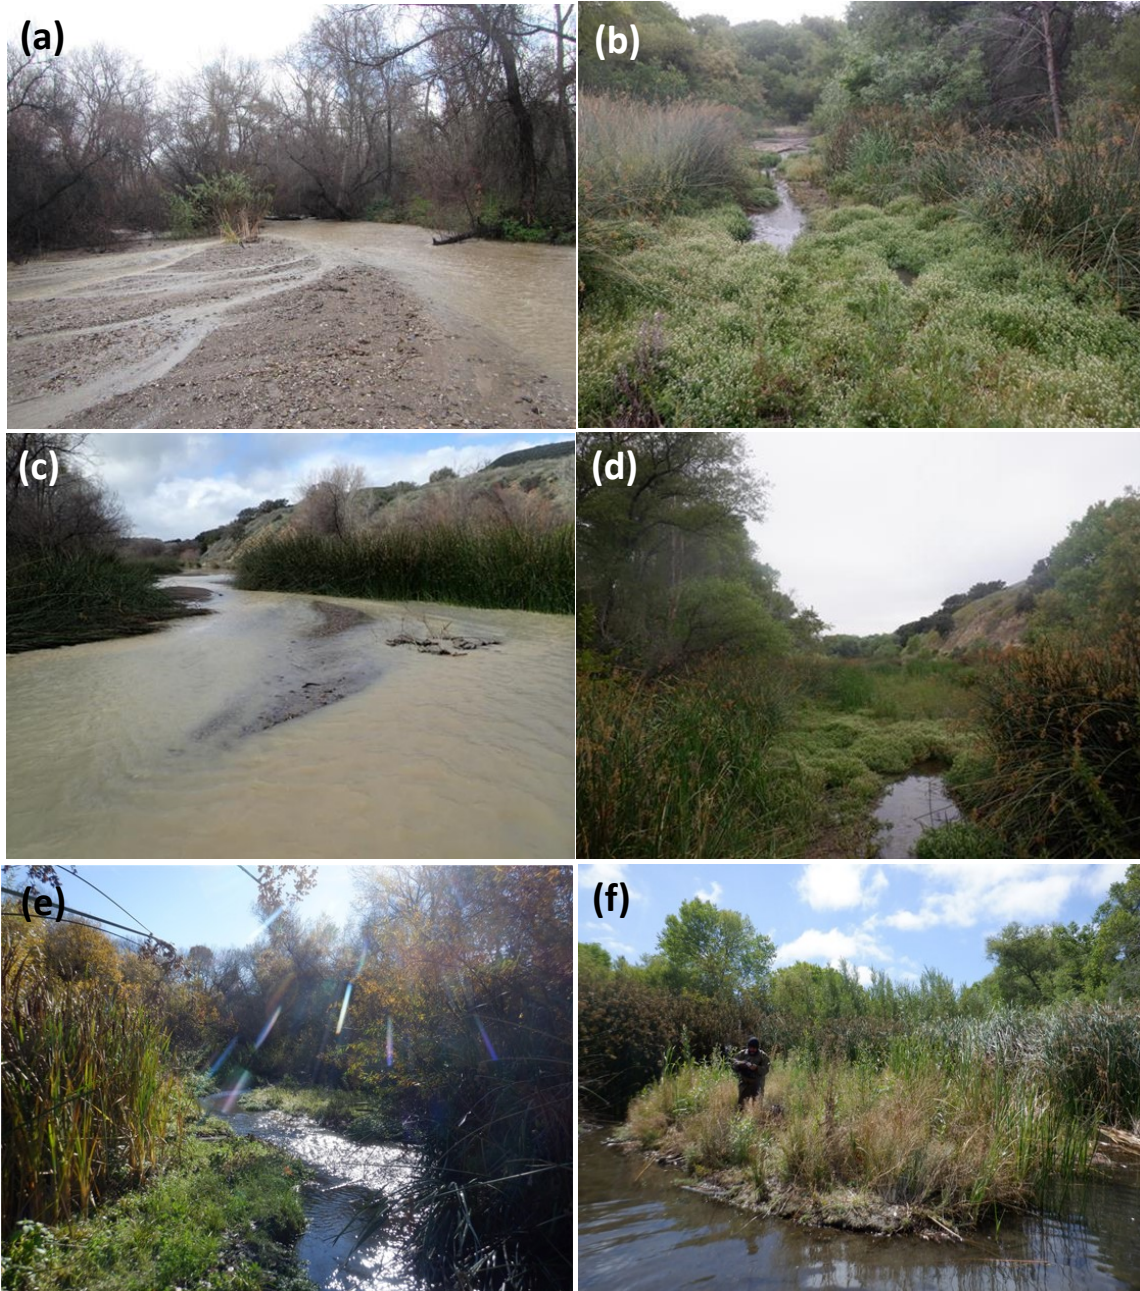
Figure 92: Delta formation at the head of the Long Pool along the LSYR mainstem looking up towards the Hilton Creek confluence on (a) 2/4/19 and (b) 5/29/20, and looking down towards the Long Pool on (c) 2/5/19, (d) 11/16/20, (e) 1/3/22, and (f) 7/6/22 showing a newly defined and evolving channel and significant riparian vegetation growth.

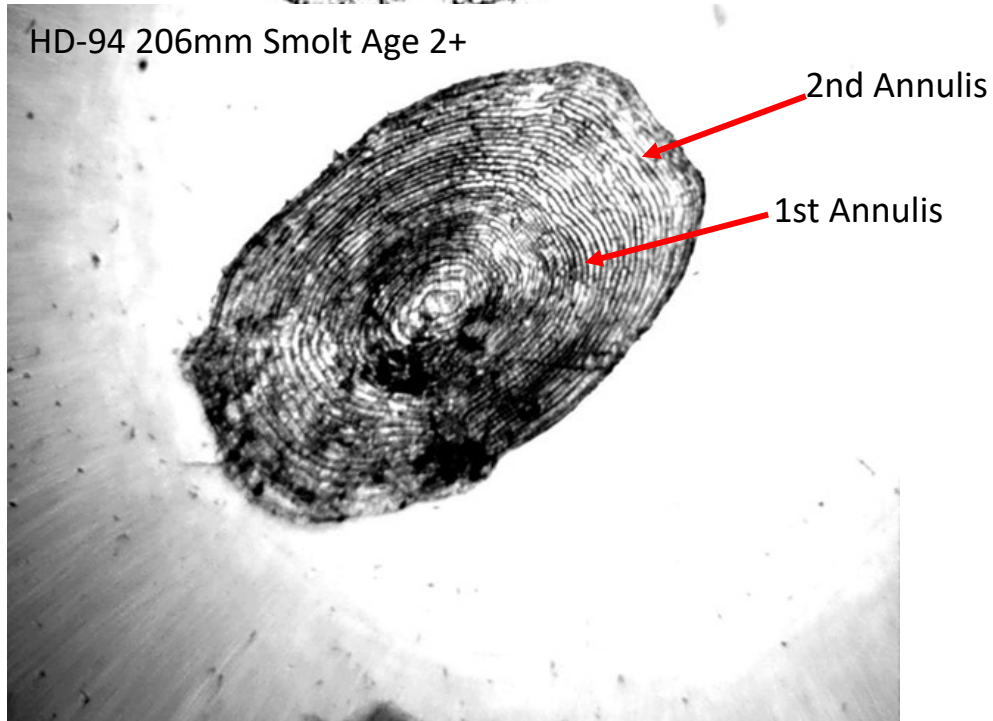
Figure 101: Two WY2016 Hilton Creek downstream migrating smolts, a (a) 151 mm aged at 1+ and (b) a 206 mm aged at 2+ fish.

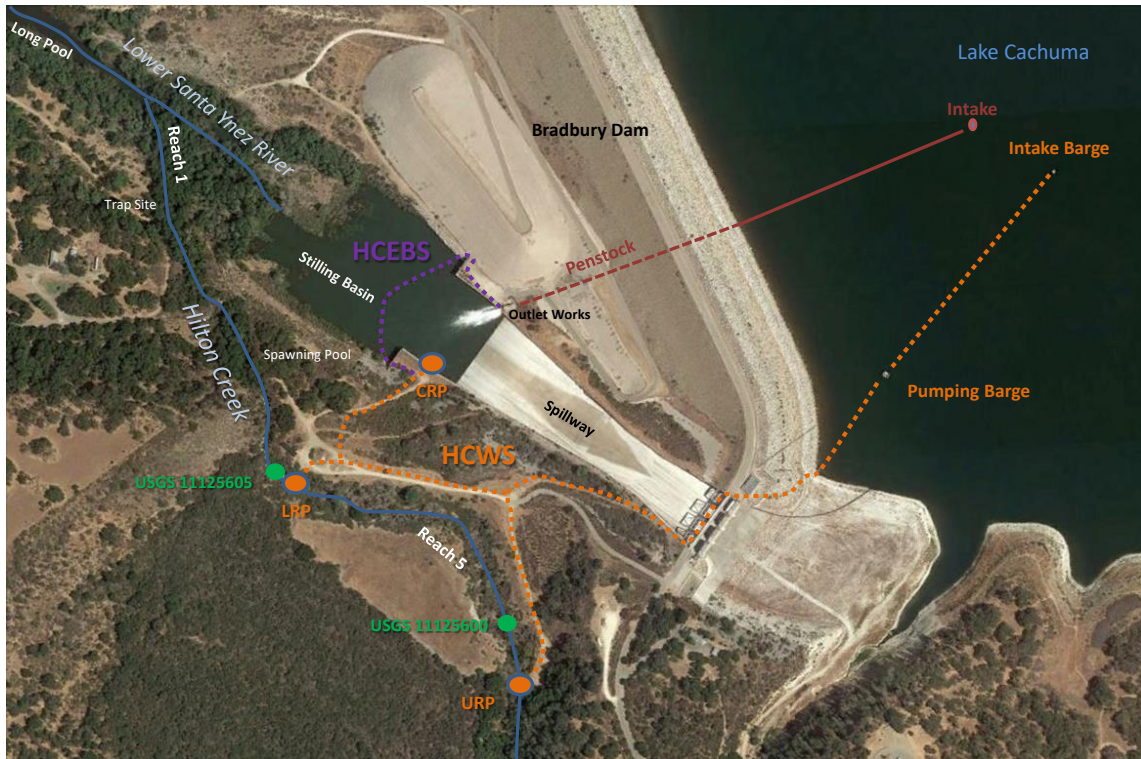
Figure 104: Release points from Lake Cachuma and Bradbury Dam.

There are three pathways for releases from Bradbury Dam at Lake Cachuma to the downstream fishery: the spillway (only used during high flow events), the Outlet Works (OW) release to the LSYR and to Hilton Creek through the Watering System (HCWS) and Hilton Creek Emergency Backup System (HCEBS) (Figure 104). The HCWS and HCEBS release to Hilton Creek at the Upper Release Point (URP) and Lower Release Point (LRP), each with an energy diffuser box and cascade to increase the dissolved oxygen concentrations (Figure 105). Hilton Creek confluences with the LSYR just downstream of the Stilling Basin. The intake for the HCWS is set at 65 feet of depth (below the thermocline) whereas the intake for the HCEBS is the bottom of the lake.
