WY2022 ANNUAL MONITORING SUMMARY

THE BIOLOGICAL OPINION FOR THE OPERATION AND MAINTENANCE OF THE CACHUMA PROJECT ON THE SANTA YNEZ RIVER IN SANTA BARBARA COUNTY, CALIFORNIA

**CACHUMA OPERATION AND MAINTENANCE BOARD
FISHERIES DIVISION**

JUNE 9, 2023

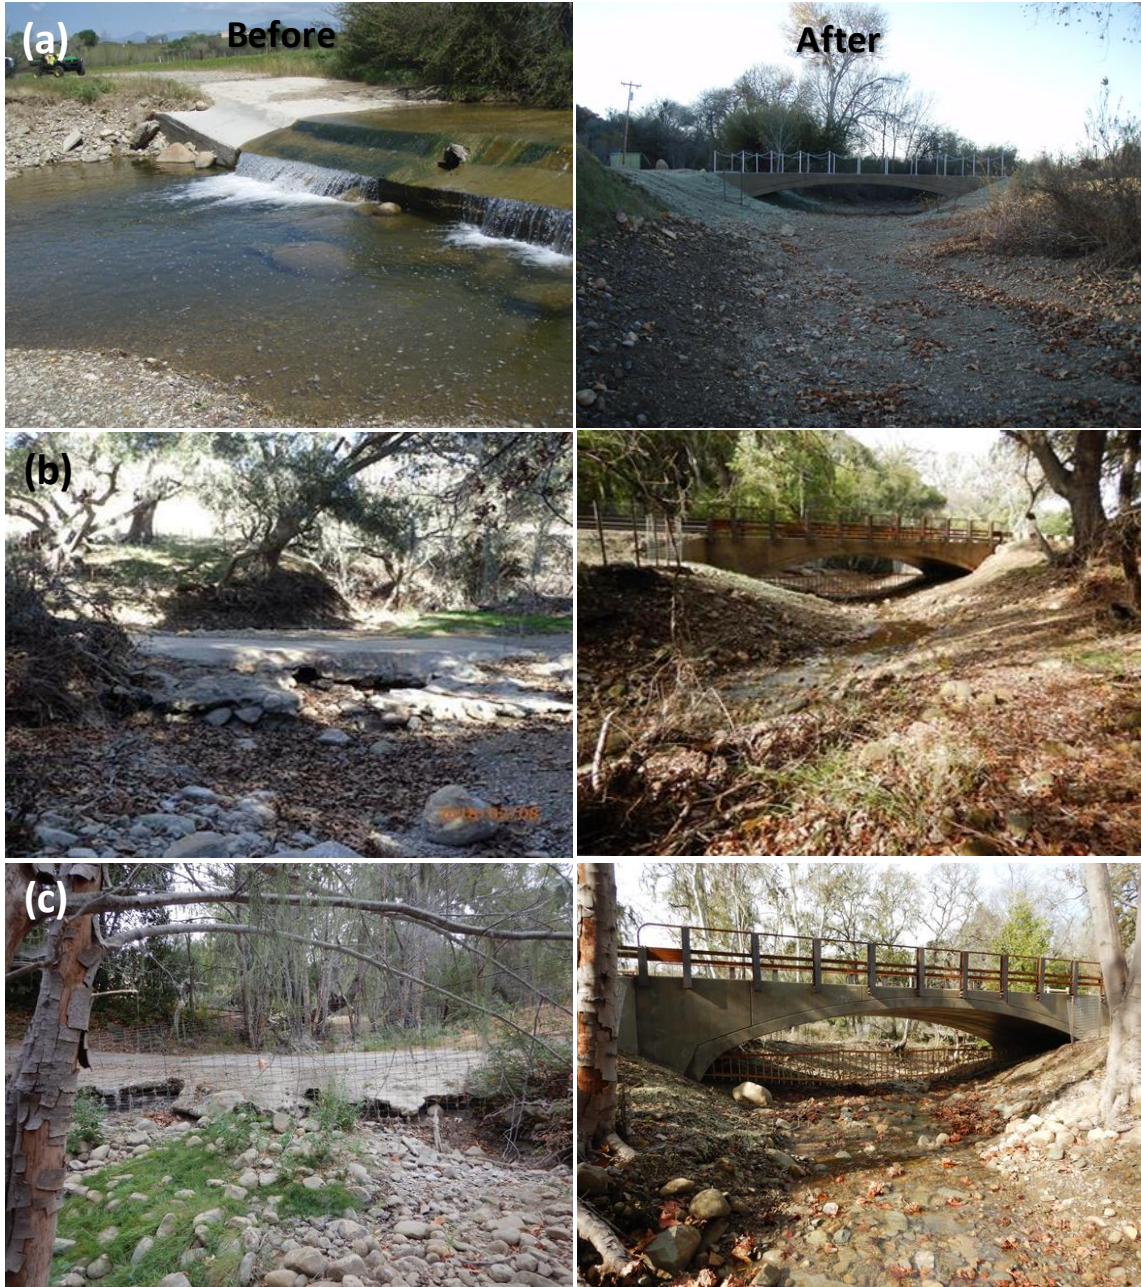
Figure 113: Fish passage and habitat restoration at (a) Quiota Creek Crossing 0A (2015), (b) Quiota Creek Crossing 5 (2018), and (c) Quiota Creek Crossing 9 (2018).

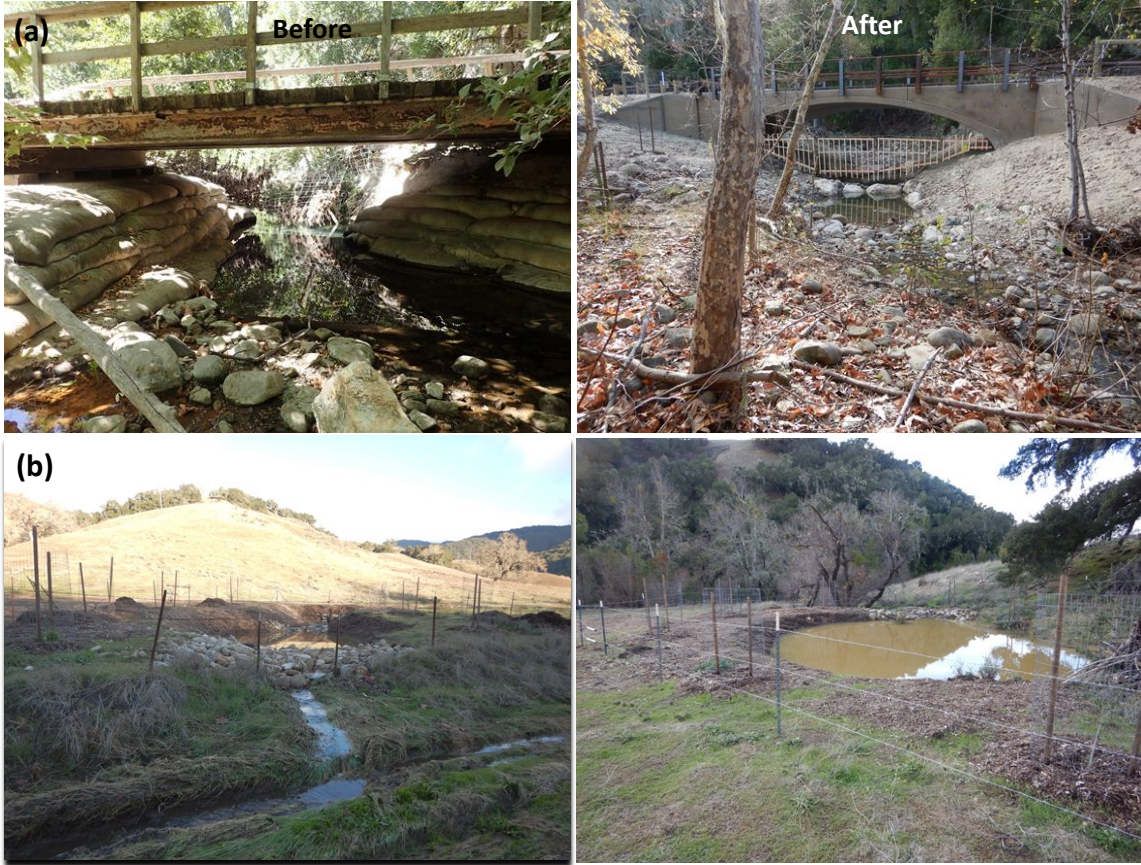
Figure 114: Fish passage and habitat restoration at (a) Quiota Creek Crossing 8 completed in 2019 and (b) South Side Erosion Control and Reforestation Project at Crossing 8 (completed in 2020).
