WY2025 ANNUAL MONITORING SUMMARY

THE BIOLOGICAL OPINION FOR THE OPERATION AND MAINTENANCE OF THE CACHUMA PROJECT ON THE SANTA YNEZ RIVER IN SANTA BARBARA COUNTY, CALIFORNIA

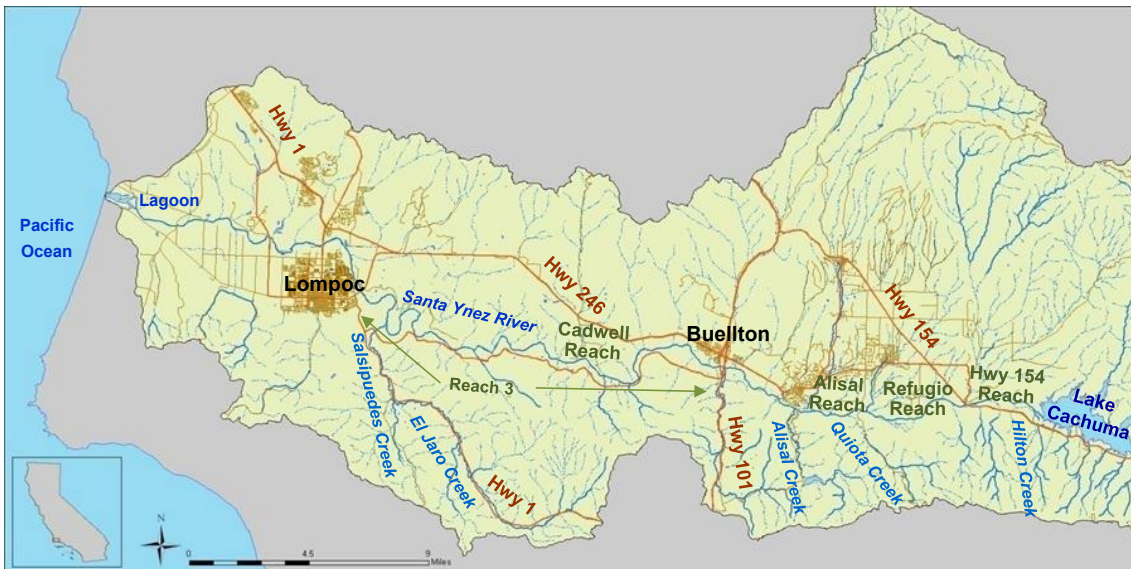
Figure ES-1: LSYR from Bradbury Dam and Lake Cachuma to the Pacific Ocean west of Lompoc, showing tributary creeks and management reaches of interest for the LSYR Fish Monitoring Program.

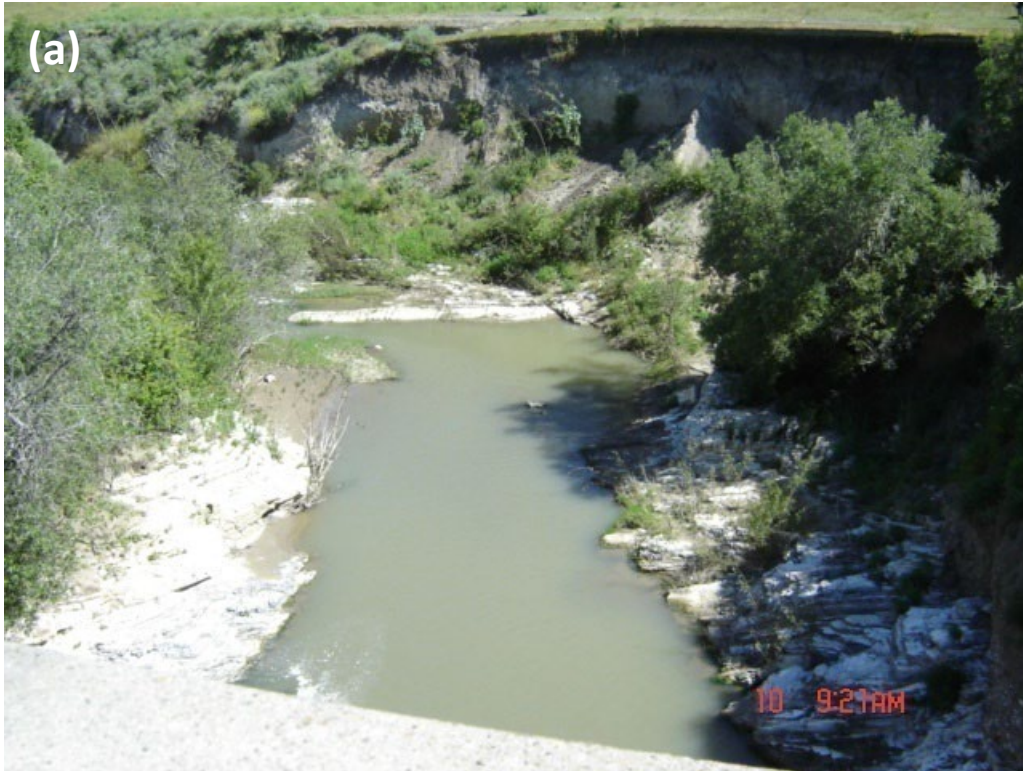
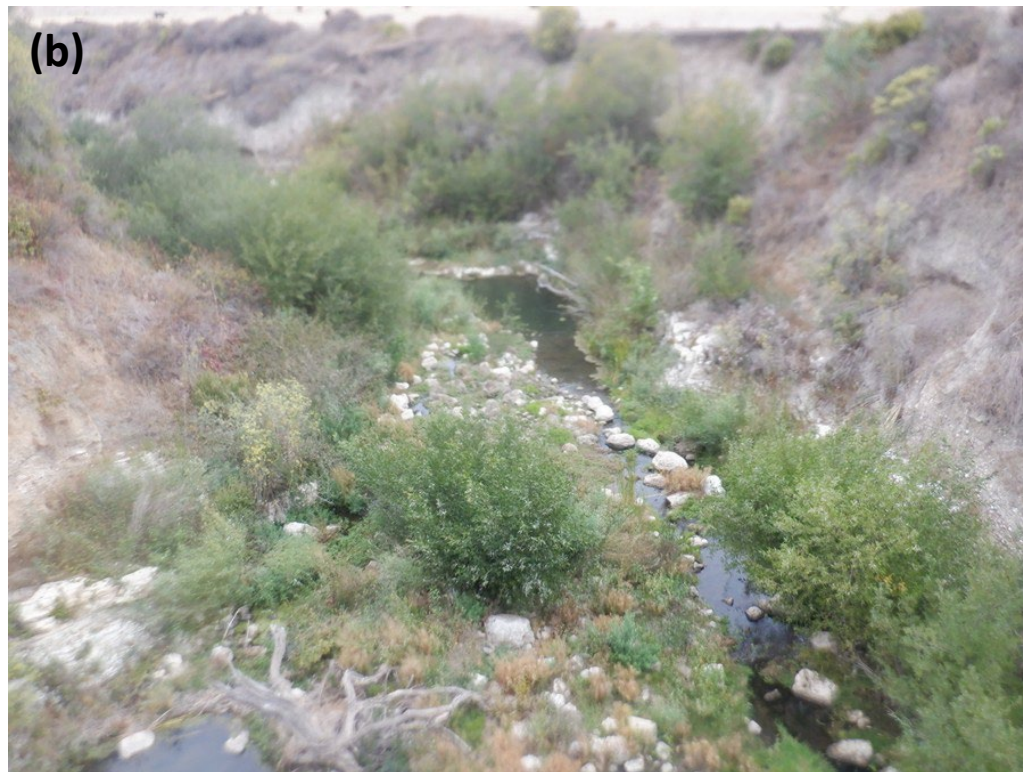
Figure 64: Photo point (T-39) collected at Salsipuedes Creek at Hwy 1 Bridge in May 2005 and (b) September 2025 (Post CalTrans Hwy 1 Bridge Replacement Project-continues to unravel).

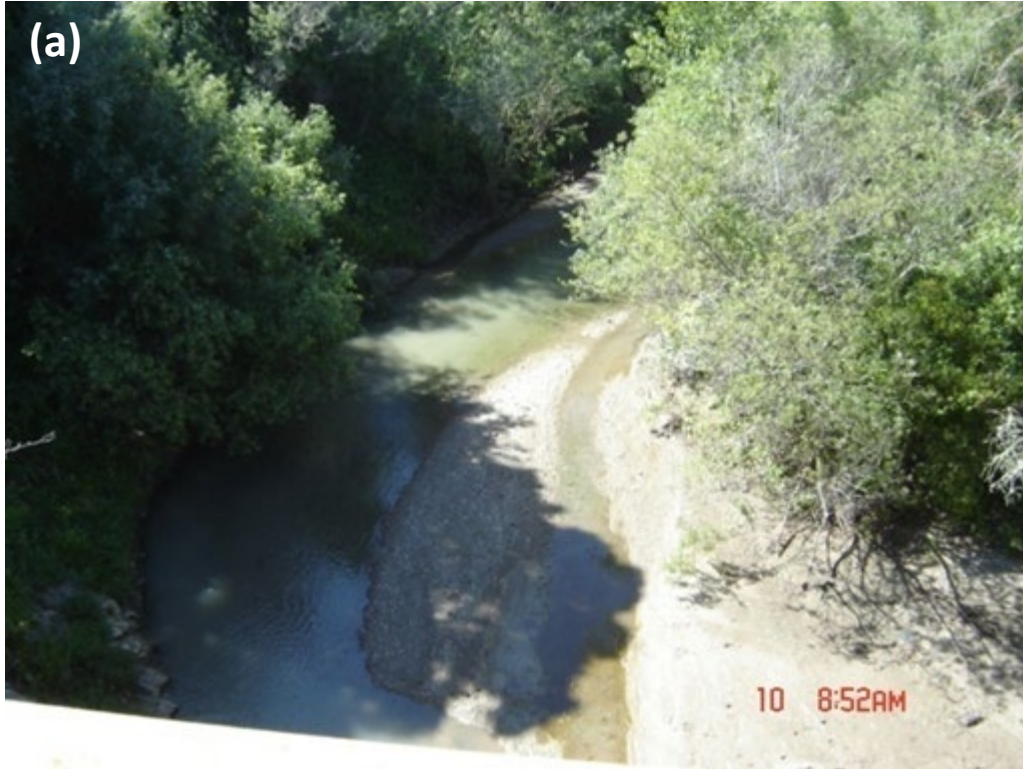
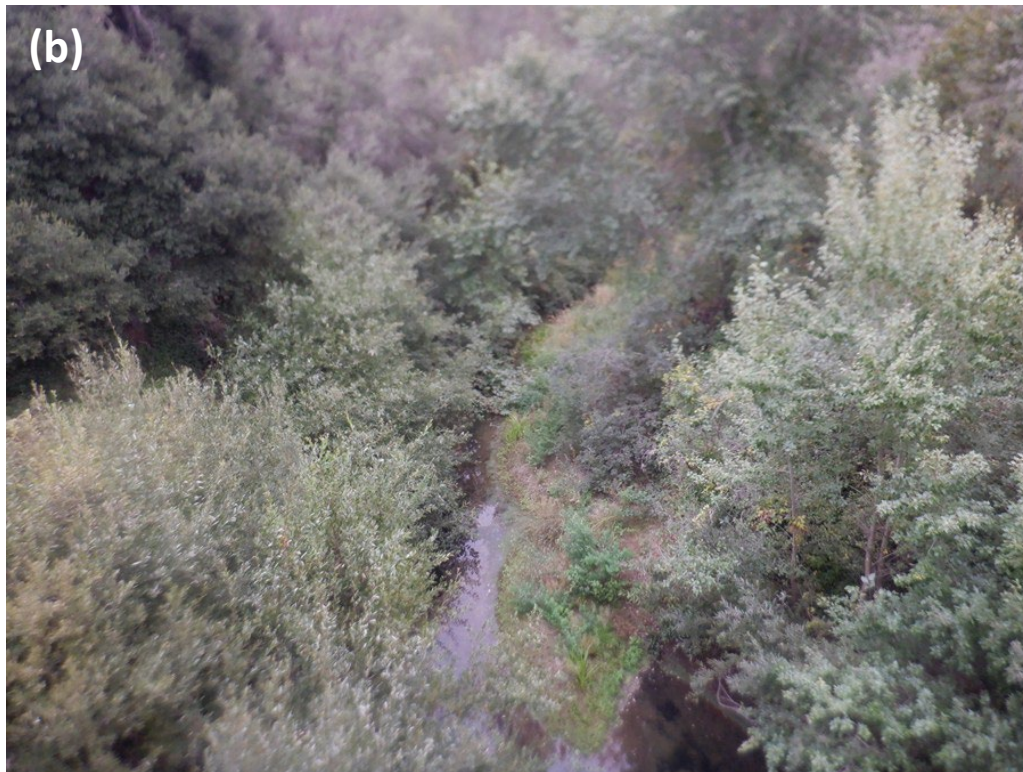
Figure 65: Photo point (T-42) collected at Salsipuedes Creek at Jalama Road Bridge in May 2005 and (b) September 2025.

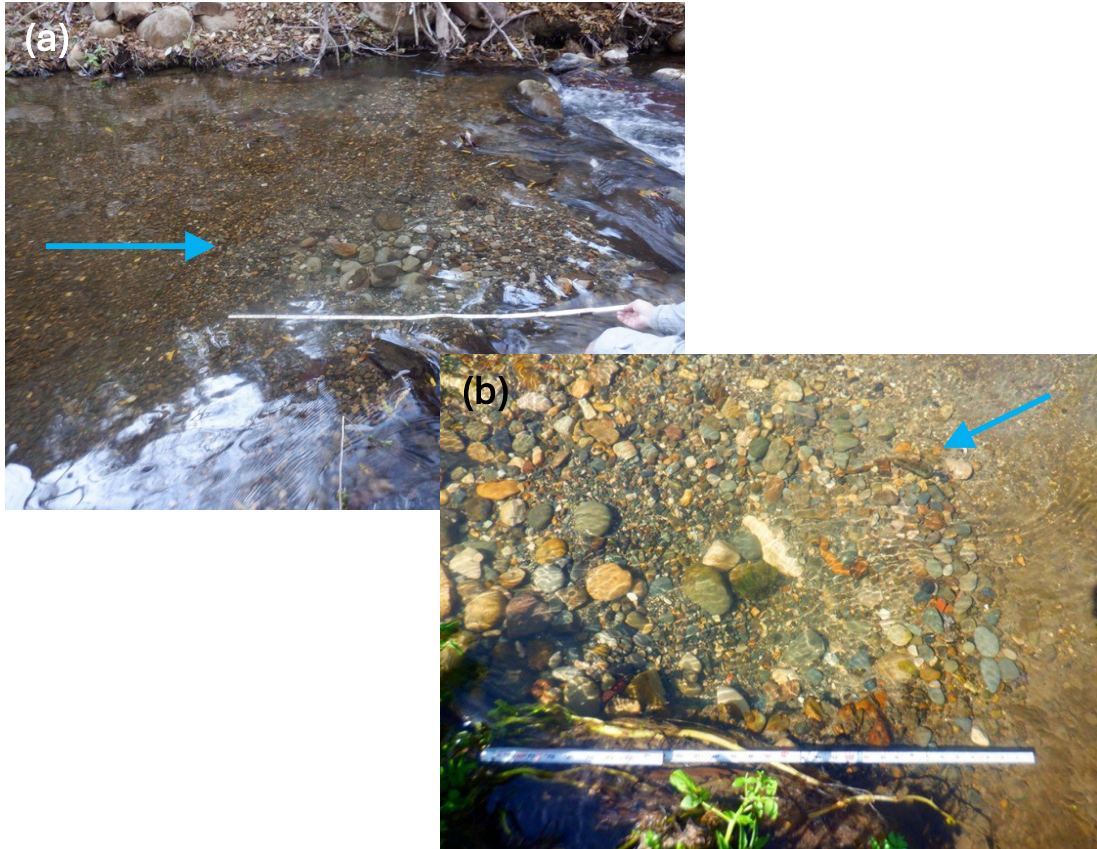
Figure 110: Comparison of a (a) Hilton Creek *O. mykiss* redd and a (b) LSYSR Pacific lamprey redd (notice the cobble placement around the redd) observed in WY2025.

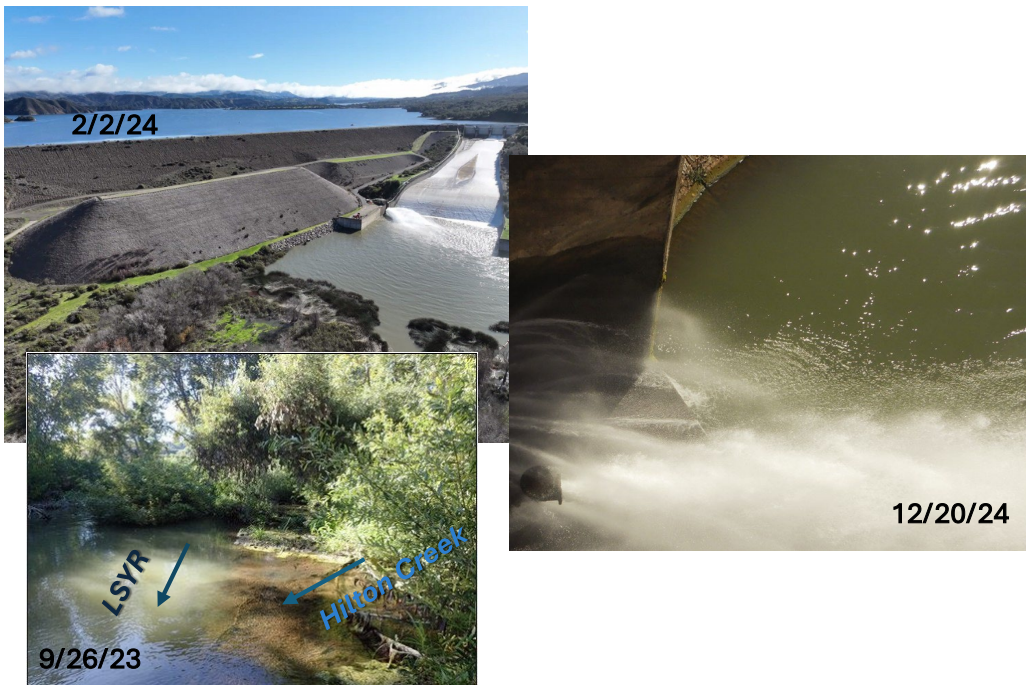
Figure 111: Turbidity in and downstream of the Stilling basin in WY2023, WY2024, and WY2025 showing water clarity differences compared to Hilton Creek.

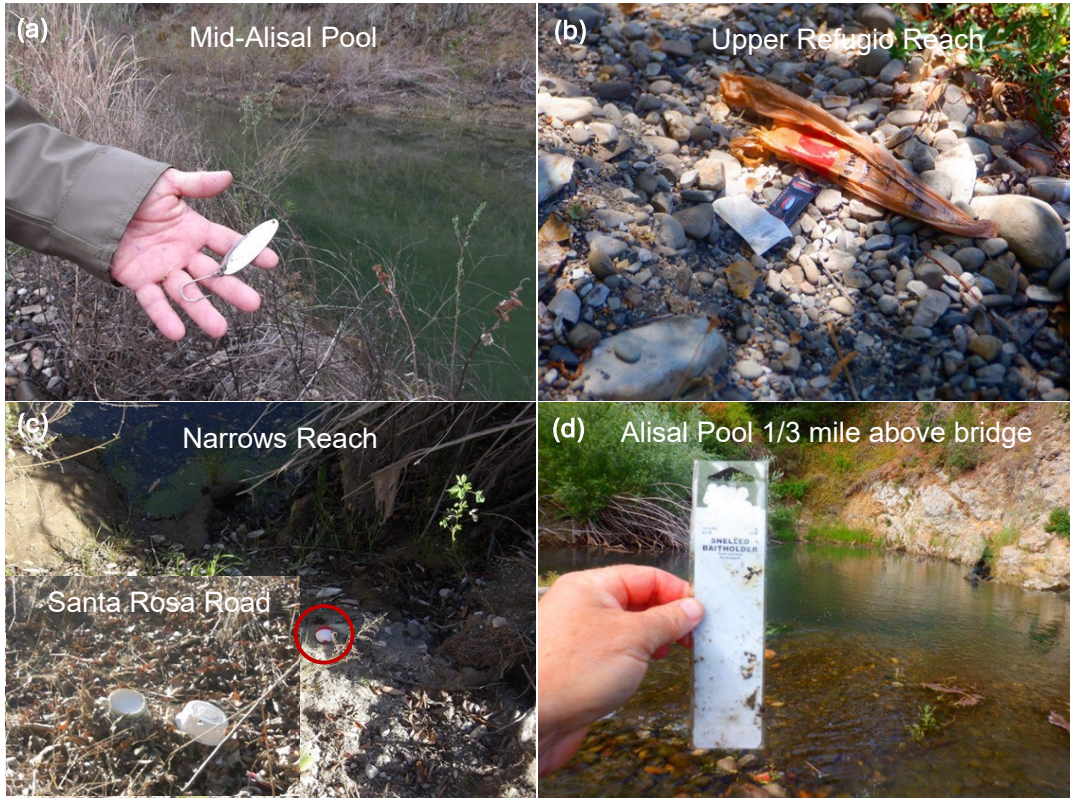
Figure 113: Poaching evidence found on the LSJR mainstem showing (a) a lure in the Alisal Reach, (b) fishing tackle in the Upper Refugio Reach, (c) a bobber and nightcrawler containers in the Narrows Reach, and (d) bait hooks above Alisal Bridge.
