WY2017 ANNUAL MONITORING SUMMARY

THE BIOLOGICAL OPINION FOR THE OPERATION AND MAINTENANCE OF THE CACHUMA PROJECT ON THE SANTA YNEZ RIVER IN SANTA BARBARA COUNTY, CALIFORNIA

**CACHUMA OPERATION AND MAINTENANCE BOARD
FISHERIES DIVISION**

JUNE 22, 2019

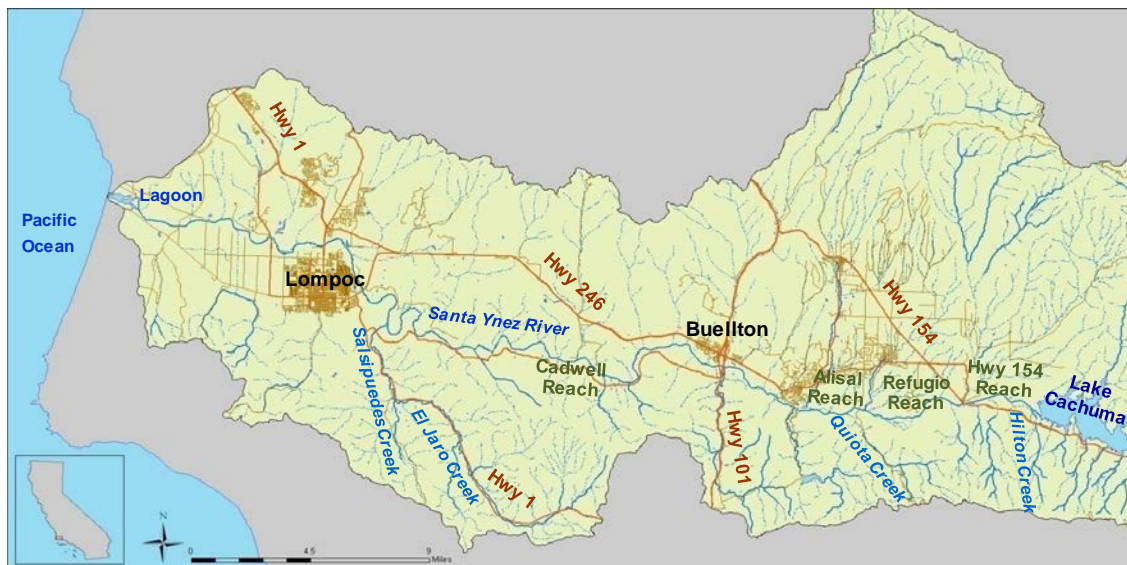
Figure ES-1: LSYR from Bradbury Dam and Lake Cachuma to the Pacific Ocean west of Lompoc, showing tributary creeks and management reaches of interest for the LSYR Fish Monitoring Program.

The monitoring tasks completed in WY2017 were performed below Bradbury Dam in the LSYR watershed and in Lake Cachuma, which is approximately half the drainage area (450 square miles) and stream distance (48 miles) to the ocean compared to the entire watershed. The area is within the Southern California Steelhead Distinct Population Segment (DPS) and the Monte Arido Highland Biogeographic Population Group (BPG) in the Southern Steelhead Recovery Planning Area (NMFS, 2012). Monitoring focused on three management reaches (Highway 154, Refugio, and Alisal reaches) and the Cadwell Reach on the LSYR mainstem, and tributaries (Hilton, Quiota, El Jaro, and Salsipuedes creeks) known to support suitable habitat for *O. mykiss* (Figure ES-1).

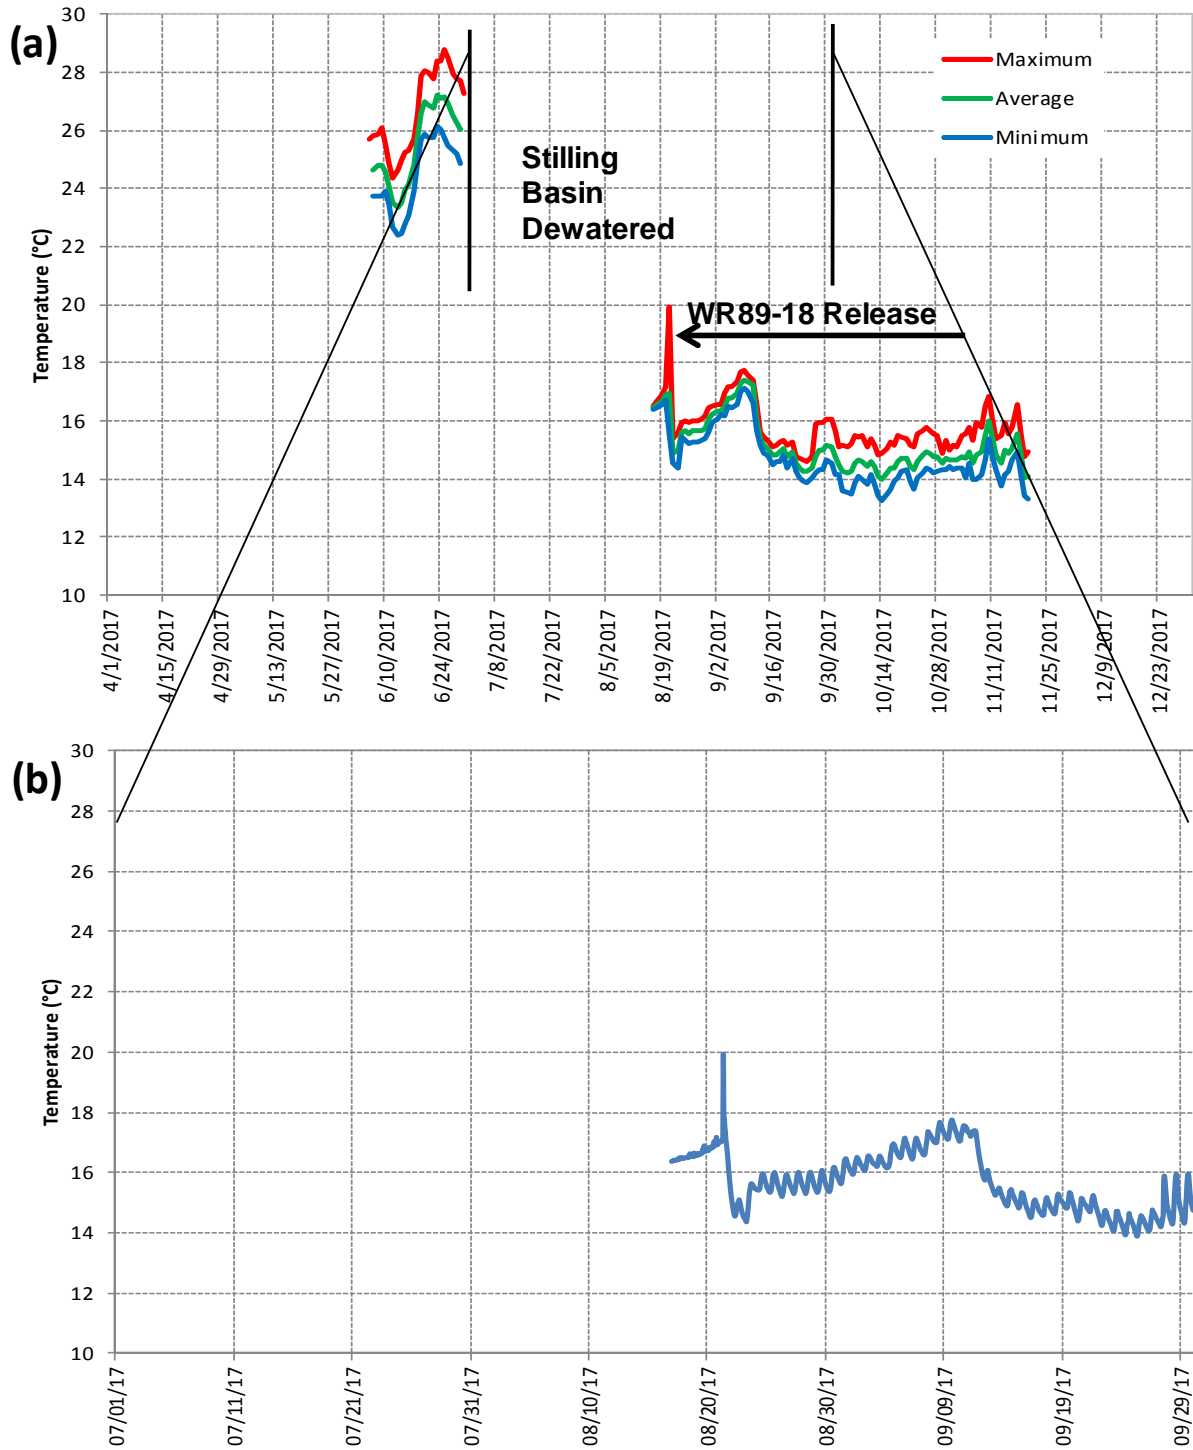
Figure 6: 2017 LSYR-0.01 (Stilling Basin parapet wall) surface (1 foot) water temperature for (a) daily maximum, average, and minimum for the entire period of deployment and (b) hourly measurements for the period of 7/1/17-10/1/17; the Stilling Basin was dewatered from 6/30/17 to 8/16/17 and the WR 89-18 release began on 8/21/17.

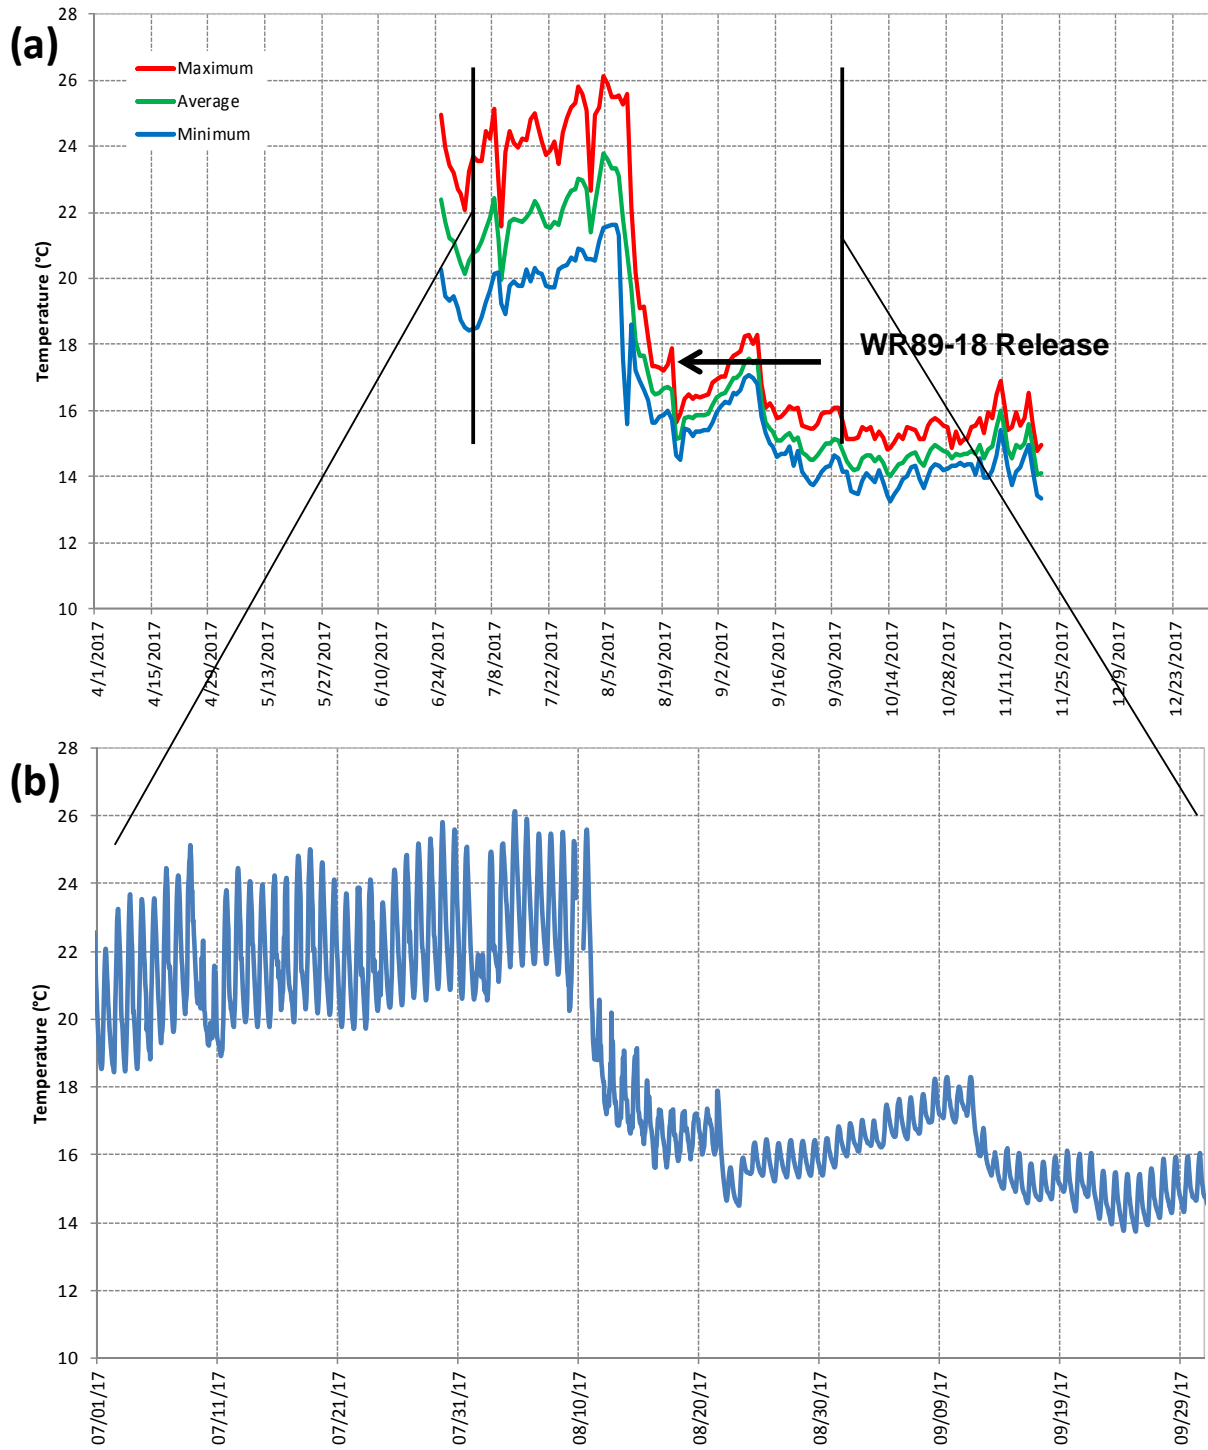
Figure 9: 2017 LSJR-0.51 (Long Pool) surface (1 foot) thermograph for (a) daily maximum, average, and minimum values and (b) hourly data from 7/1/17–10/1/17.

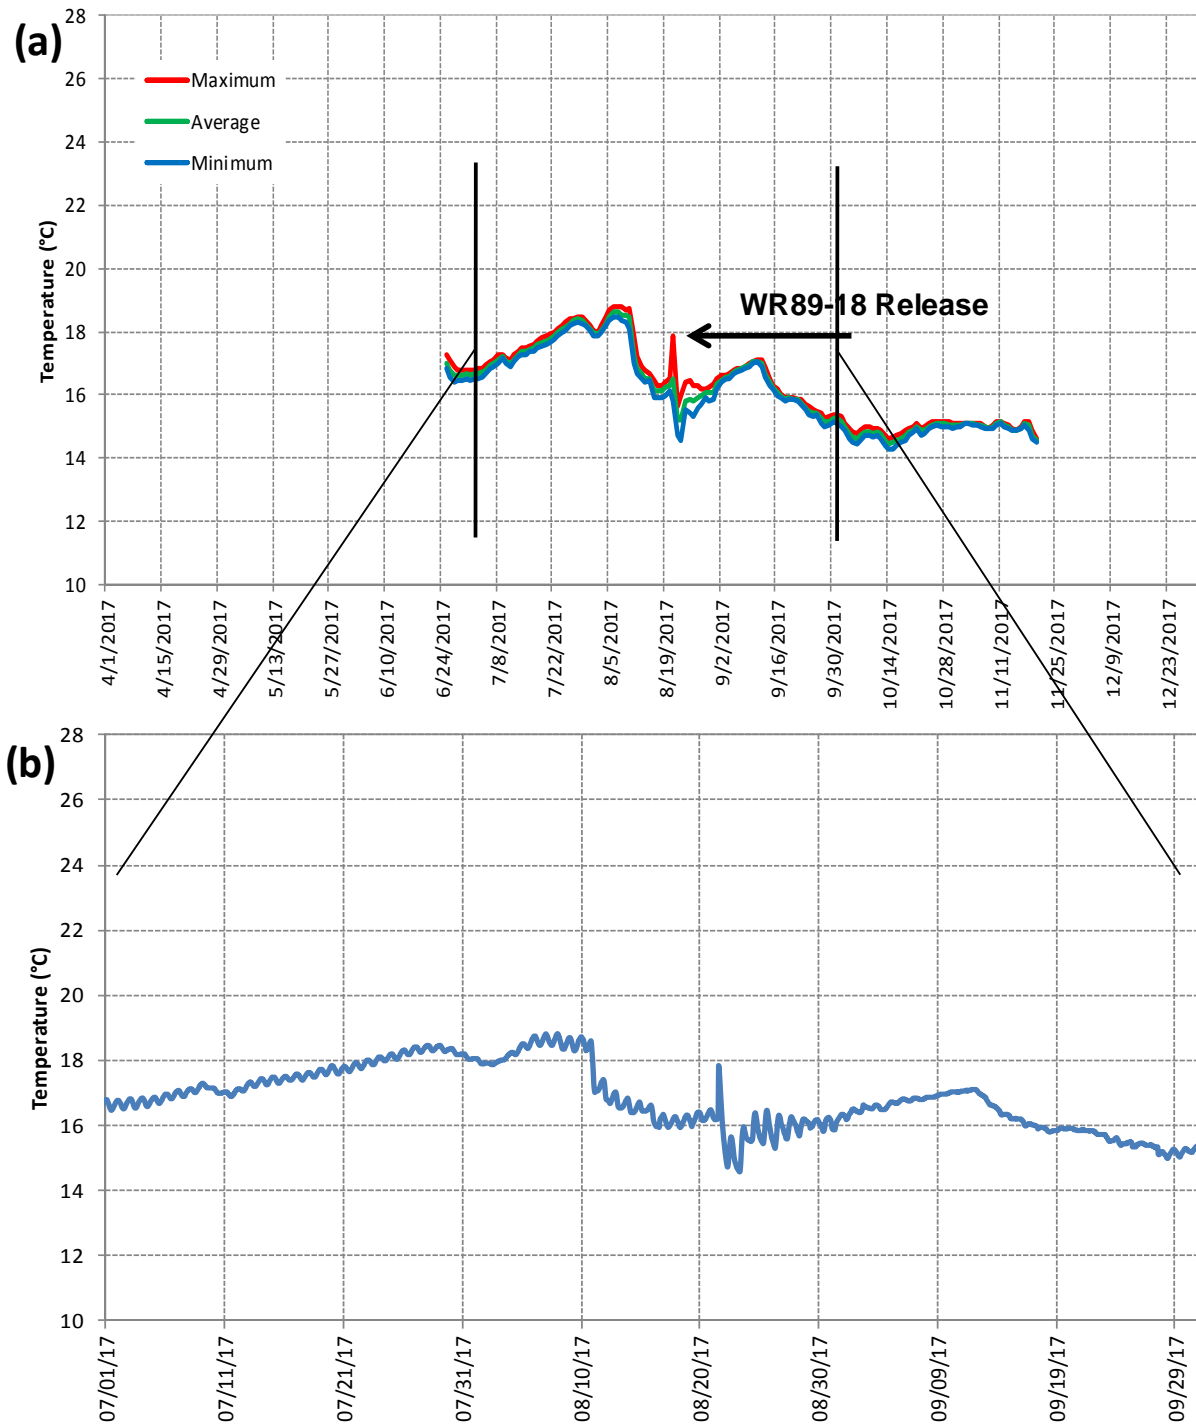
Figure 11: 2017 LSYSR-0.51 (Long Pool) bottom (9 feet) thermograph for (a) daily maximum, average, and minimum values and (b) hourly data from 7/1/17-10/1/17.

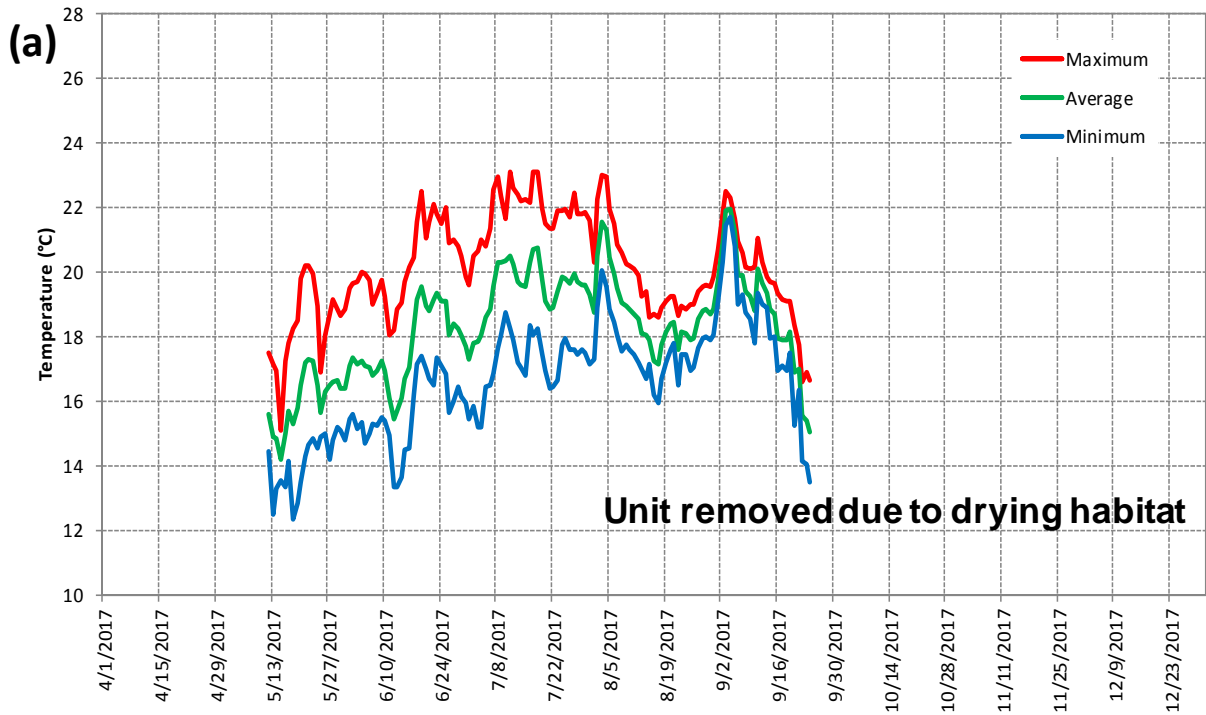
Figure 28: 2017 Quiota Creek (QC-2.66) bottom (2.5 feet) thermograph for (a) daily maximum, average, and minimum daily values and (b) hourly data for the entire period of deployment; unit removed due to drying habitat.

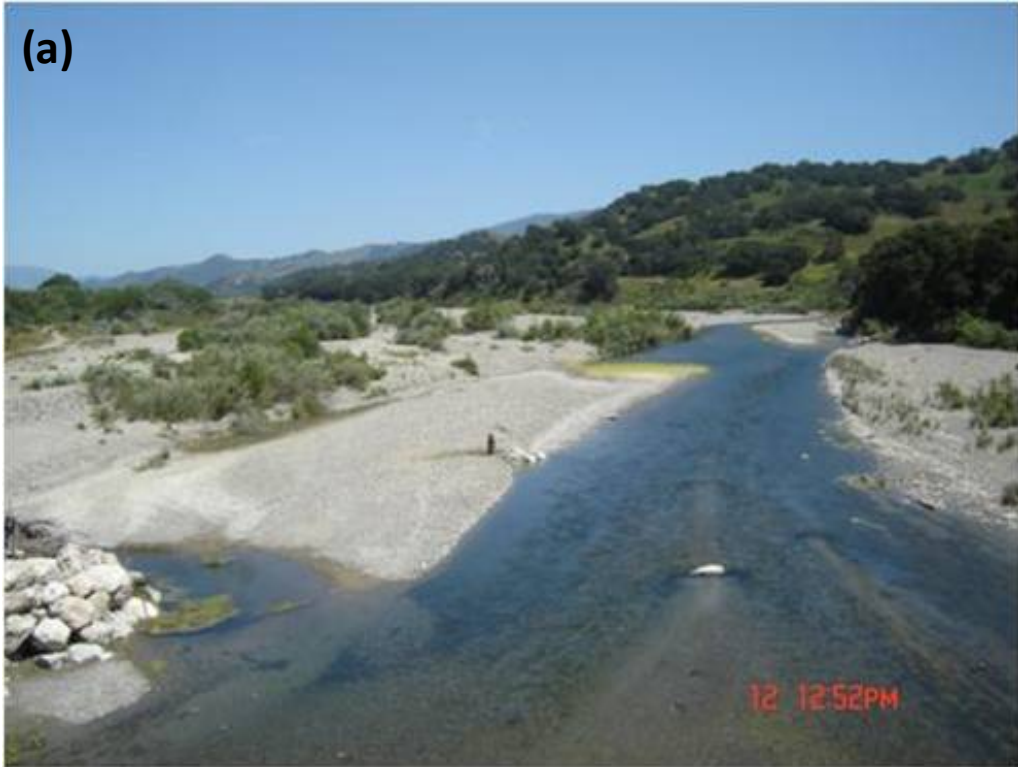
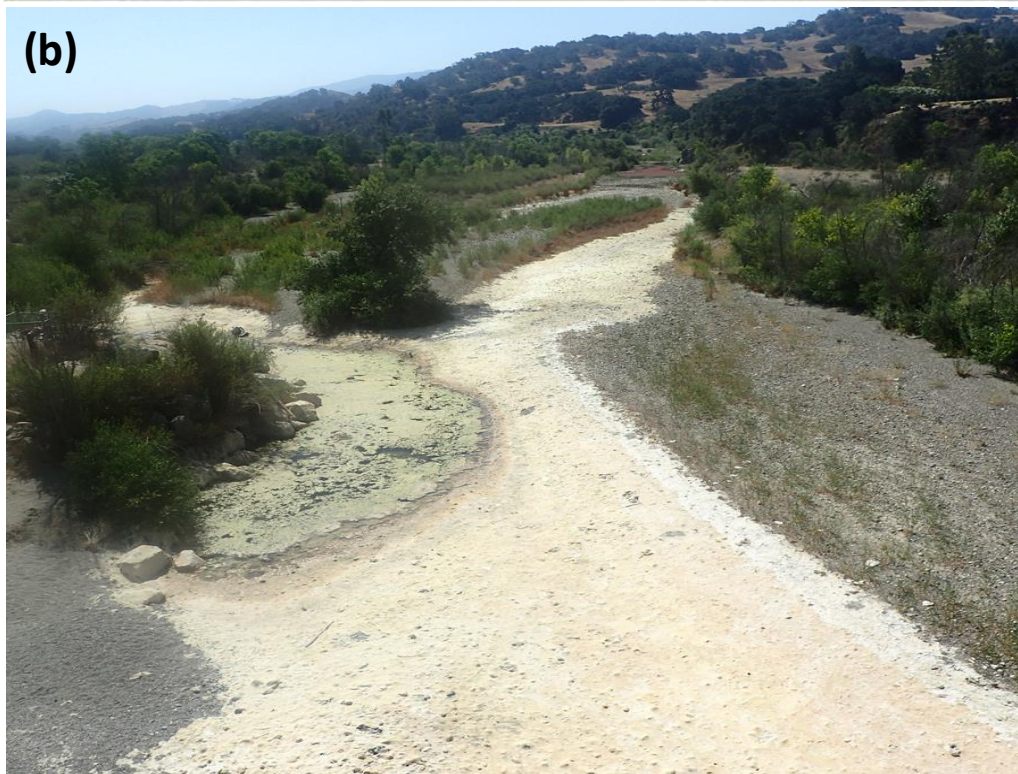
Figure 41: Photo point (M-12) collected at Refugio Bridge looking upstream in (a) May 2005, and (b) July 2017.

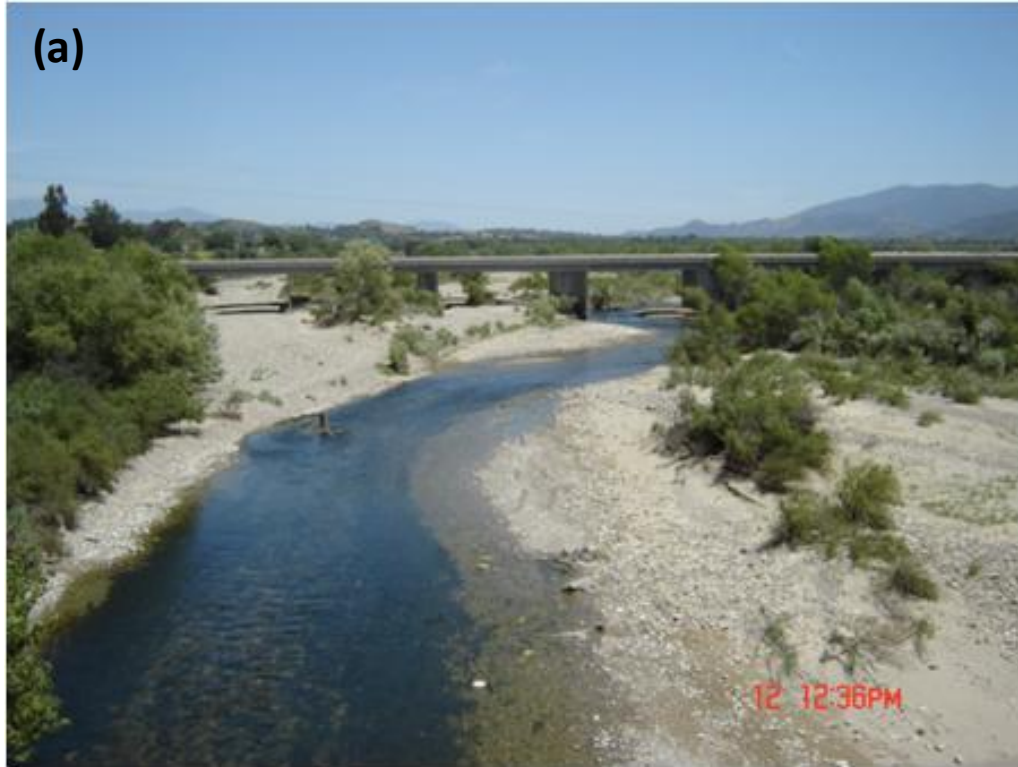
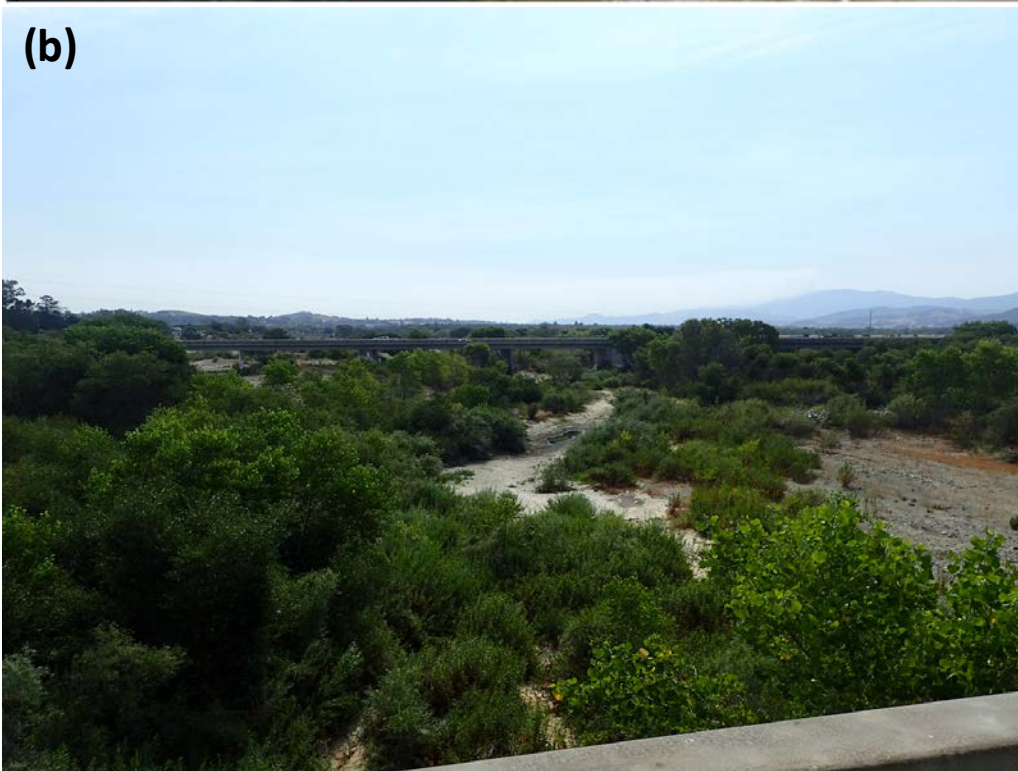
Figure 42: Photo point (M-14) collected at Alisal Bridge looking upstream in a) May 2005, and b) July 2017.

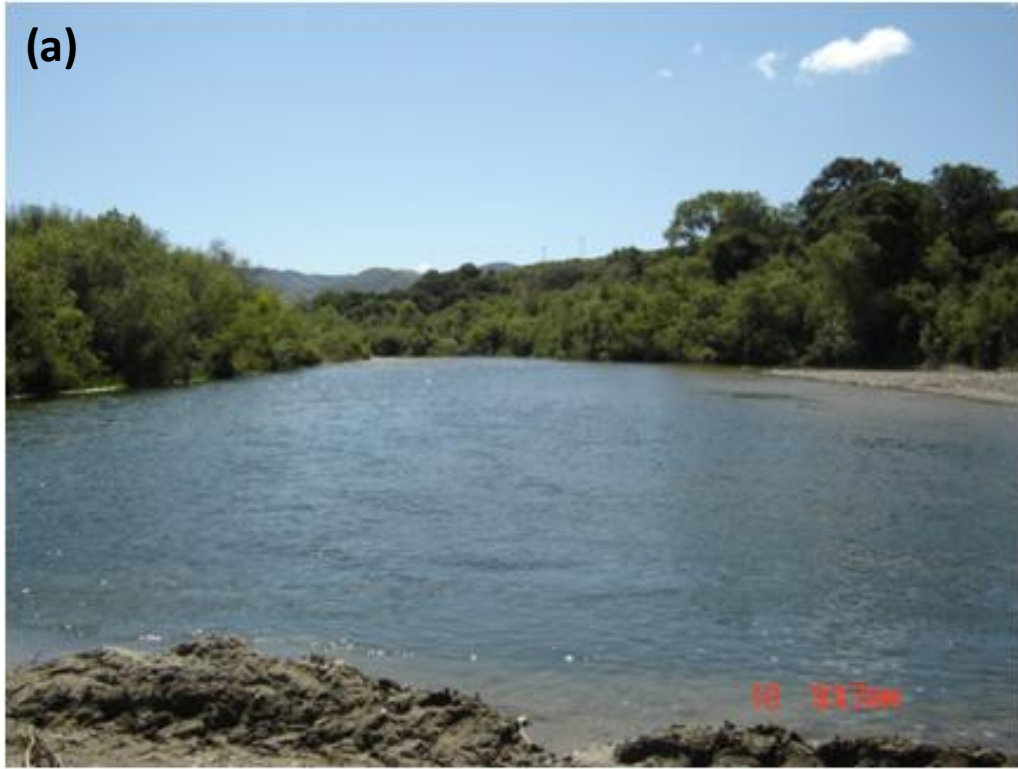
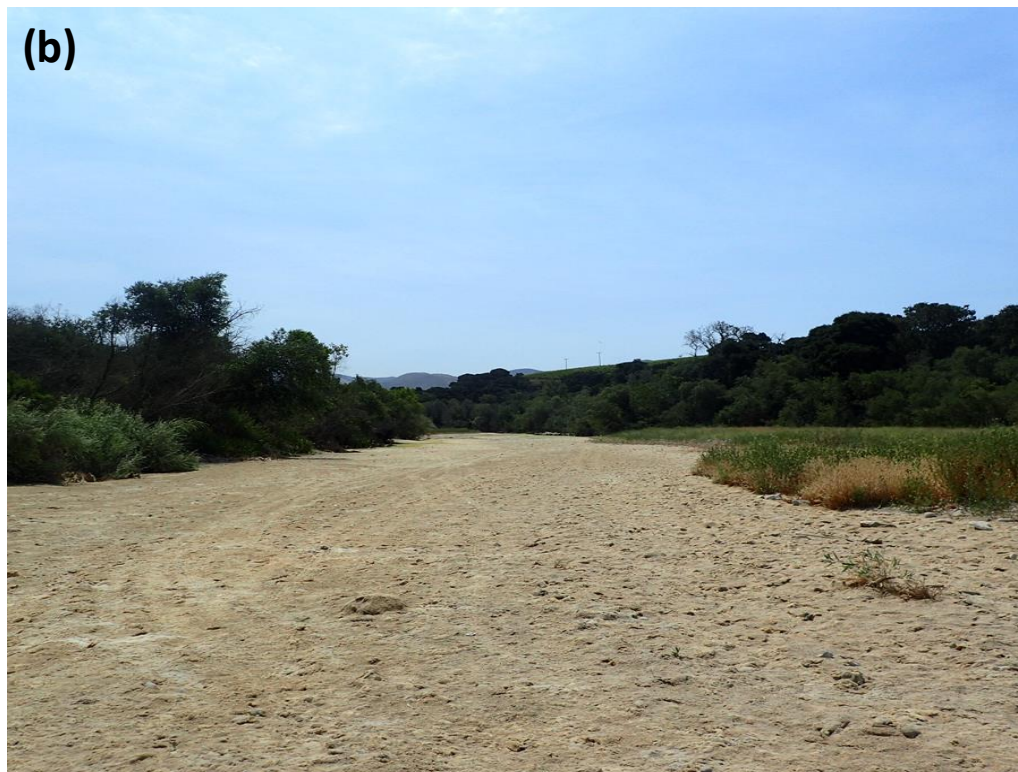
Figure 43: Photo point (M-19) collected at Avenue of the Flags Bridge looking upstream in (a) May 2005, and (b) July 2017.

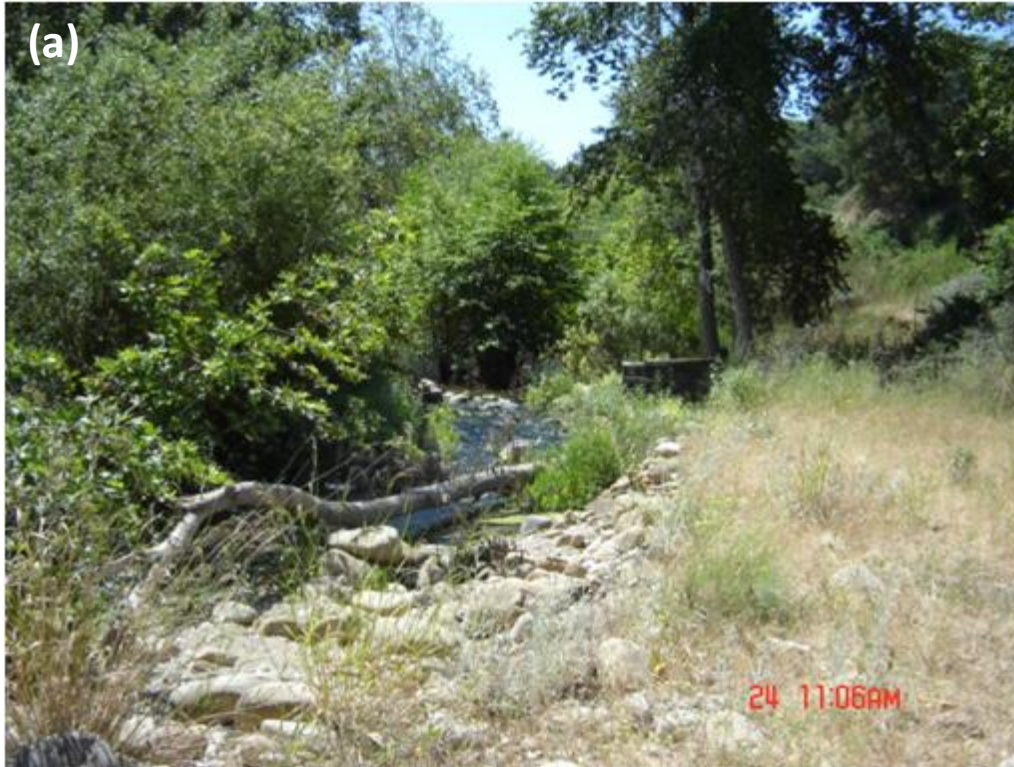
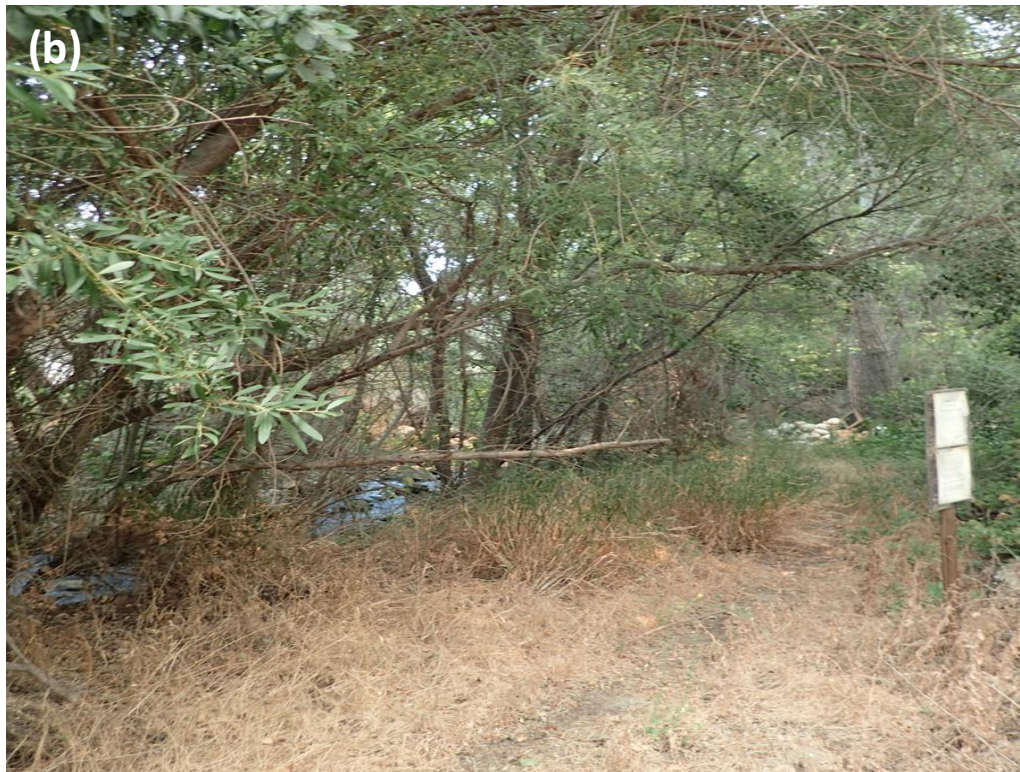
Figure 44: Photo point (M-21) collected at Sweeney Road Crossing looking upstream in (a) May 2005, and (b) July 2017.

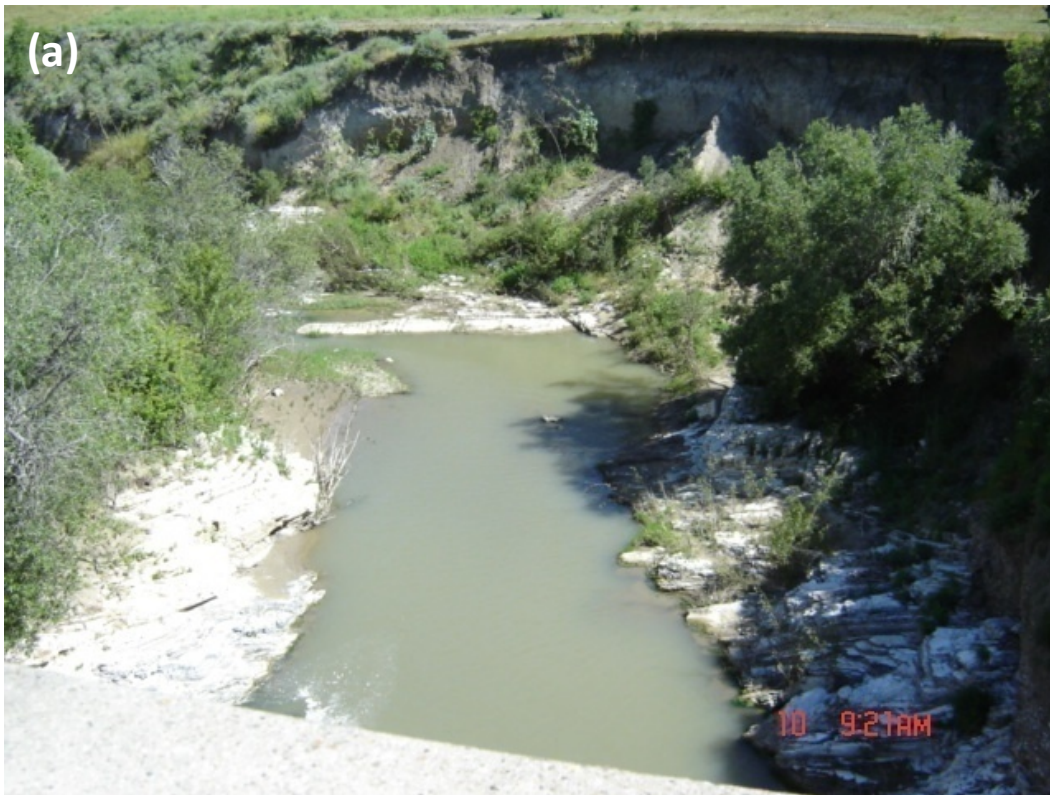
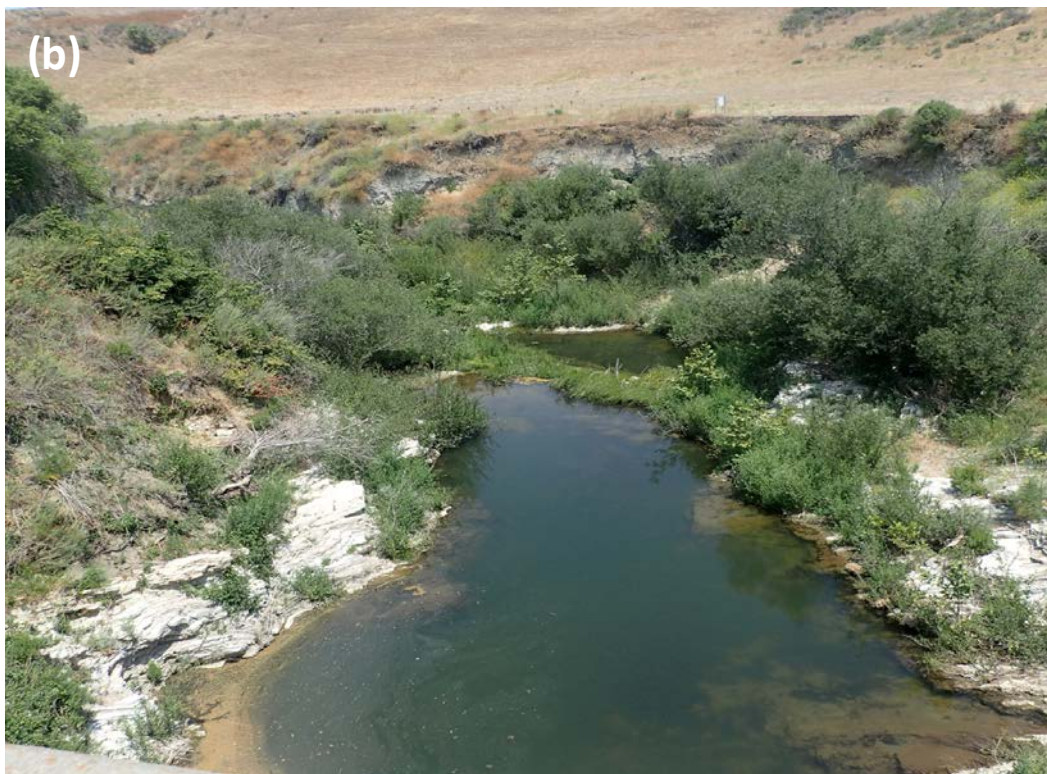
Figure 47: Photo point (T-28) collected at Salsipuedes Creek at Santa Rosa Bridge in (a) May 2005 and (b) July 2017.

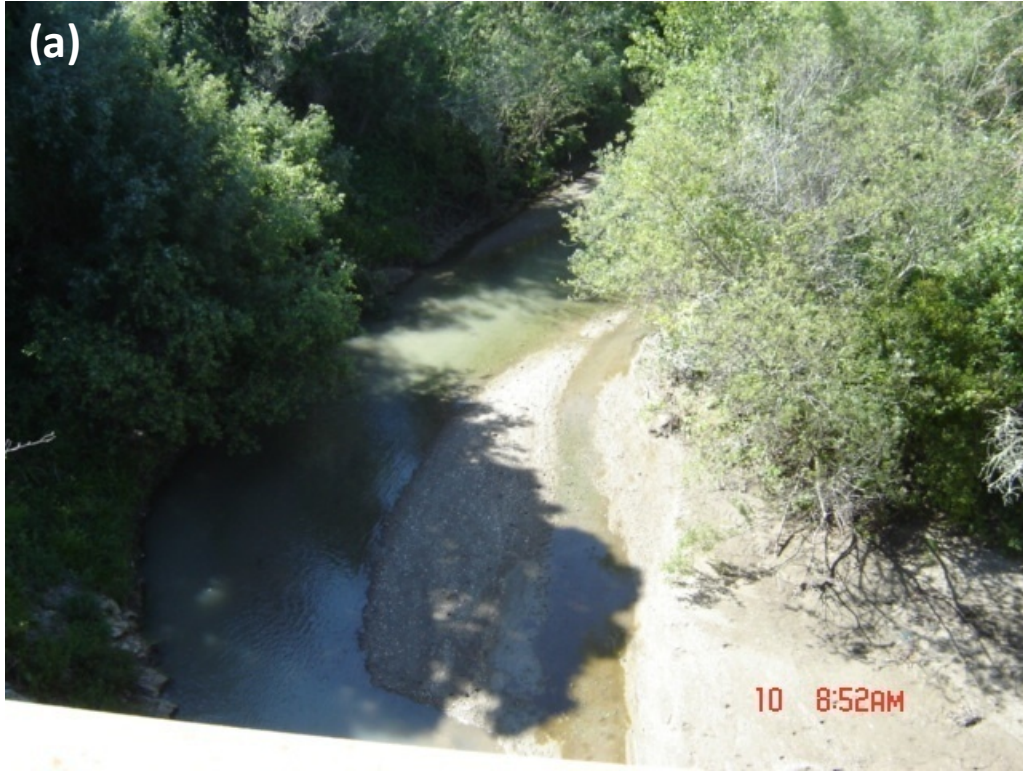
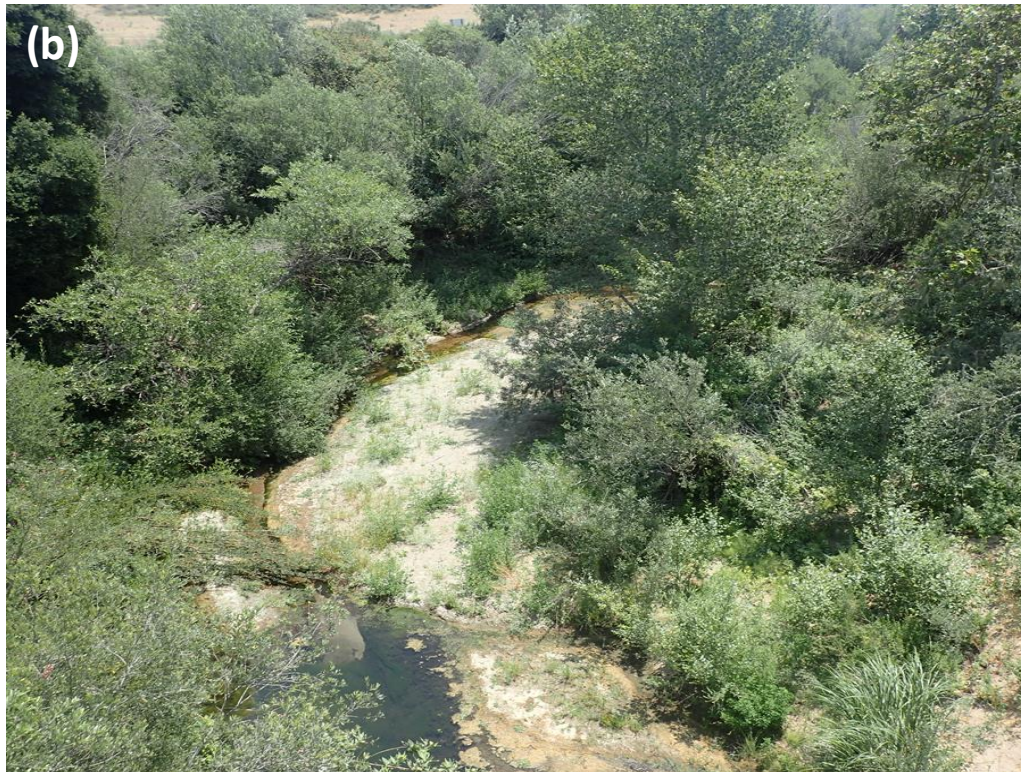
Figure 48: Photo point (T-39) collected at Salsipuedes Creek at Hwy 1 Bridge in May 2005 and (b) July 2017.

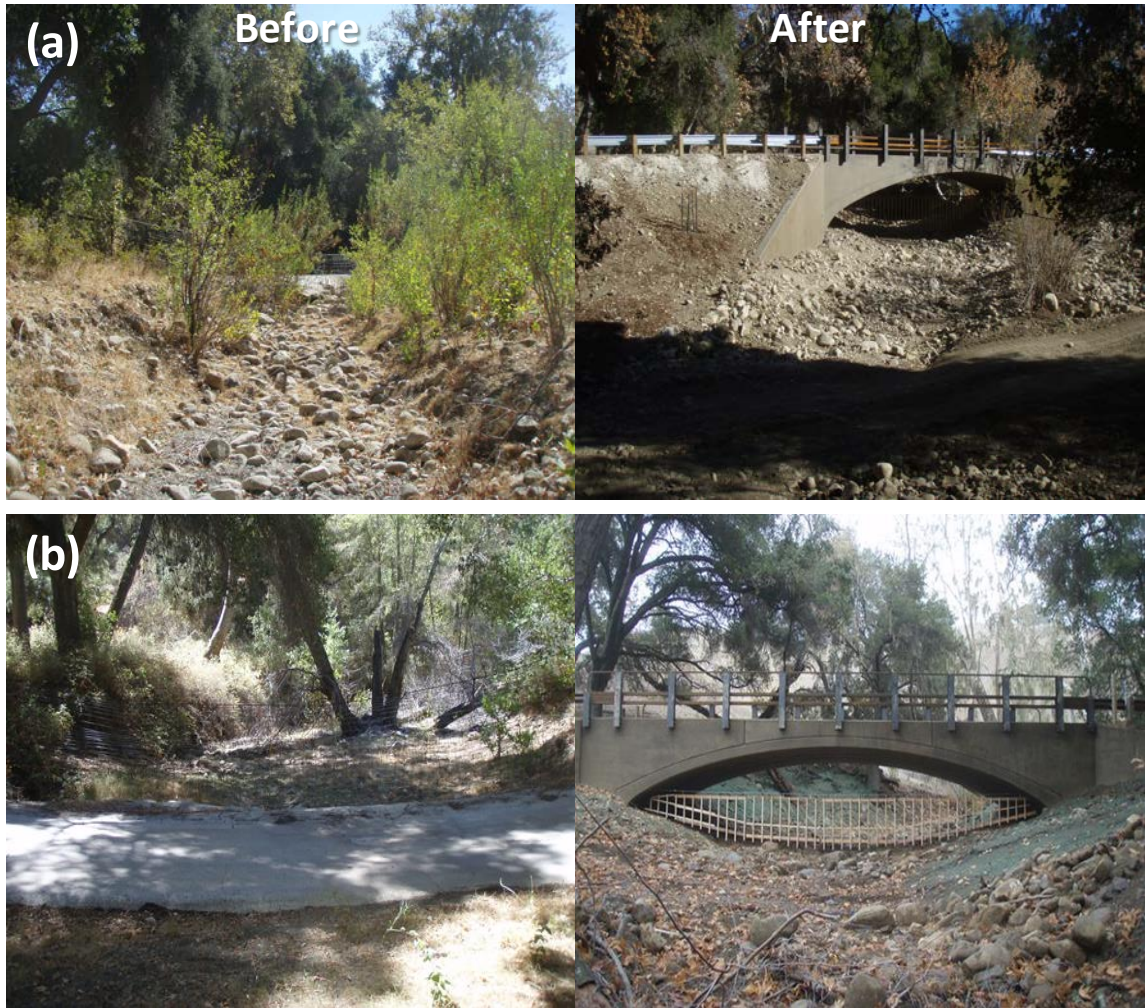
Figure 68: Fish passage and habitat restoration at (a) Quiota Creek Crossing 1 (in 2014) and (b) Quiota Creek Crossing 3 (in 2015).
