WY2016 ANNUAL MONITORING SUMMARY

**THE BIOLOGICAL OPINION FOR THE OPERATION
AND MAINTENANCE OF THE CACHUMA PROJECT
ON THE SANTA YNEZ RIVER
IN SANTA BARBARA COUNTY, CALIFORNIA**

**CACHUMA OPERATION AND MAINTENANCE BOARD
FISHERIES DIVISION**

APRIL 22, 2019

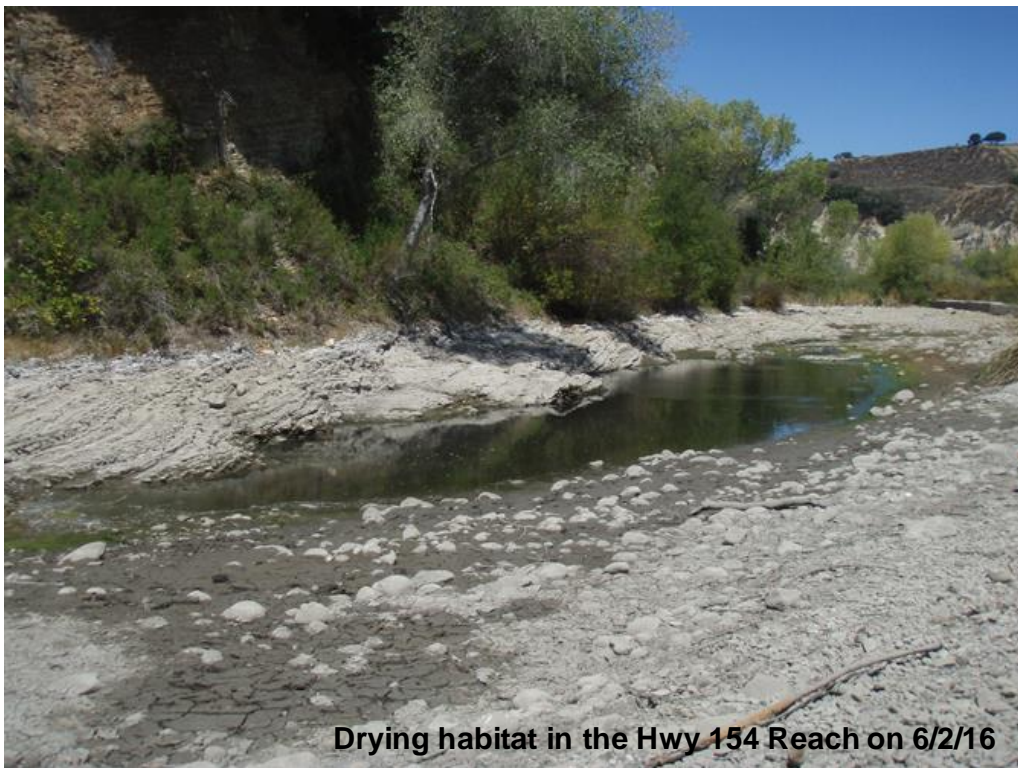
Drying habitat in the Hwy 154 Reach on 6/2/16

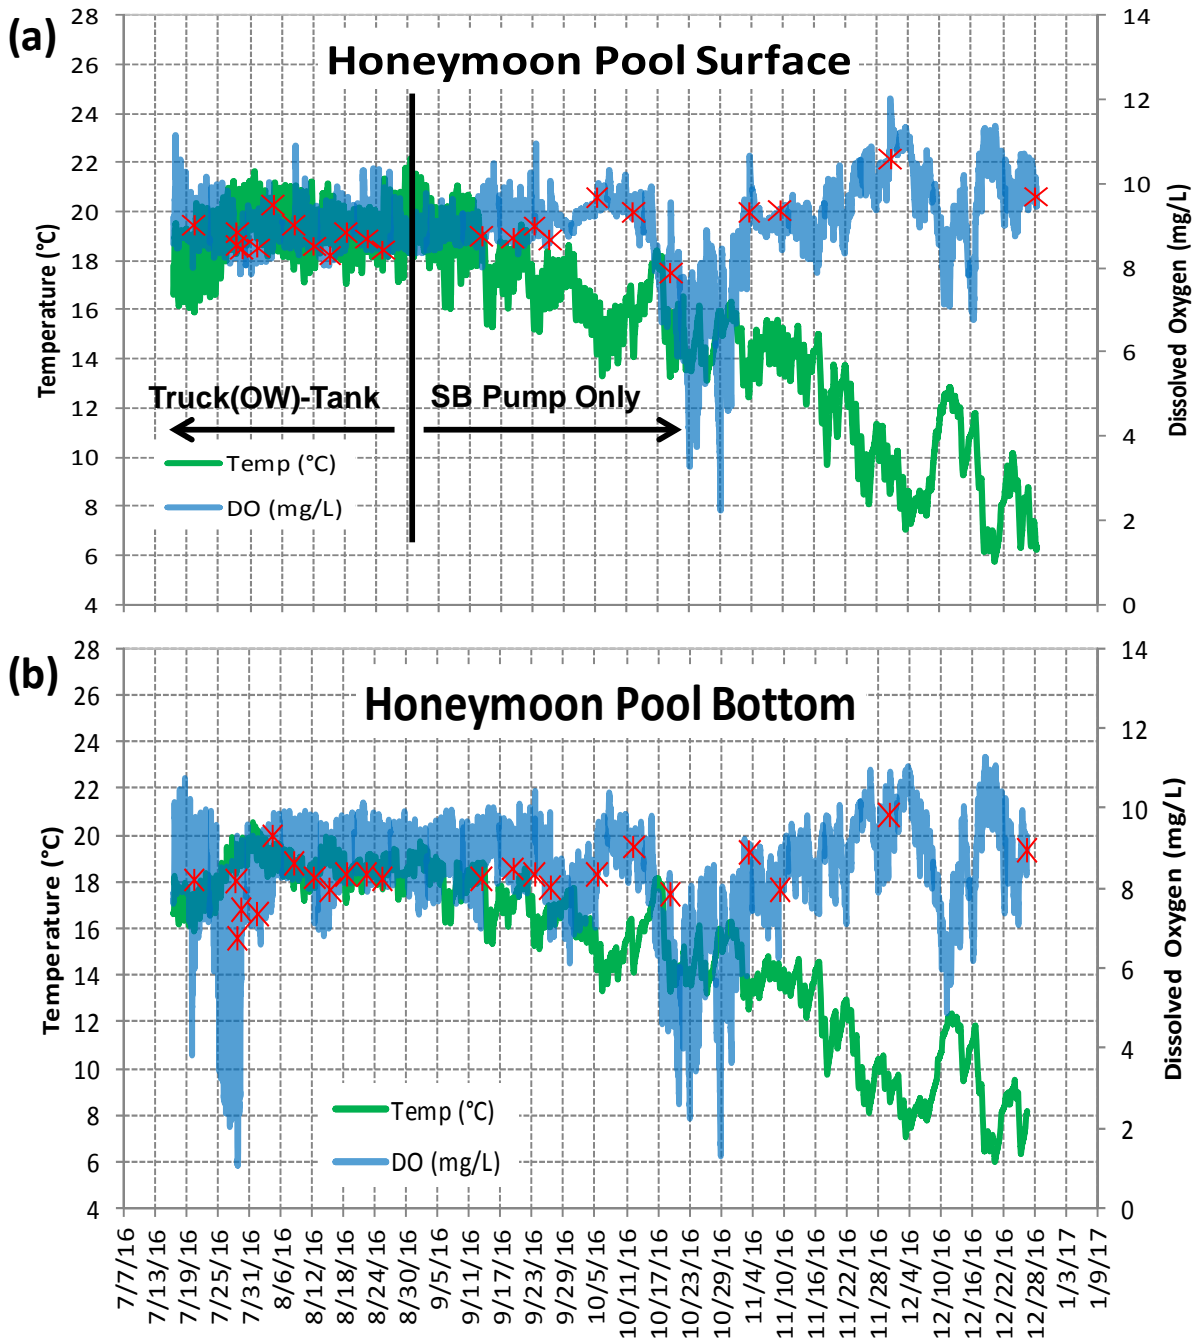
Figure 26: 2016 Hilton Creek (HC-0.26) water temperatures and dissolved oxygen concentrations at the Honeymoon Pool for the (a) surface and (b) bottom of the habitat reflecting the changes in flow delivery regimes over the period (red asterisks indicate when the instruments were downloaded).

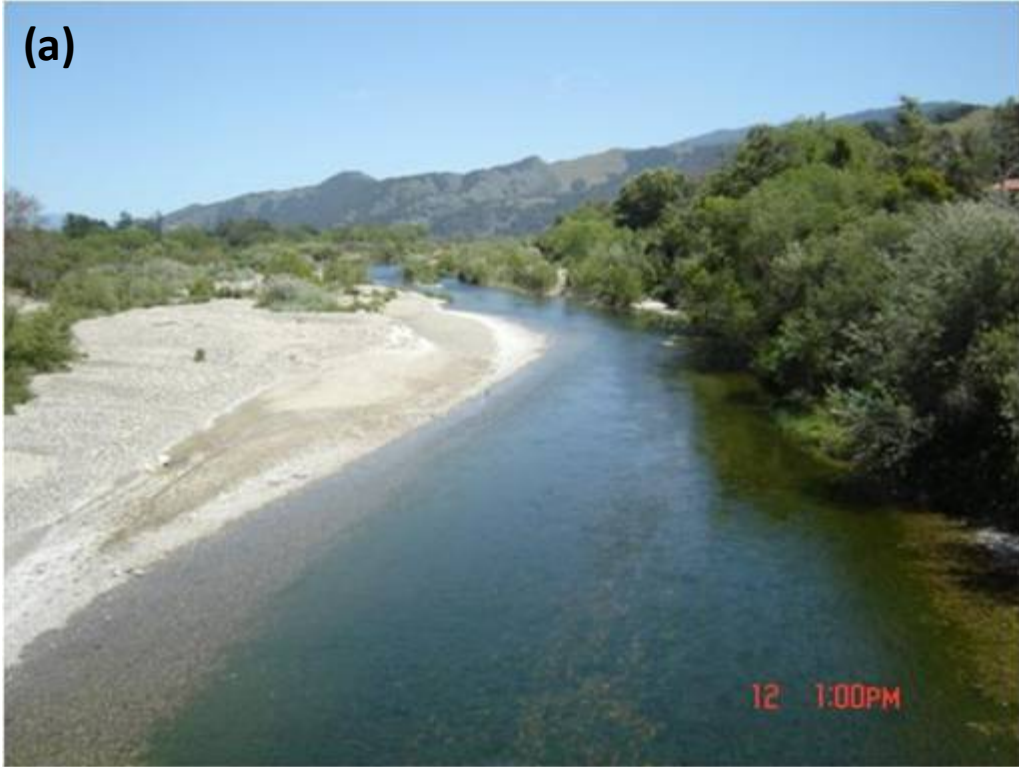
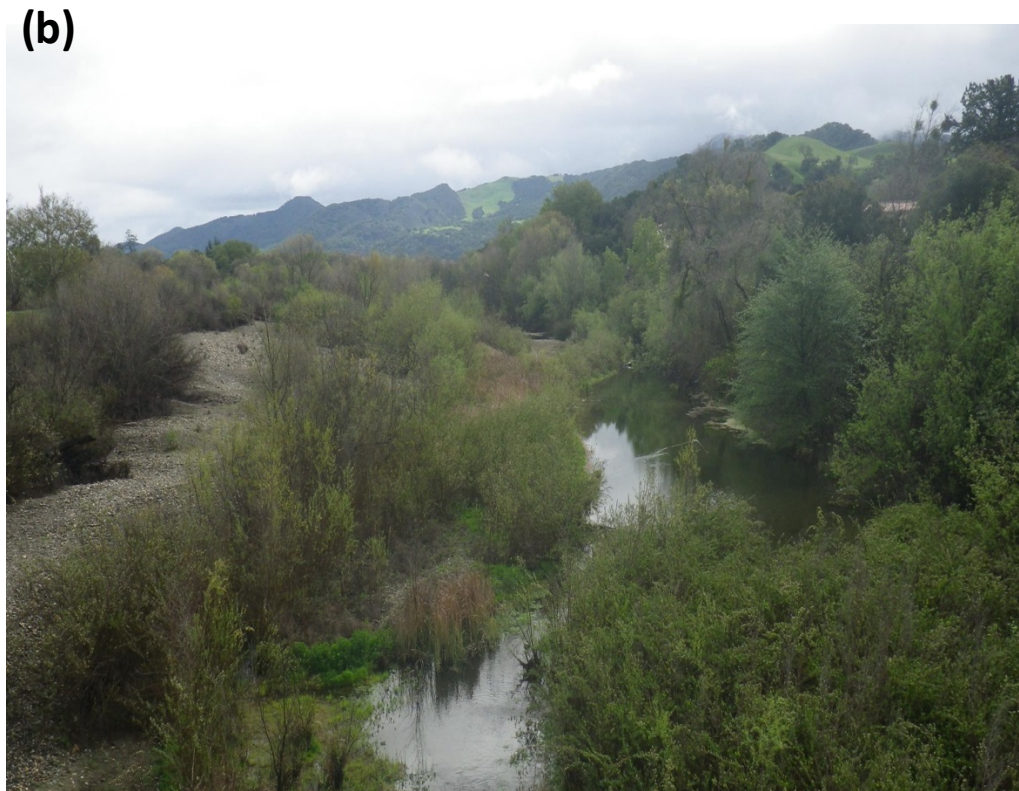
Figure 31: Photo point (M-12) collected at Refugio Bridge looking upstream in (a) May 2005, and (b) March 2016.

Figure 31: Photo point (M-12) collected at Refugio Bridge looking upstream in (a) May 2005, and (b) March 2016.

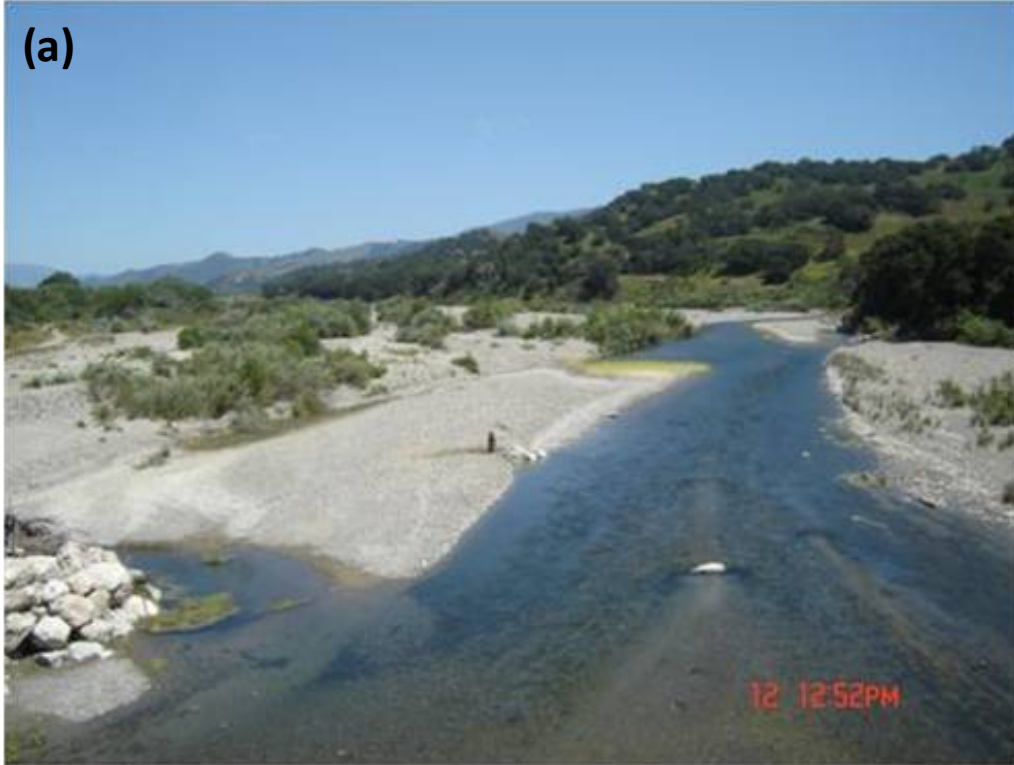
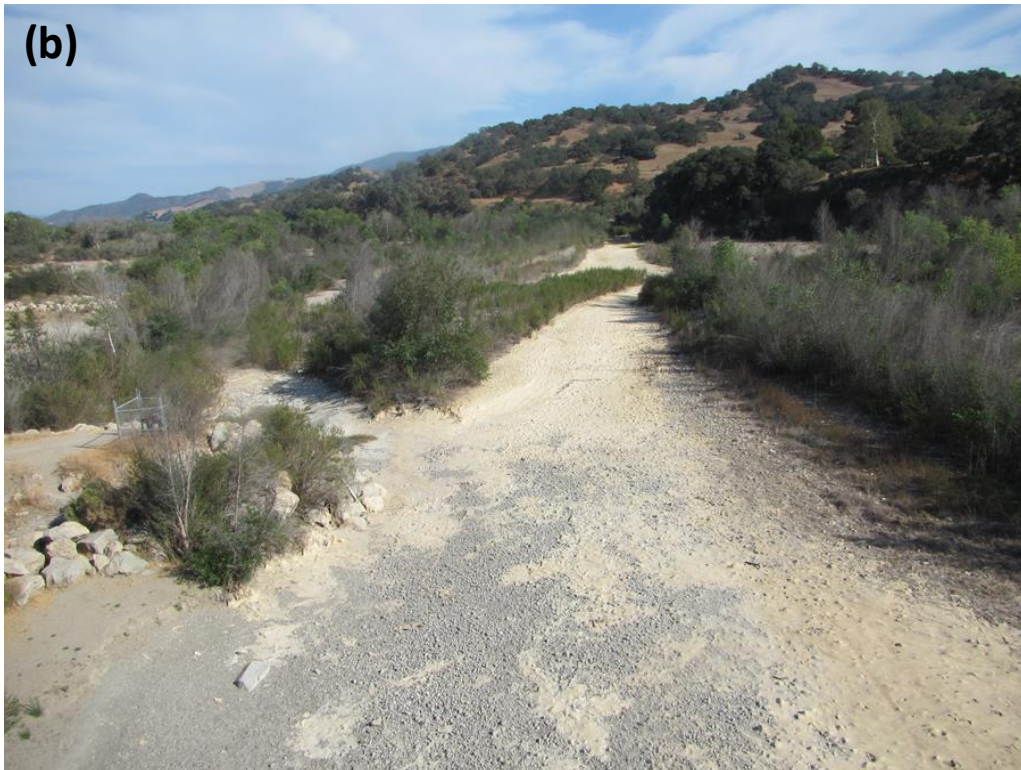
Figure 32: Photo point (M-14) collected at Alisal Bridge looking upstream in a) May 2005, and b) September 2016. Note all the dead riparian vegetation.

comparison problematic. Extensive riparian vegetation died off due to the ongoing drought as observed within the Refugio, Alisal, and Avenue reaches in WY2016.

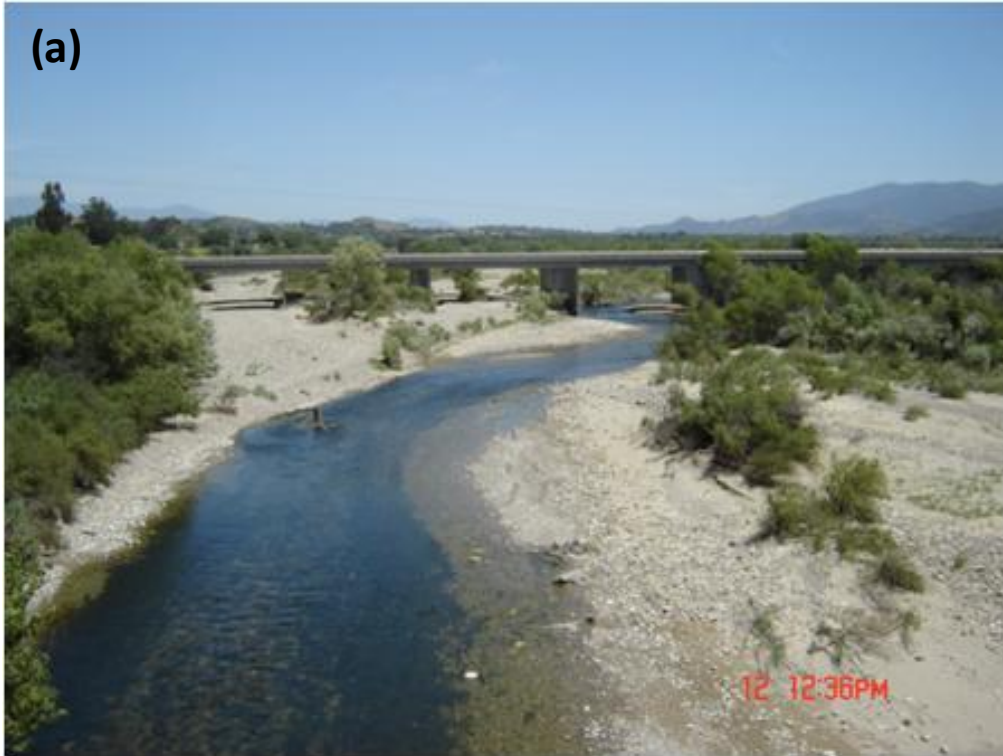
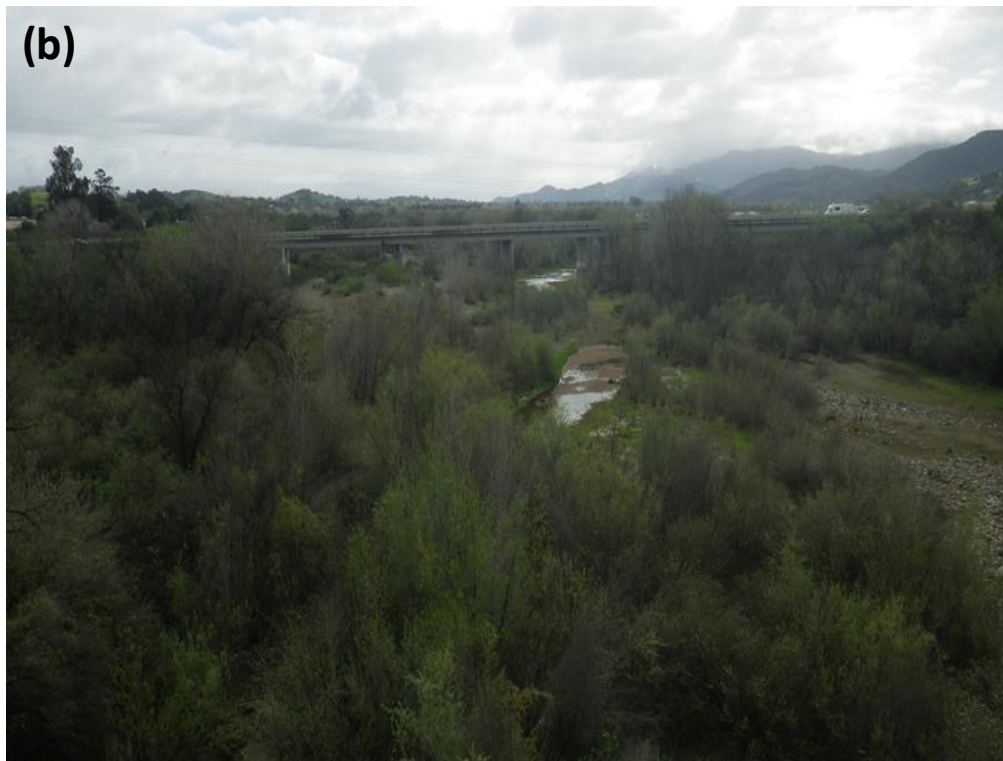
Figure 33: Photo point (M-19) collected at Avenue of the Flags Bridge looking upstream in (a) May 2005, and (b) March 2016.

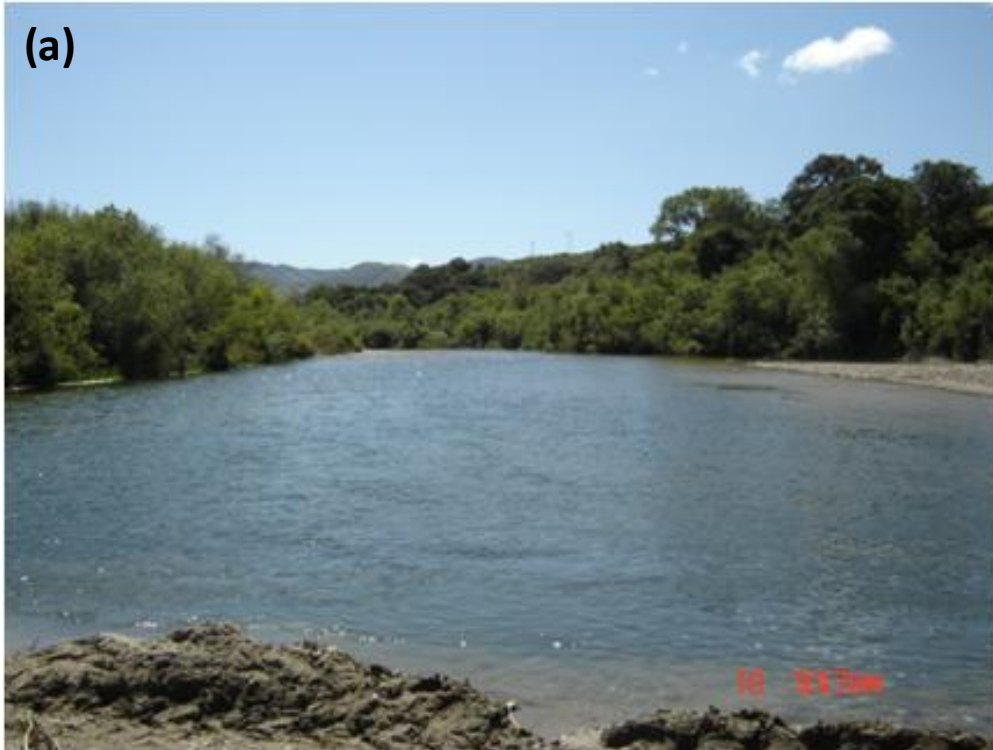
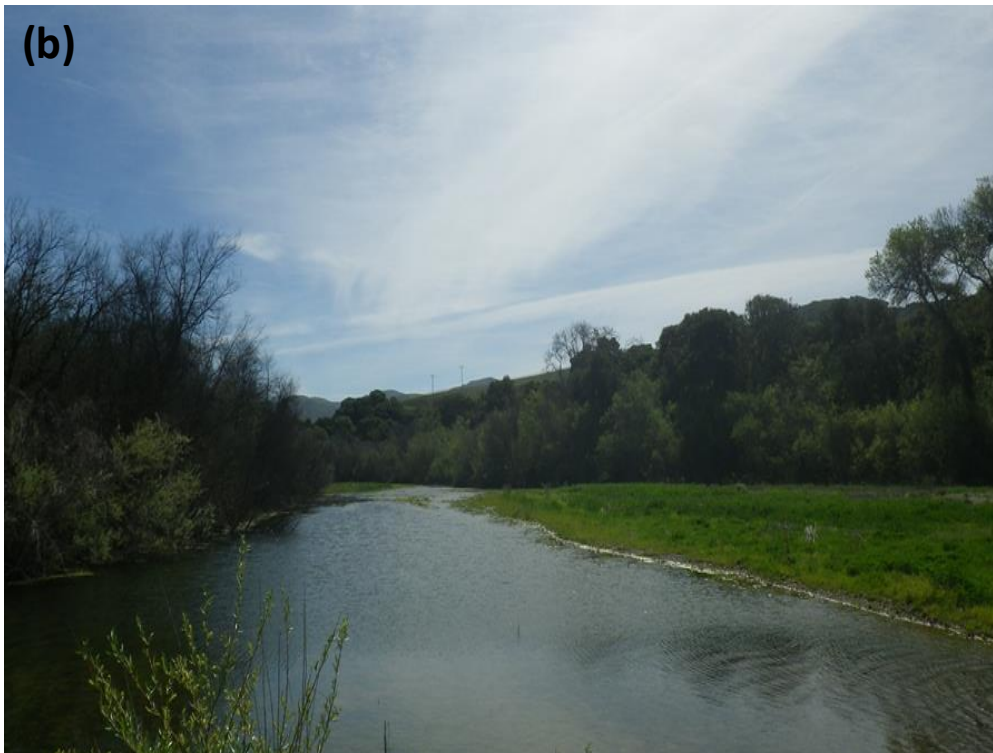
Figure 34: Photo point (M-21) collected at Sweeney Road Crossing looking upstream in (a) May 2005, and (b) March 2016.

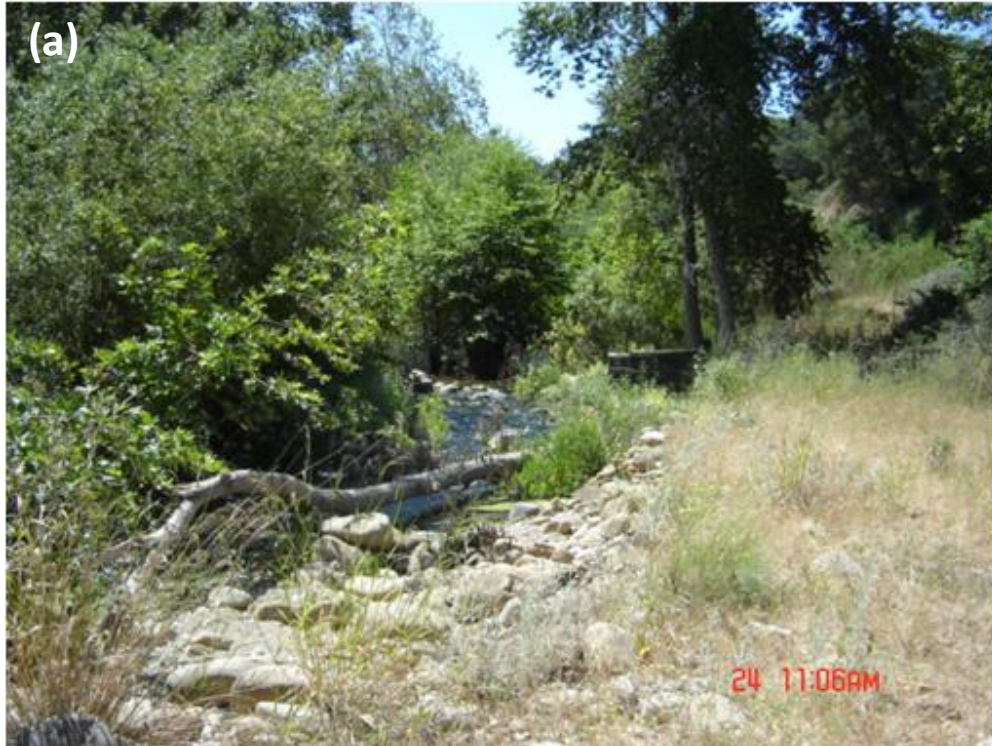
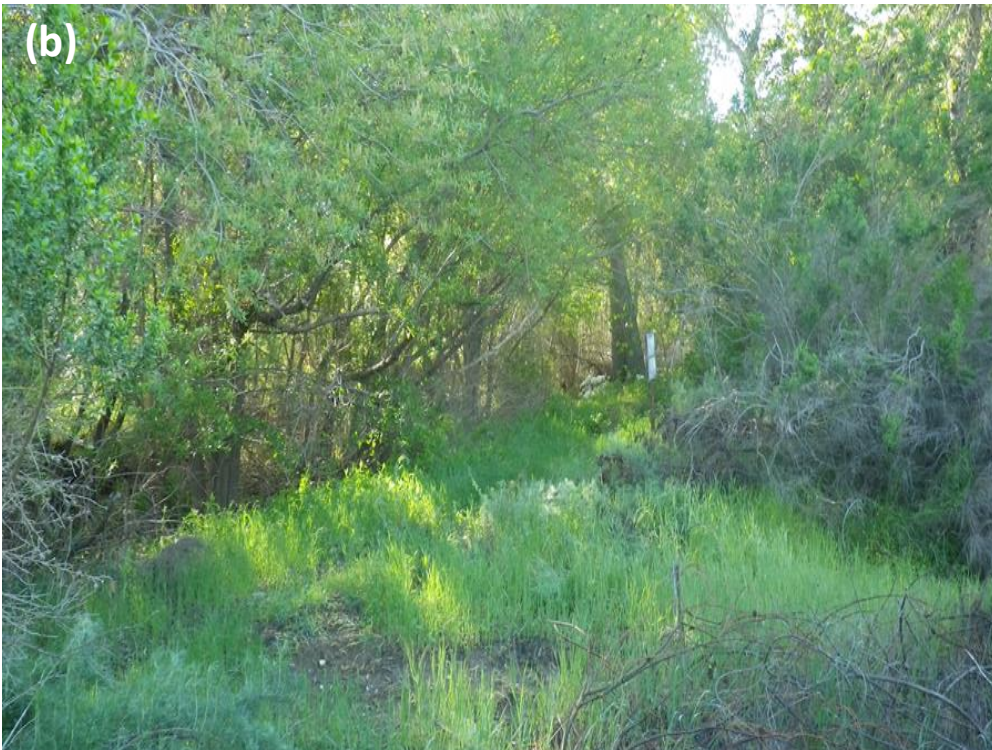
Figure 35: Photo point (T-1) collected at Hilton Creek looking upstream towards the trap site on (a) May 2005, and (b) March 2016.

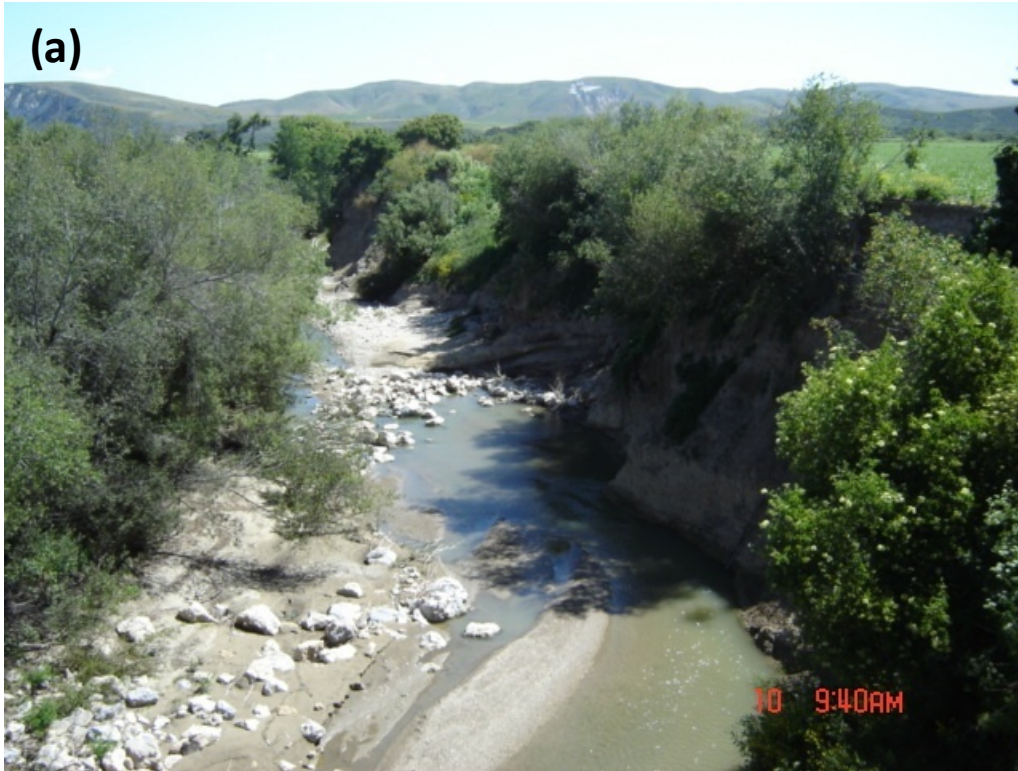
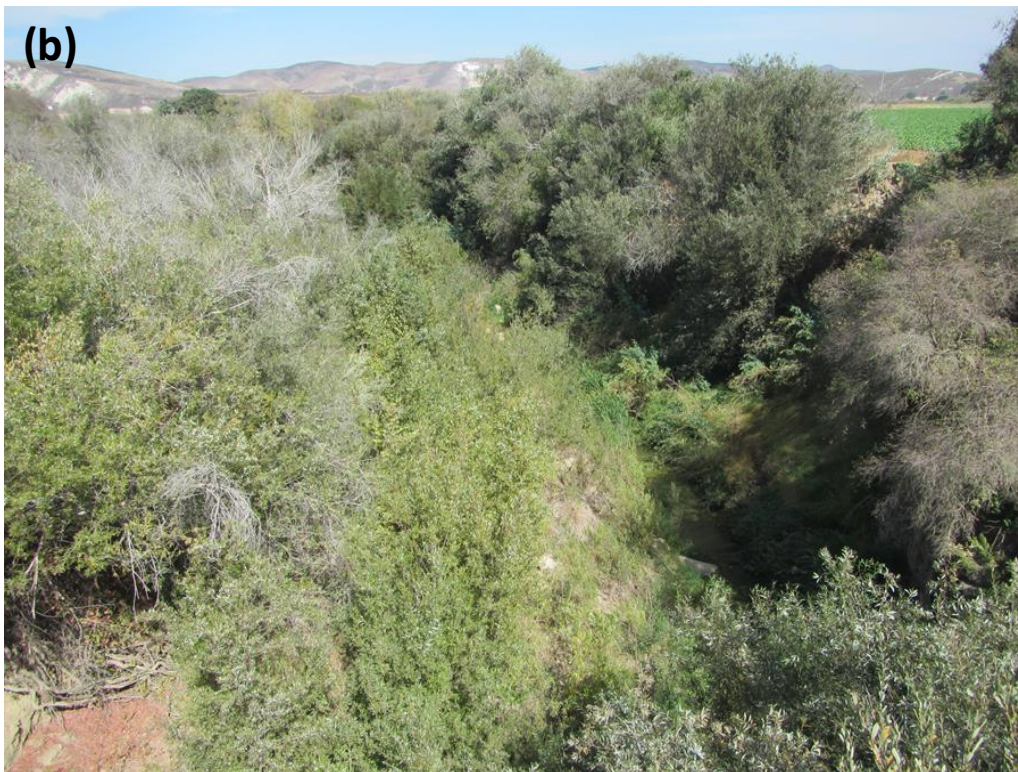
Figure 37: Photo point (T-28) collected at Salsipuedes Creek at Santa Rosa Bridge in (a) May 2005 and (b) September 2016.

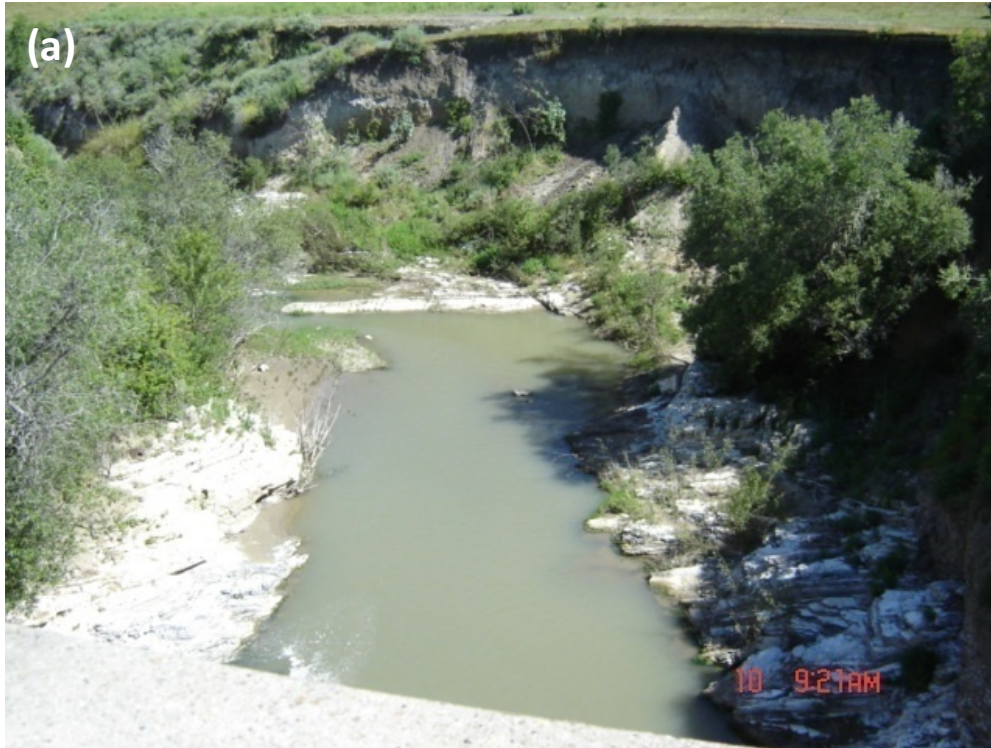
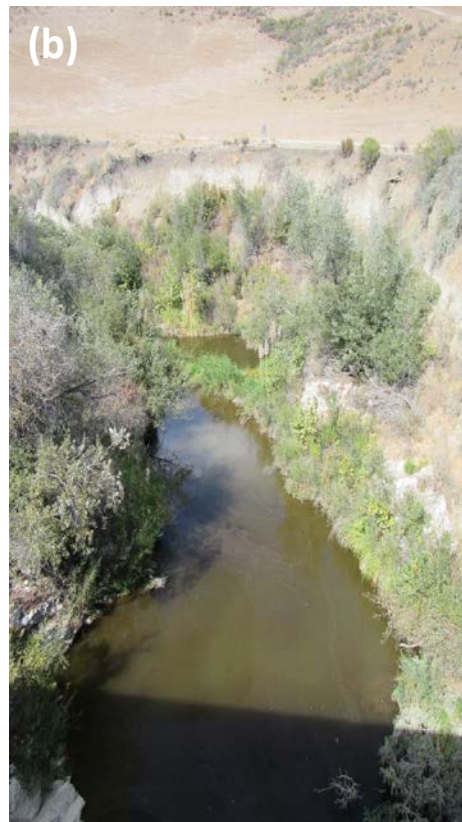
Figure 38: Photo point (T-39) collected at Salsipuedes Creek at Hwy 1 Bridge in May 2005 and (b) September 2016.

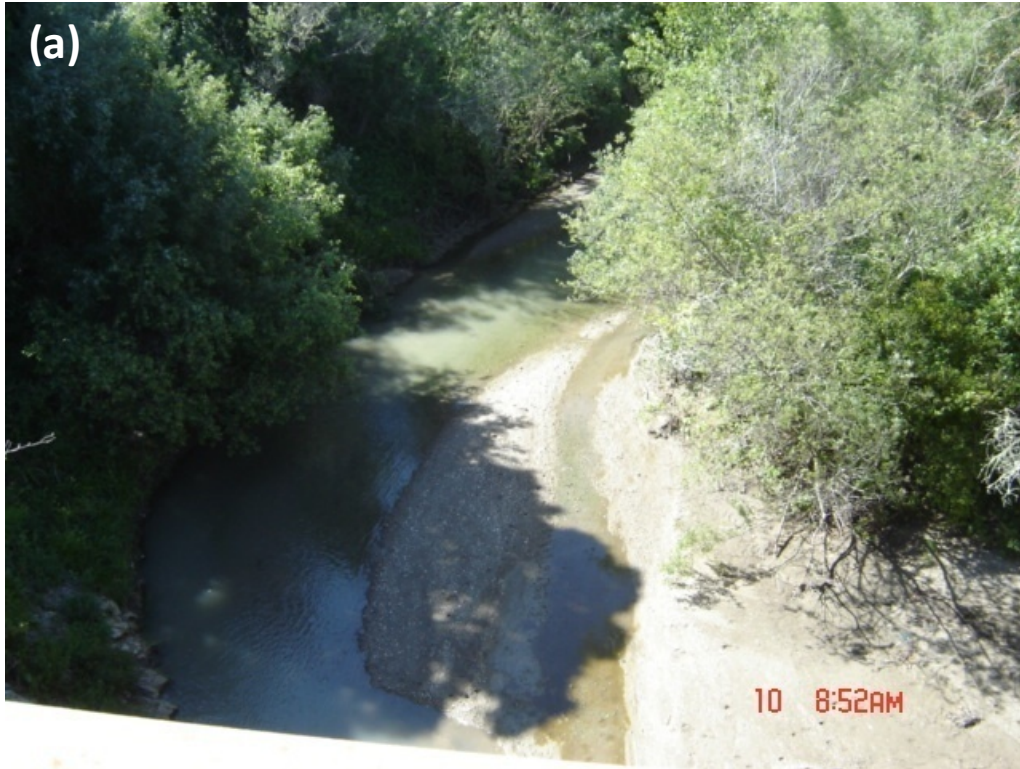
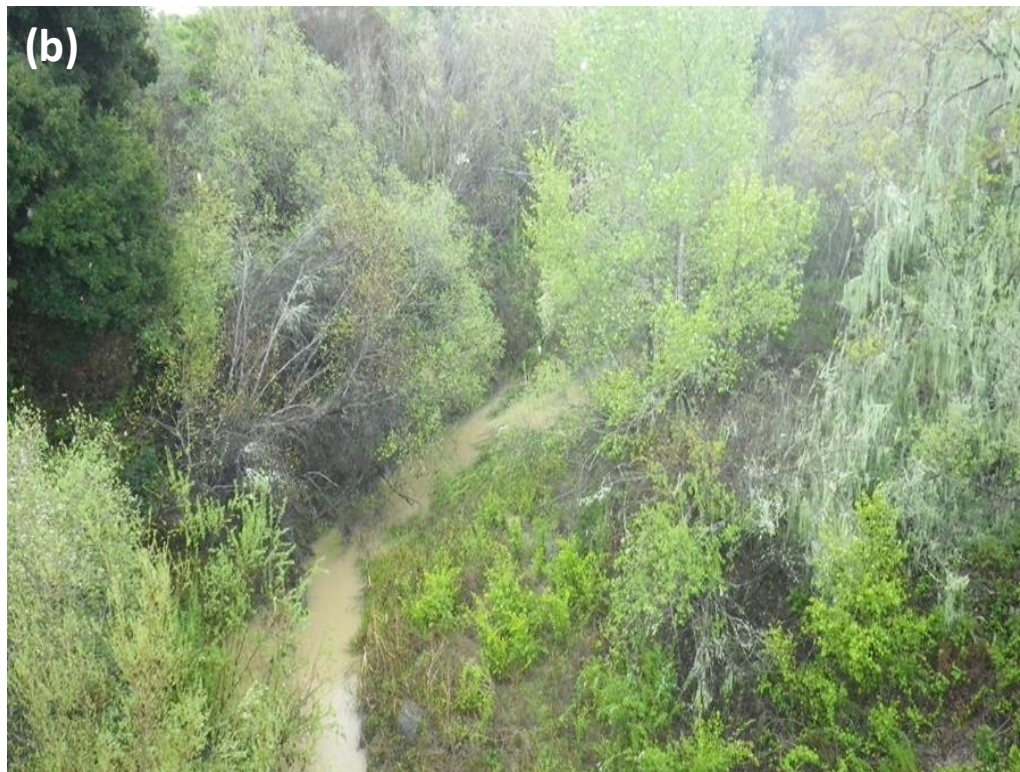
Figure 39: Photo point (T-42) collected at Salsipuedes Creek at Jalama Road Bridge in May 2005 and (b) March 2016.

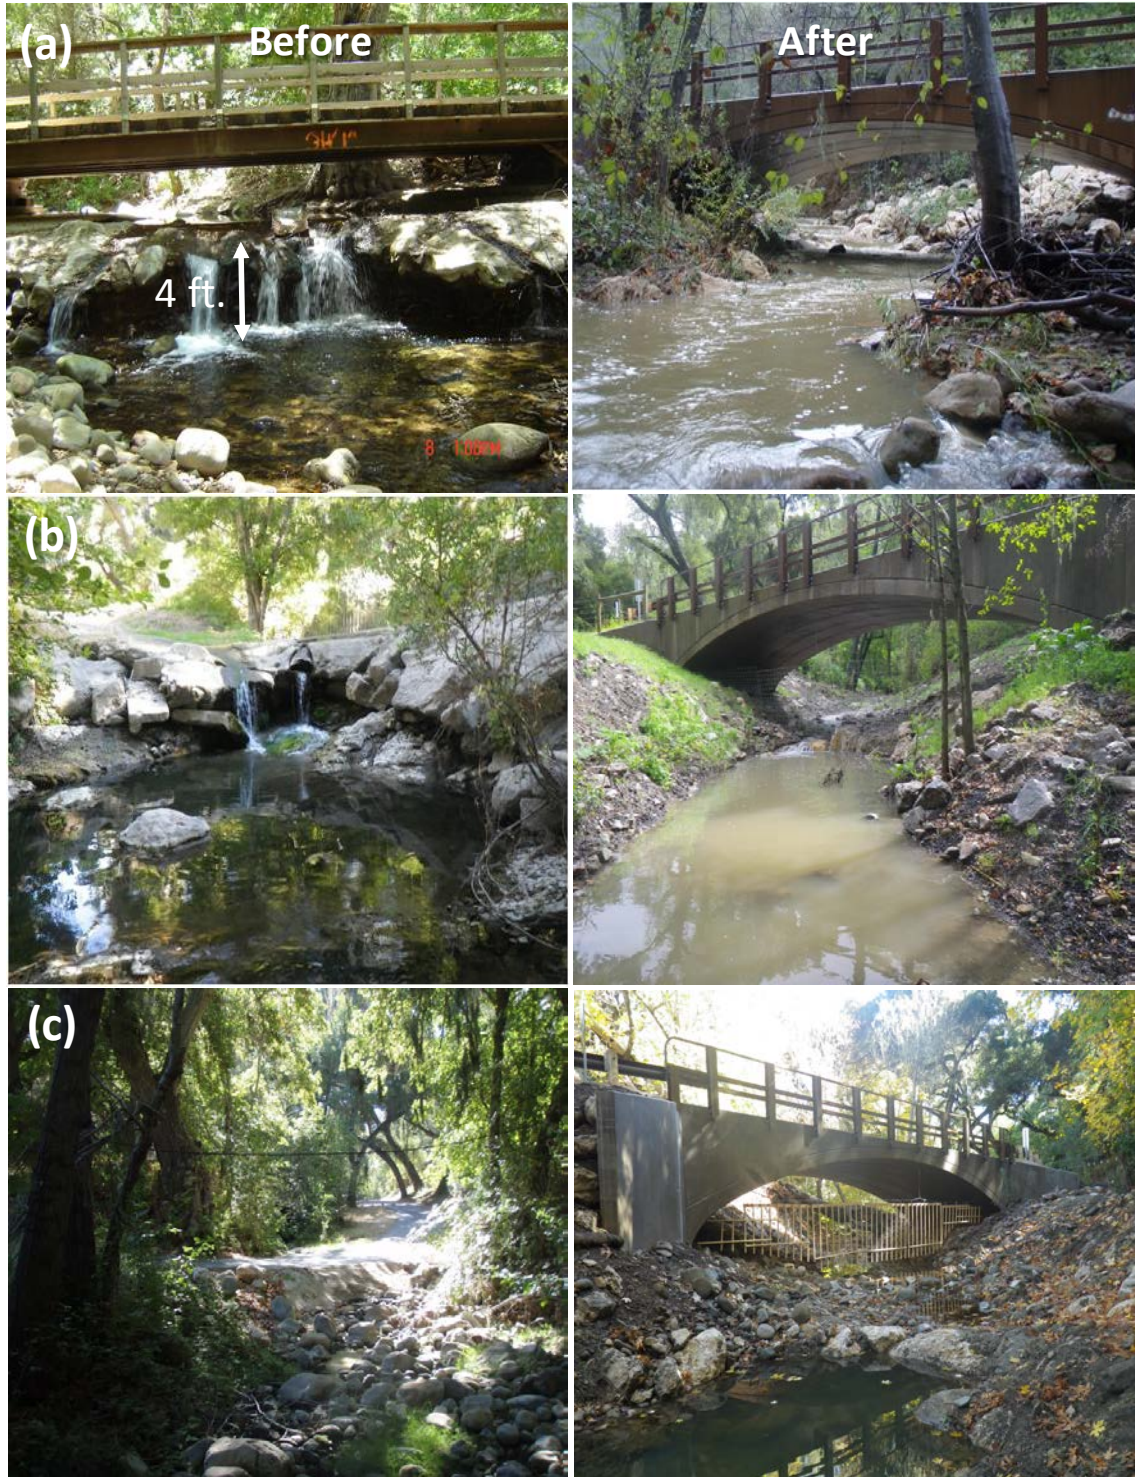
Figure 54: Fish passage and habitat restoration at a) Quiota Creek Crossing 6 (2008), (b) Quiota Creek Crossing 2 (2011), and Quiota Creek Crossing 7 (2013).

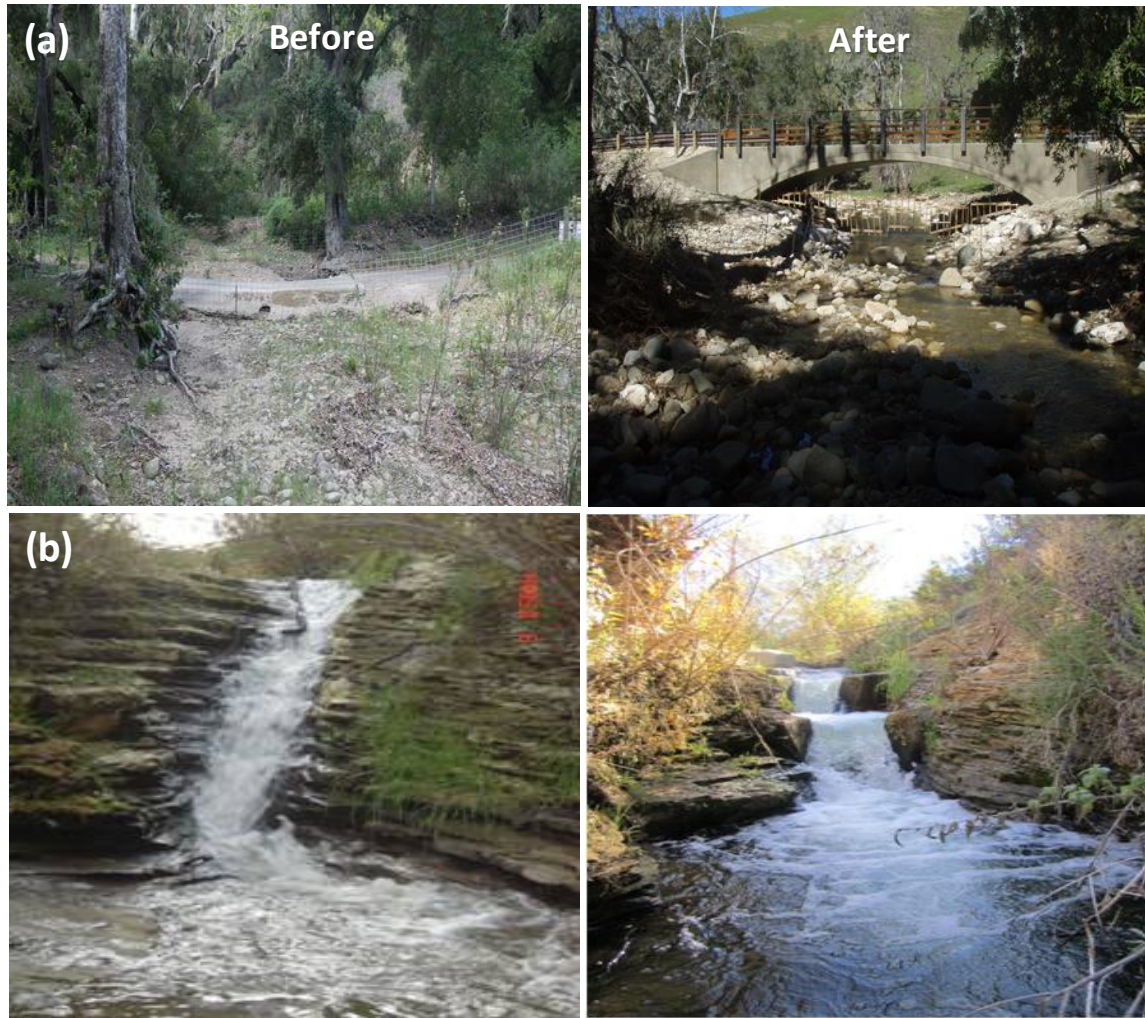
Figure 56: Fish passage and habitat restoration at (a) Quiota Creek Crossing 4 (completed in 2016) and (b) Hilton Creek at the Cascade Chute Project (completed in 2005).

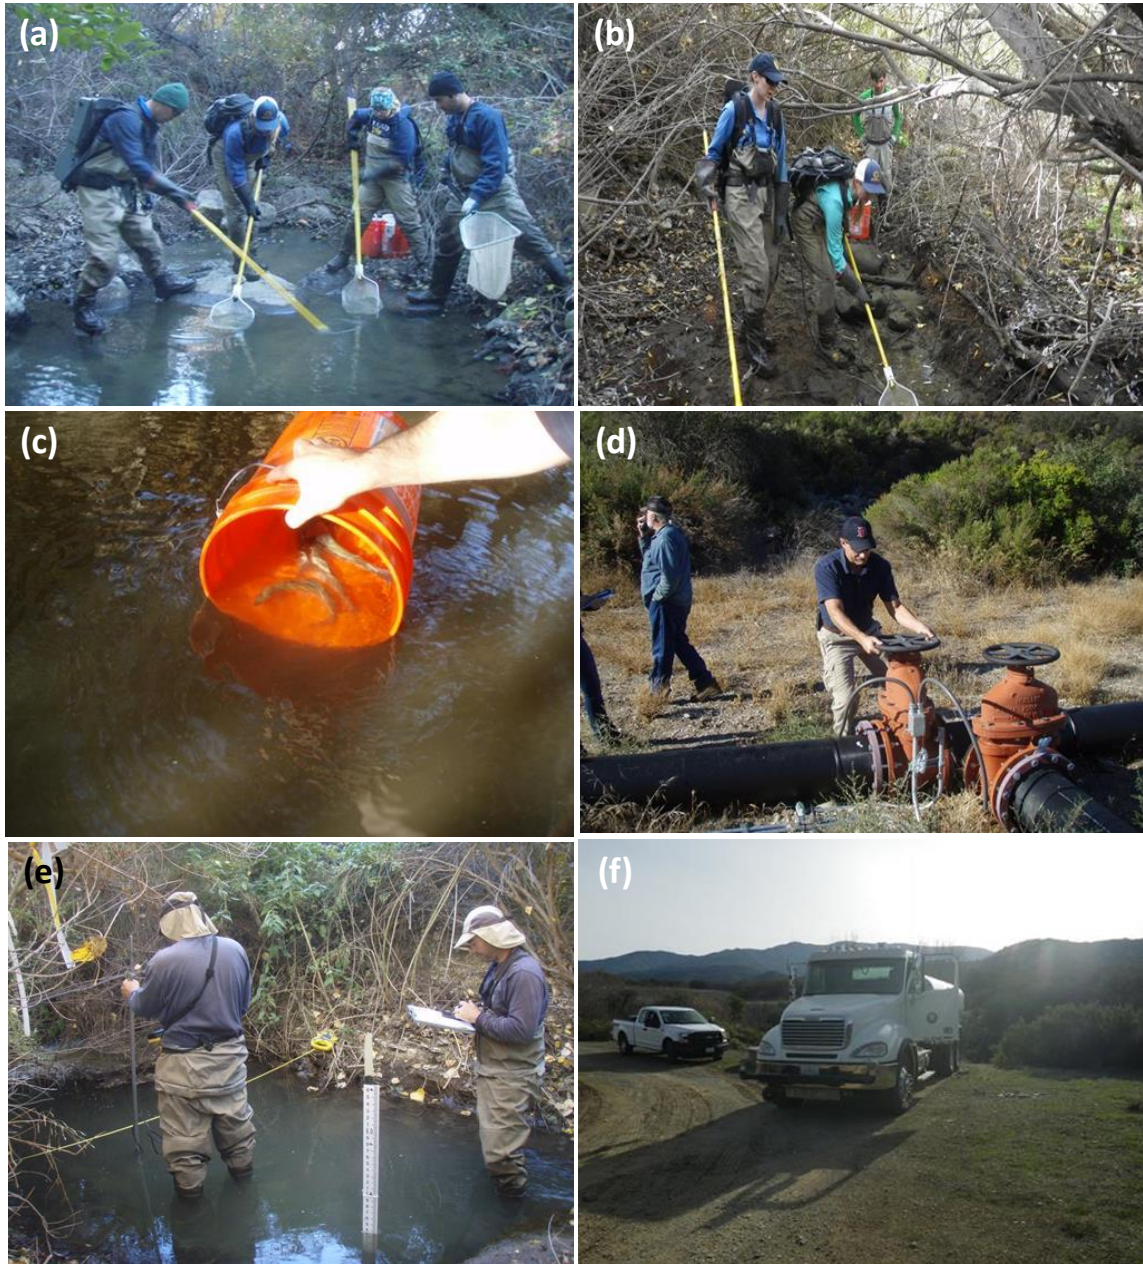
Figure 58: Transfer of lake water deliveries to Hilton Creek from the HCWS-URP to the HCEBS-LRP showing (a+b) electrofishing operations, (c) release of rescued fish downstream of the LRP, (d) adjustment of HCEBS valves, (e) monitoring flow rates, and (f) staged water truck to provide emergency water deliveries if needed.

There was one planned interruption of flow to Hilton Creek starting on 11/23/15 and ending on 12/2/15 as Reclamation needed to switch the delivery system to the creek from the Hilton Creek Watering System (HCWS) discharging at the Upper Release Point (URP) to the Hilton Creek Emergency Backup System (HCEBS) on gravity flow to the Lower Release Point (LRP). This was due to critical drought conditions and diminished lake storage. All fish in between the URP and the LRP needed to be relocated downstream since that section of the creek would dry out with the change in operations. The switch resulted in relocating 247 *O. mykiss* (7 Prickly sculpin, *Cottus asper*) and there were 11 *O. mykiss* (5 sculpin) mortalities. A report with details was submitted by Reclamation to NMFS and the necessary operation will only be discussed below in the context of monitored water quality and observed fish through migrant trapping and snorkel surveys.

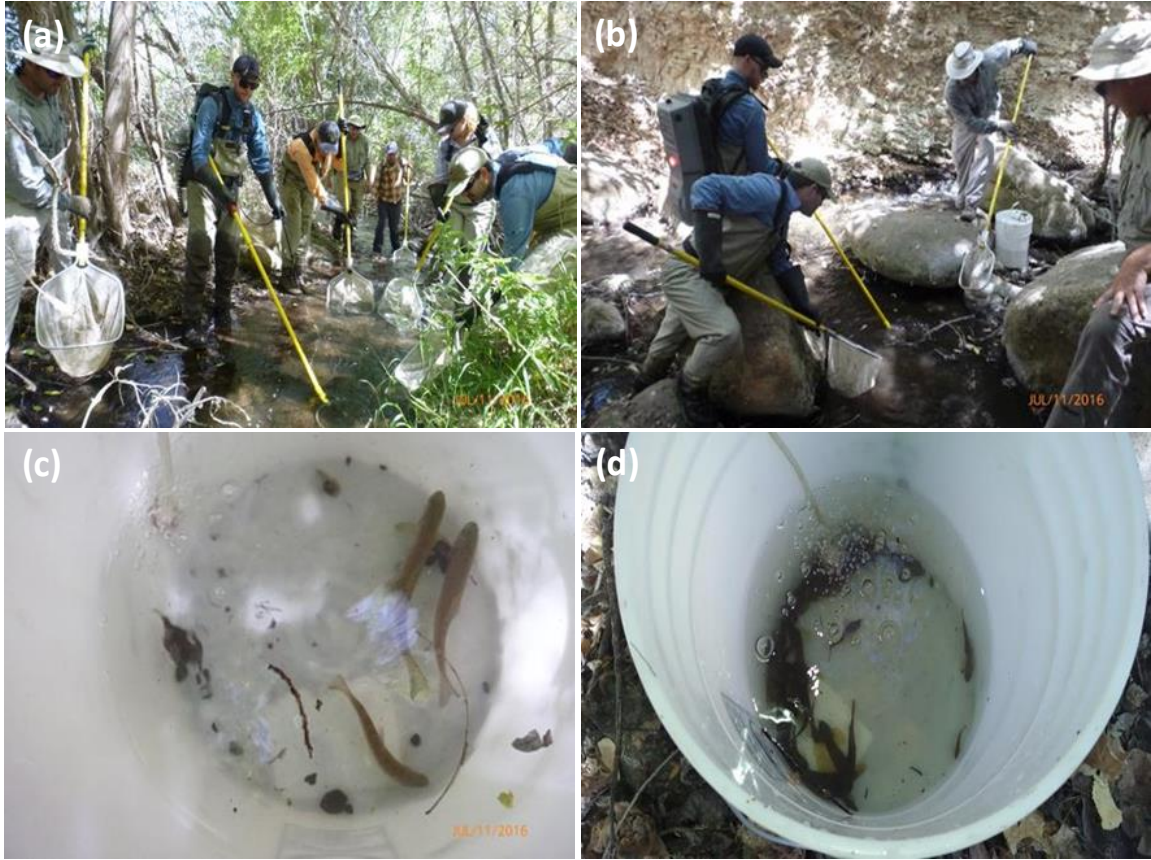
Figure 60: Fish rescue and relocation efforts in lower Hilton Creek just prior to the start of the WR 89-18 release, showing (a+b) electrofishing operations and (c+d) captured fish ready for relocation.

Prior to the start of WR 89-18 release on 7/12/16, lake discharge to Hilton Creek was maintained by HCEBS gravity flow to the LRP that reached approximately 1,500 feet of creek habitat just downstream. The HCEBS would no longer provide gravity flow to Hilton Creek once the WR 89-18 release started due to low reservoir head and high release rates out of the Outlet Works. As a result, the Fish Rescue Team (FRT) was called upon by Reclamation to rescue and relocate *O. mykiss* within the lower most section of Hilton Creek near the LSYR confluence and move them to larger pool habitats located downstream of the LRP. The operation took 2 days (7/11/16 and 7/12/16) and was done just prior to the start of the WR 89-18 release, focusing on Reach 1 and Reach 3 of Hilton Creek (Figure 60). Participants in the rescue operations included CDFW, NMFS, COMB-FD, and Reclamation. A total of 33 *O. mykiss* were captured and relocated to the Spawning Pool and Honeymoon Pool of Hilton Creek within Reach 4. A total of 245 sculpin were captured and relocated to the Long Pool. Several non-native species (green sunfish and largemouth bass juveniles) were also captured within Reach 1 and were dispatched. A report was provided to Reclamation with the results of the operation (COMB, 2016d).

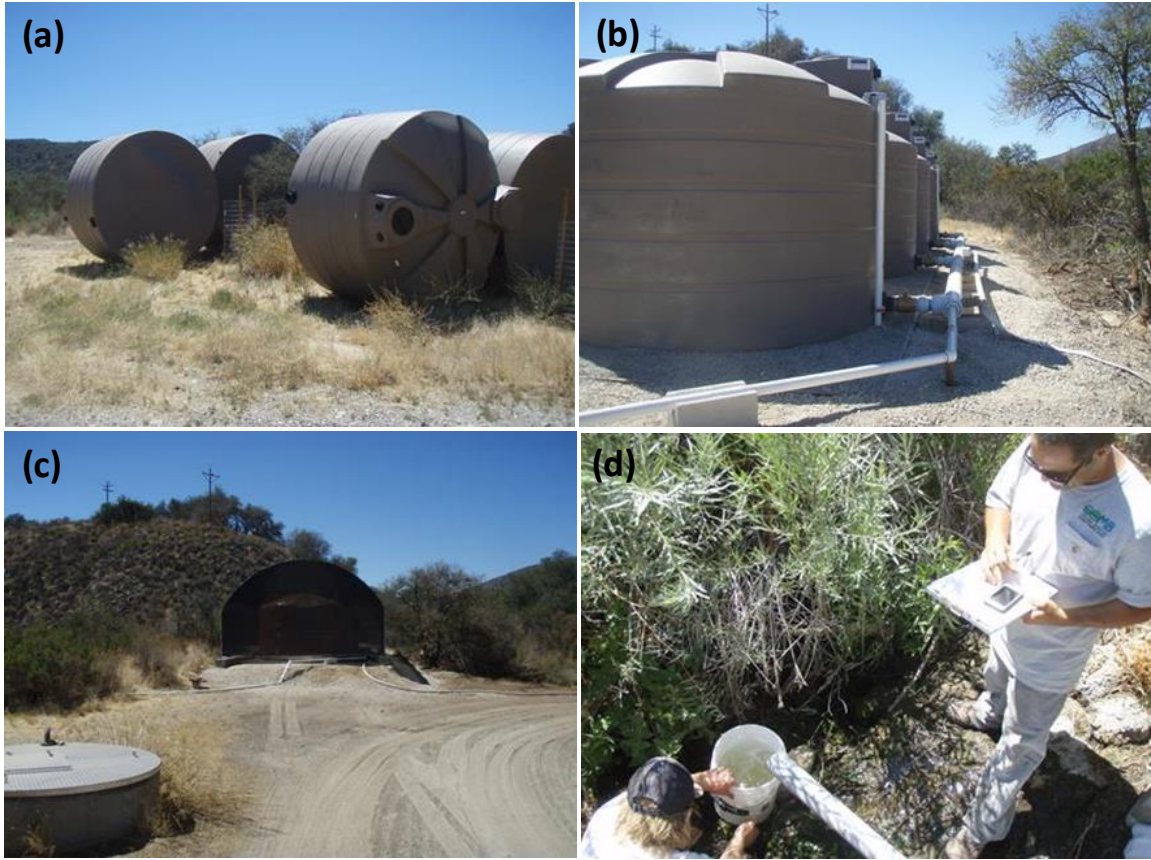
Figure 61: Hilton Creek Water Tanks (5-thousand gallons each): (a) arrival of the tanks, (b) installation, (c) shade protection, and (d) measuring trickle flow at 0.03 cfs.

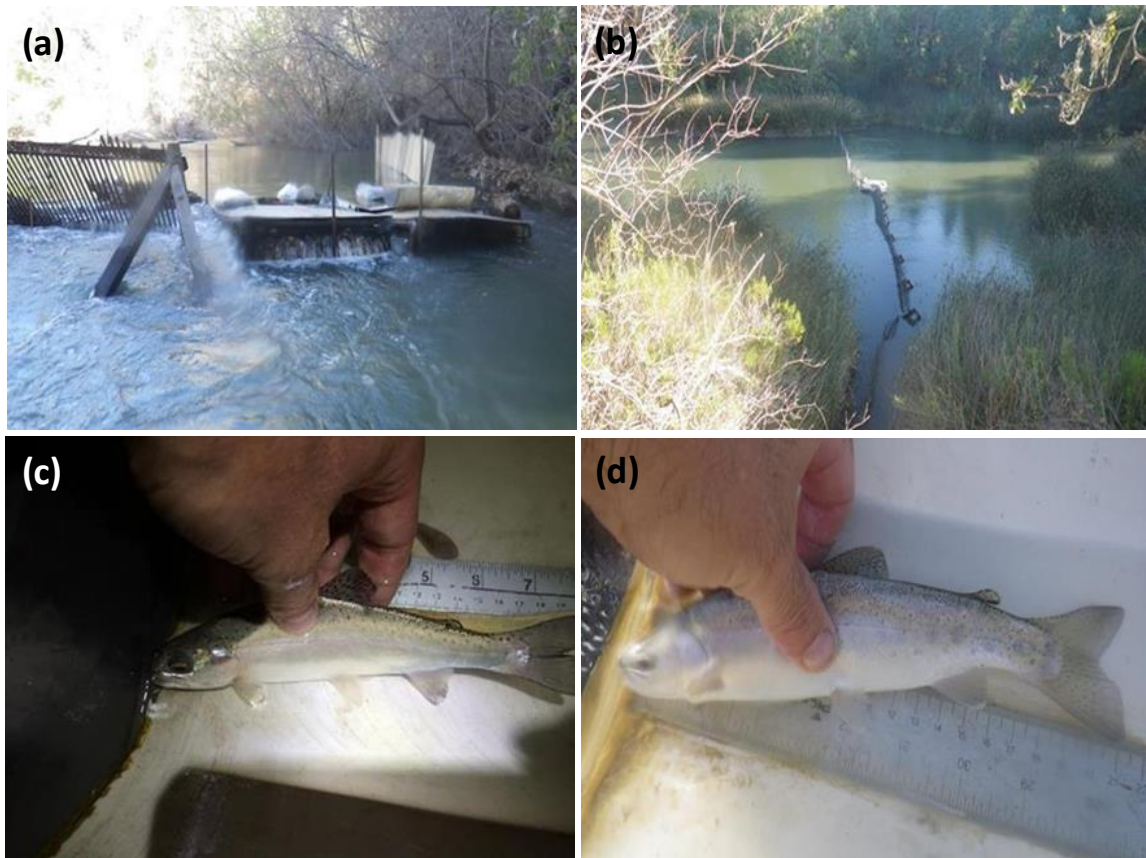
Figure 63: WR 89-18 release trapping operations (a) downstream of the Stilling Basin and (b) at the tailout of the Long Pool, showing a captured *O. mykiss* at (c) the Stilling Basin trap and (d) the Long Pool trap.
