WY2016 ANNUAL MONITORING SUMMARY

**THE BIOLOGICAL OPINION FOR THE OPERATION
AND MAINTENANCE OF THE CACHUMA PROJECT
ON THE SANTA YNEZ RIVER
IN SANTA BARBARA COUNTY, CALIFORNIA**

**CACHUMA OPERATION AND MAINTENANCE BOARD
FISHERIES DIVISION**

APRIL 22, 2019

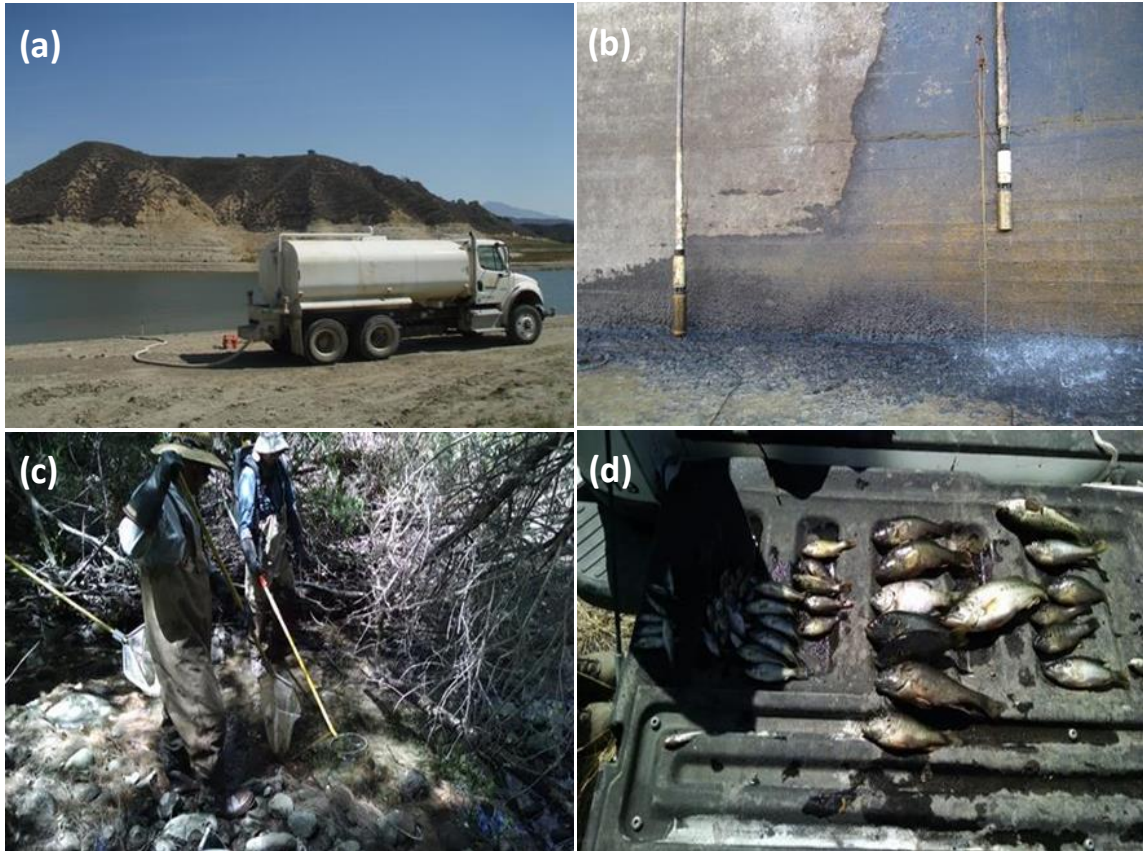
Figure 64: Post WR 89-18 release efforts to maintain trickle flow to Hilton Creek and conduct fish rescue and relocation downstream of the dam, showing (a) water tanker truck filling up on the shores of Lake Cachuma using a trash pump, (b) Stilling Basin submersible pumps during dewatering efforts in 2017, (c) fish rescue operations by electrofishing between the Stilling Basin and Long Pool, and (d) non-native fish removal.

An alternative extraction point to fill the water tanks was located along the shores of Lake Cachuma via a trash pump to a water truck (Figure 64). This procedure was continued through 9/2/16 at which point the contract for the tanker truck expired. With that eventuality in mind, Reclamation installed on 8/26/16 the submersible electric (well) pumps (operational and backup) in the Stilling Basin that were connected to the Chute Release Point (CRP) of the HCWS (Figure 62). The system allowed for water extraction from near the bottom of the Stilling Basin where water temperatures were the coolest and delivered it directly to the LPR where it cascaded down into the creek and provided minimum stream flow to sustain the remaining *O. mykiss* population in Hilton Creek. The low discharge rate from the submersible pump maintained approximately 0.03 cfs, which was a similar discharge rate to what was being provided previously by the Hilton Creek Tanks during the WR 89-18 Release.

The abrupt end of the WR 89-18 Release necessitated an emergency fish rescue/relocation effort downstream of the Stilling Basin and within the accessible areas of the Highway 154 Reach from 8/29/16 to 9/2/16 by COMB-FD staff and CDFW personnel (Figure 64). The COMB-FD conducted several passes each day using bank

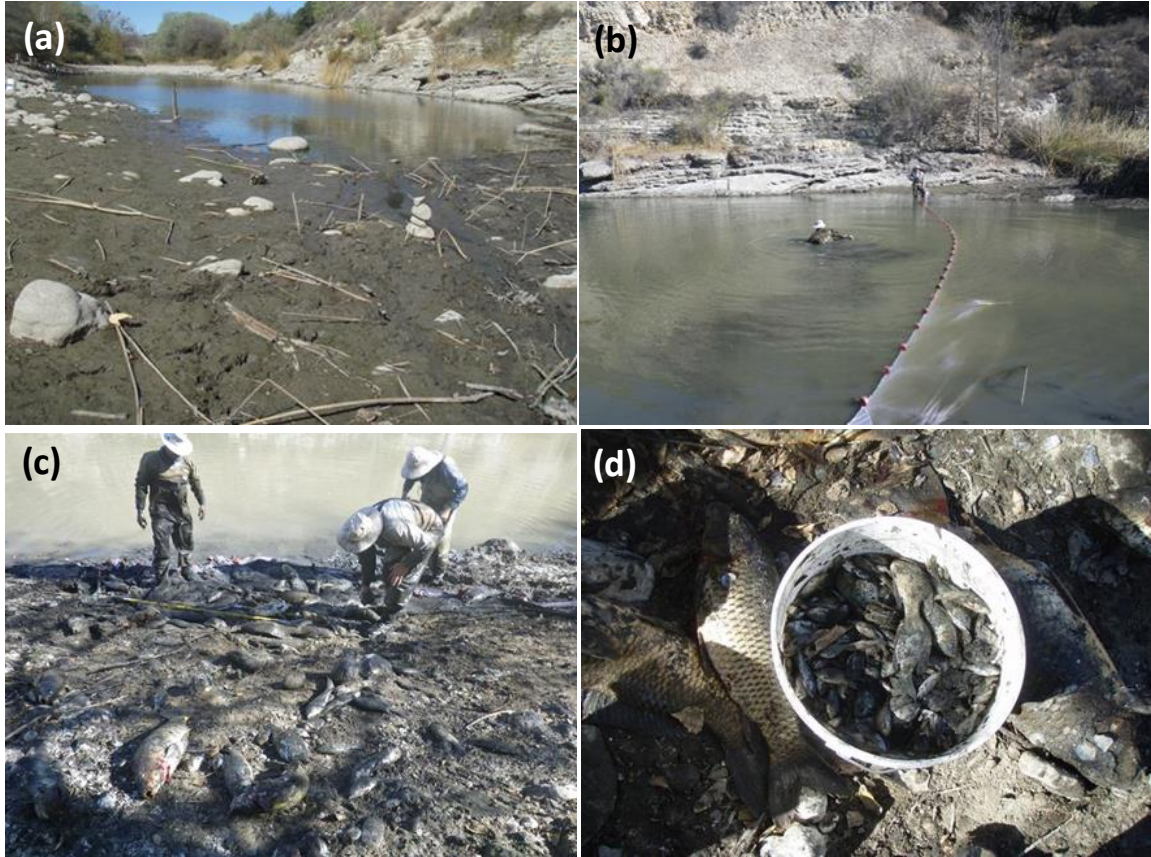
Figure 65: Fish rescue operations at the Long Pool dried out after the end of 2016 WR 89-18 releases showing (a) a swiftly shrinking Long Pool, (b) seining, and (c+d) captured fish from the seine hauls.

On 10/19/16, after discussion with NMFS, Reclamation approved a fish rescue, relocation, and non-native fish removal effort within the Long Pool (LSYR-0.51) due to the ongoing drought and drying conditions of that habitat after the cessation of the 2016 WR 89-18 Release (Figure 65). With assistance from CDFW, COMB-FD carried out a fish rescue on 10/20/16 and 10/26/16 within the Long Pool. The objective of the operation was to capture and relocate any remaining *O. mykiss* from the Long Pool and move them to Hilton Creek, with a secondary objective of removing and dispatching any non-native fish species from that habitat. A report was provided to Reclamation (COMB, 2016c).
