WY2018 ANNUAL MONITORING SUMMARY

THE BIOLOGICAL OPINION FOR THE OPERATION AND MAINTENANCE OF THE CACHUMA PROJECT ON THE SANTA YNEZ RIVER IN SANTA BARBARA COUNTY, CALIFORNIA

**CACHUMA OPERATION AND MAINTENANCE BOARD
FISHERIES DIVISION**

JANUARY 29, 2020

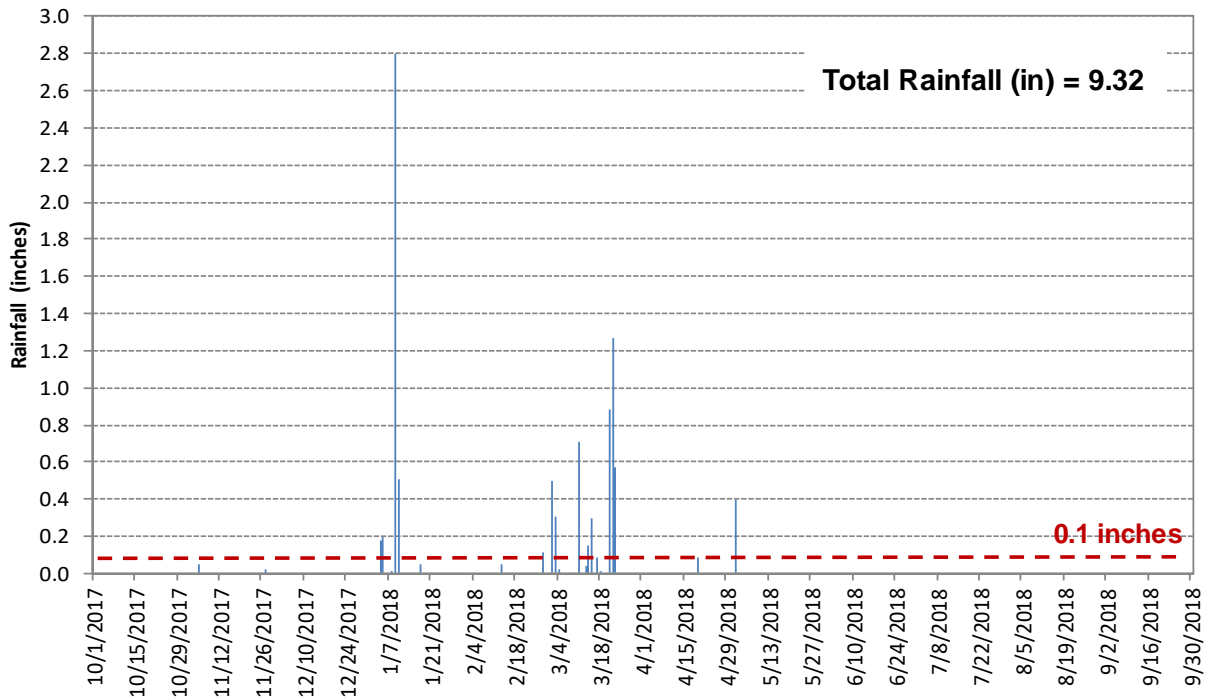
Figure 1: WY2018 rainfall recorded at Bradbury Dam (USBR).

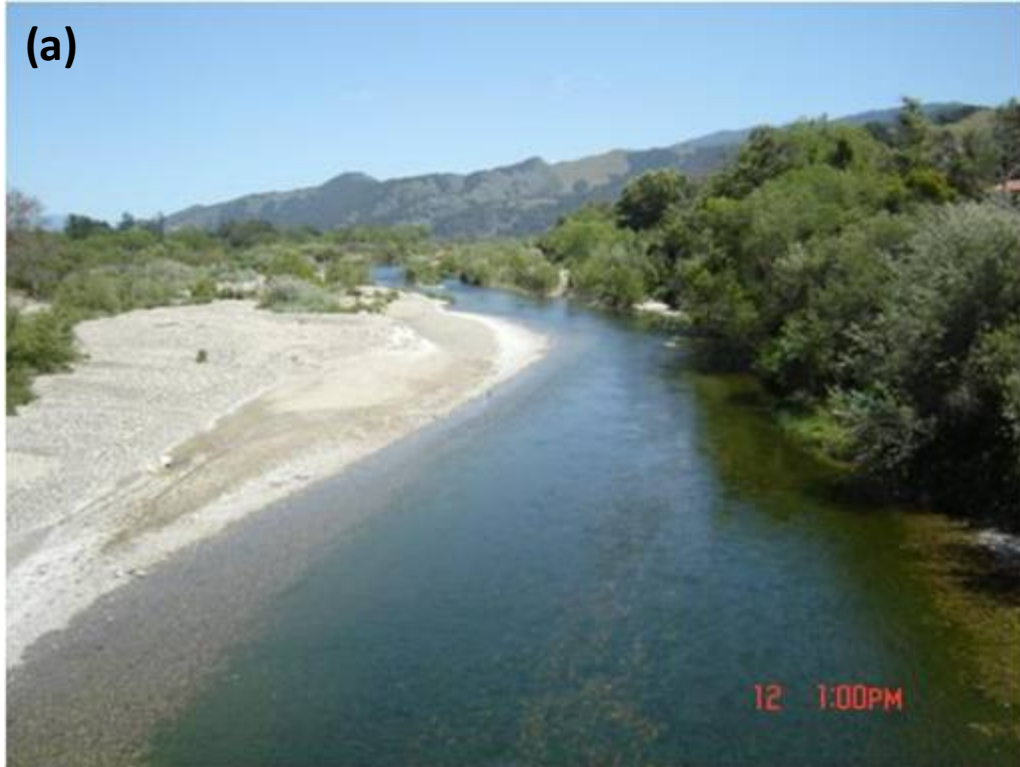
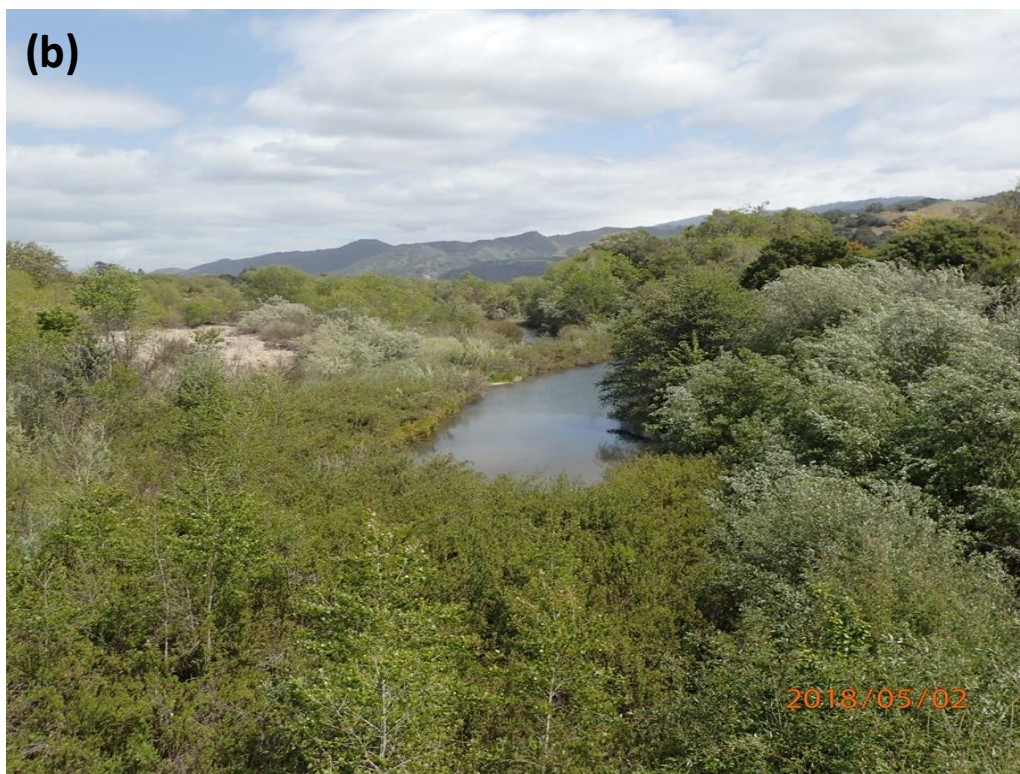
Figure 43: Photo point (M-12) collected at Refugio Bridge looking upstream in (a) May 2005, and (b) May 2018.

Figure 43: Photo point (M-12) collected at Refugio Bridge looking upstream in (a) May 2005, and (b) May 2018.

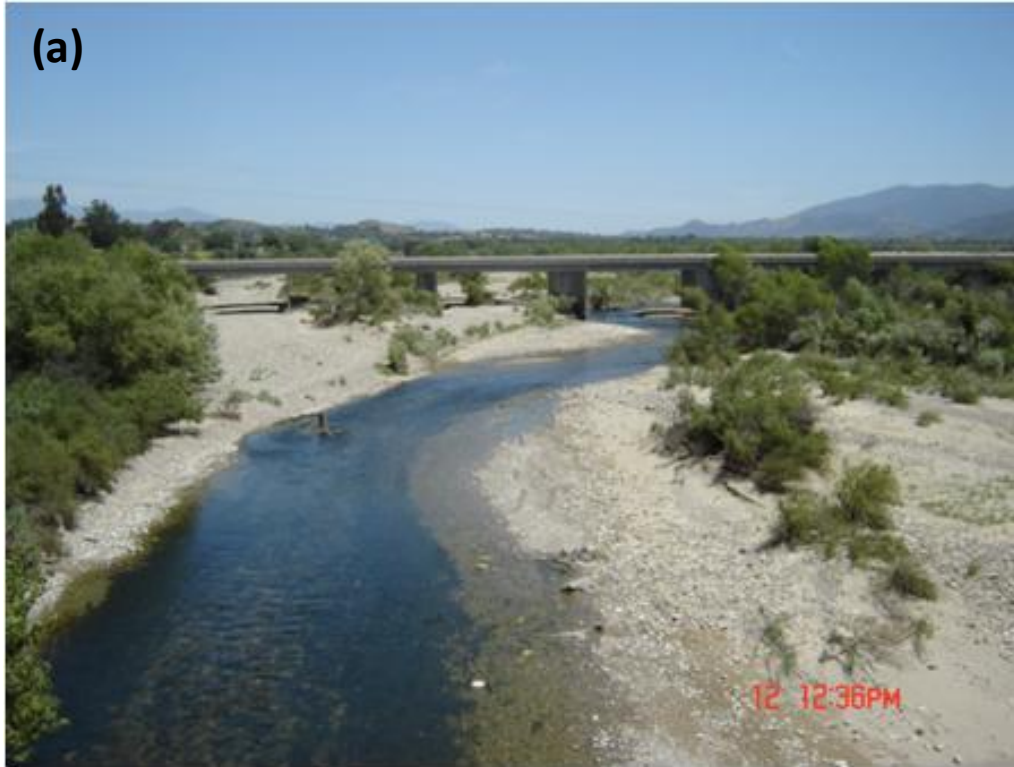
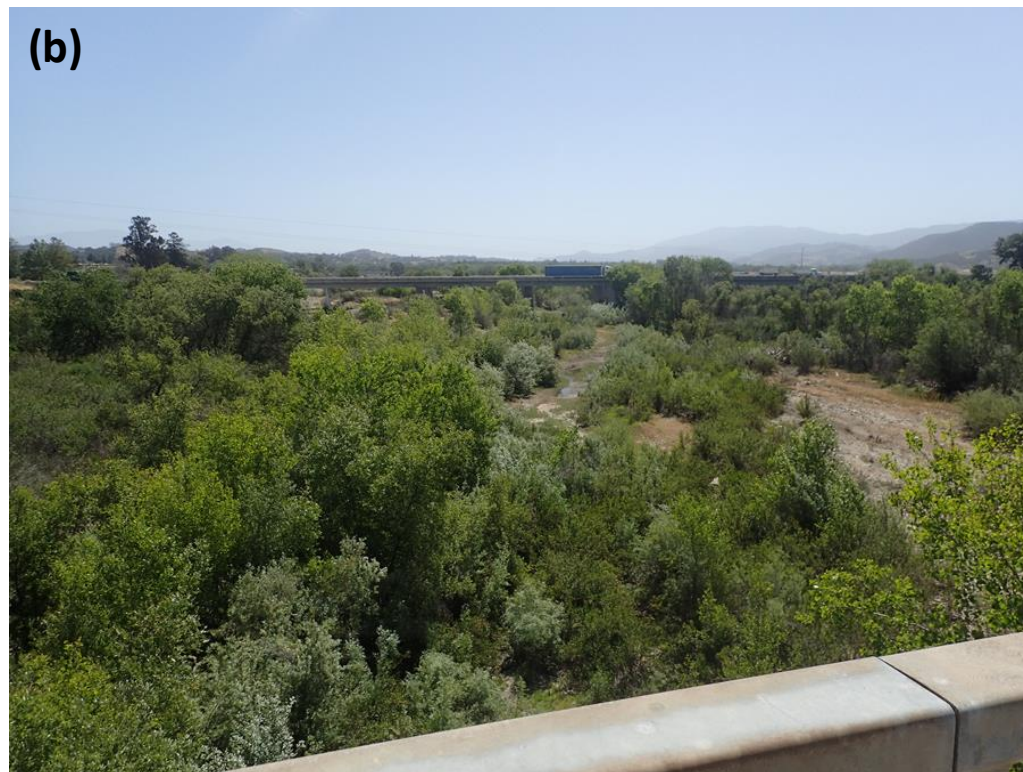
Figure 45: Photo point (M-19) collected at Avenue of the Flags Bridge looking upstream in (a) May 2005, and (b) May 2018.

Figure 45: Photo point (M-19) collected at Avenue of the Flags Bridge looking upstream in (a) May 2005, and (b) May 2018.

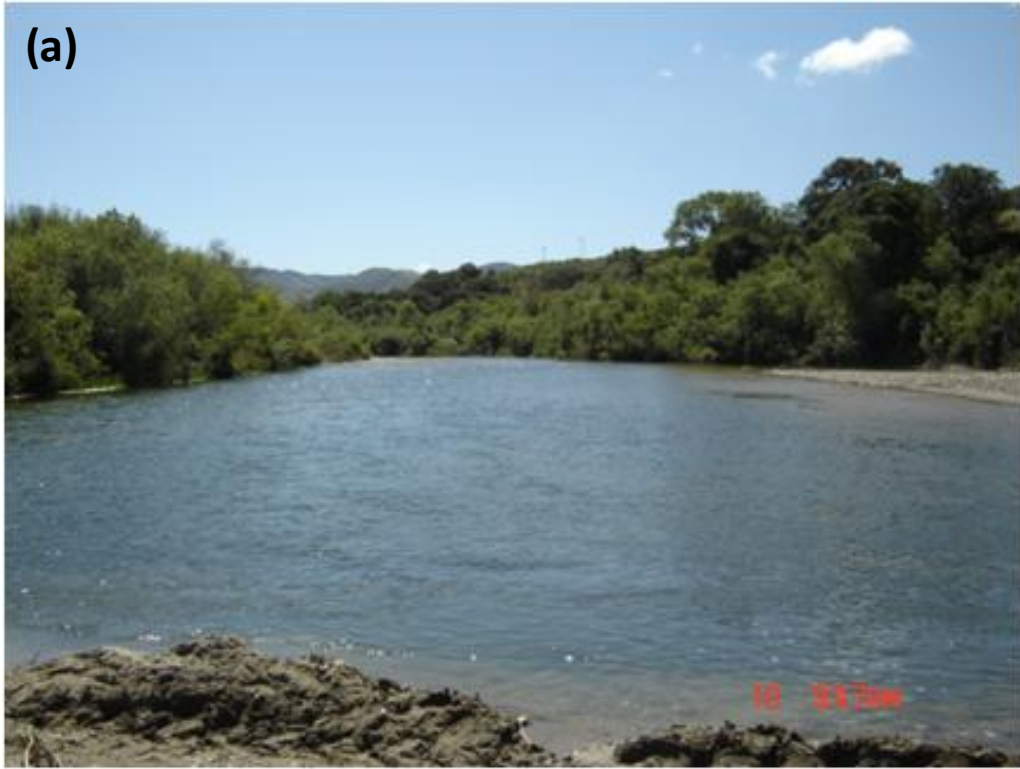
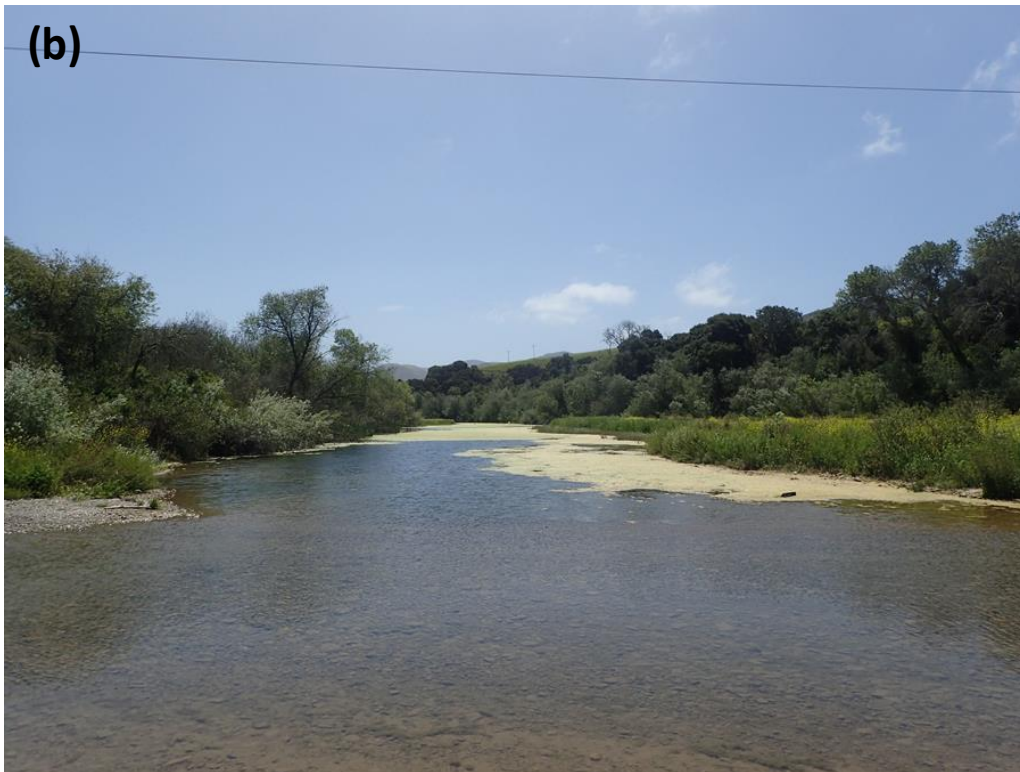
Figure 46: Photo point (M-21) collected at Sweeney Road Crossing looking upstream in (a) May 2005, and (b) May 2018.

Figure 46: Photo point (M-21) collected at Sweeney Road Crossing looking upstream in (a) May 2005, and (b) May 2018.

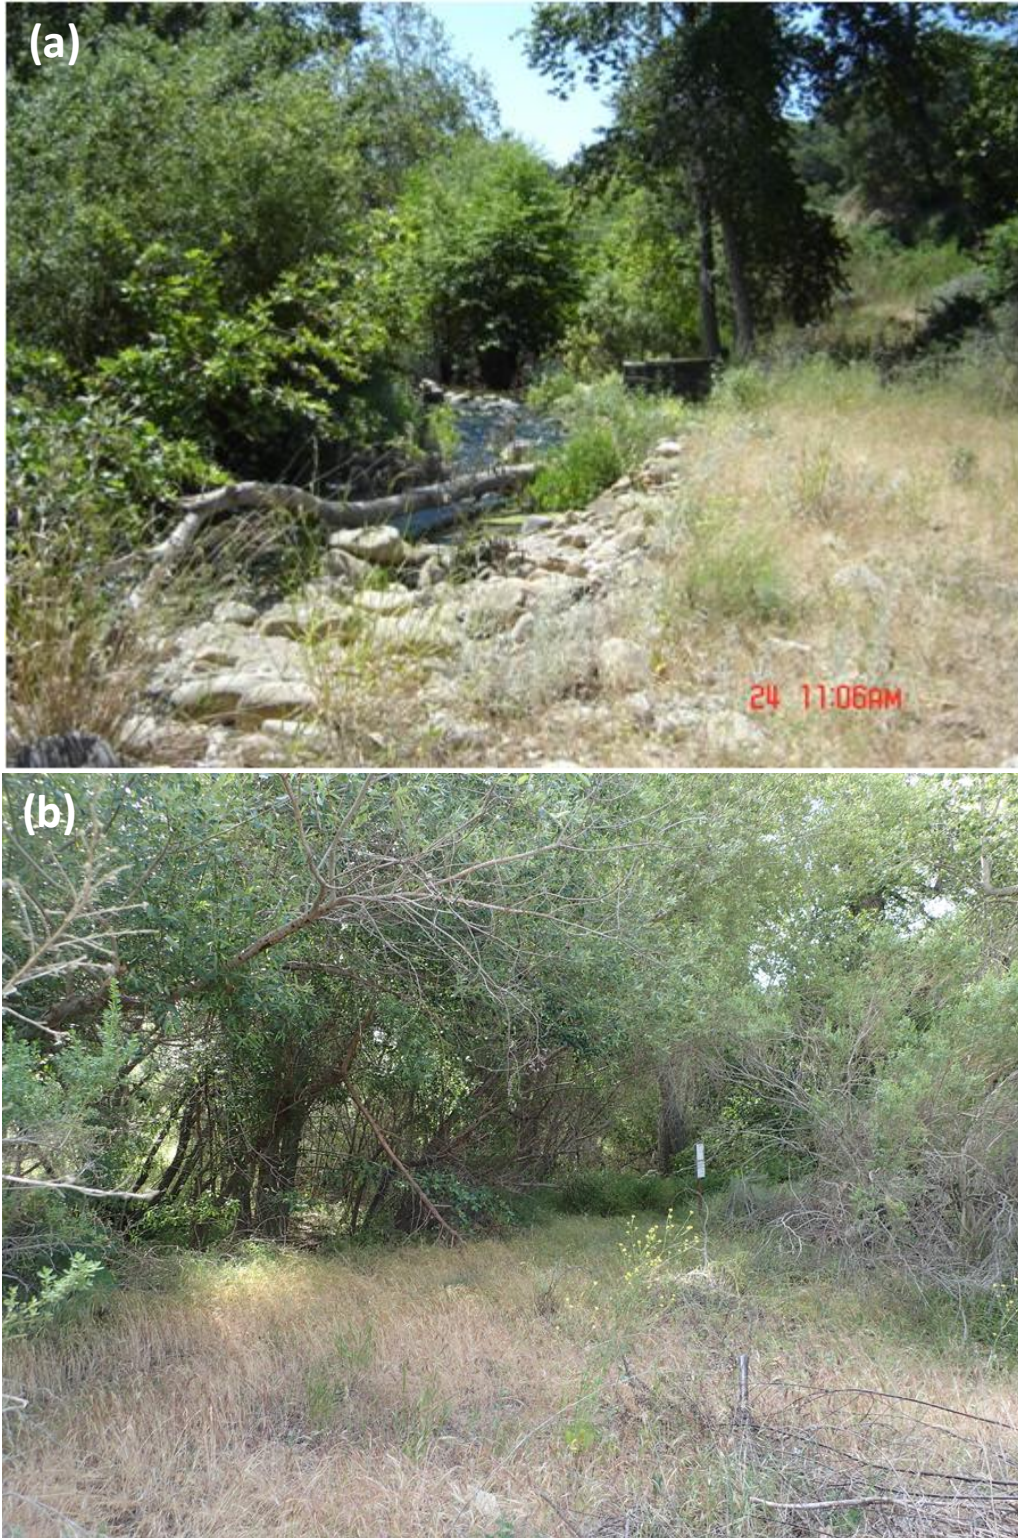
Figure 47: Photo point (T-1) collected at Hilton Creek looking upstream towards the trap site on (a) May 2005, and (b) May 2018.

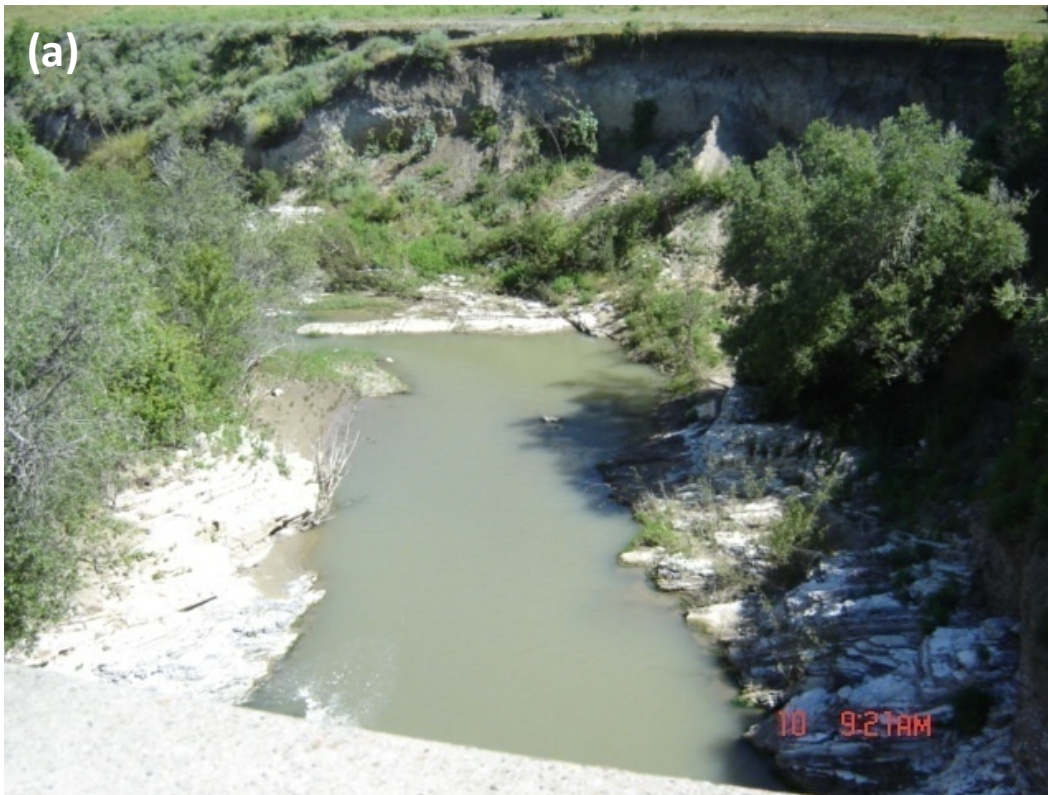
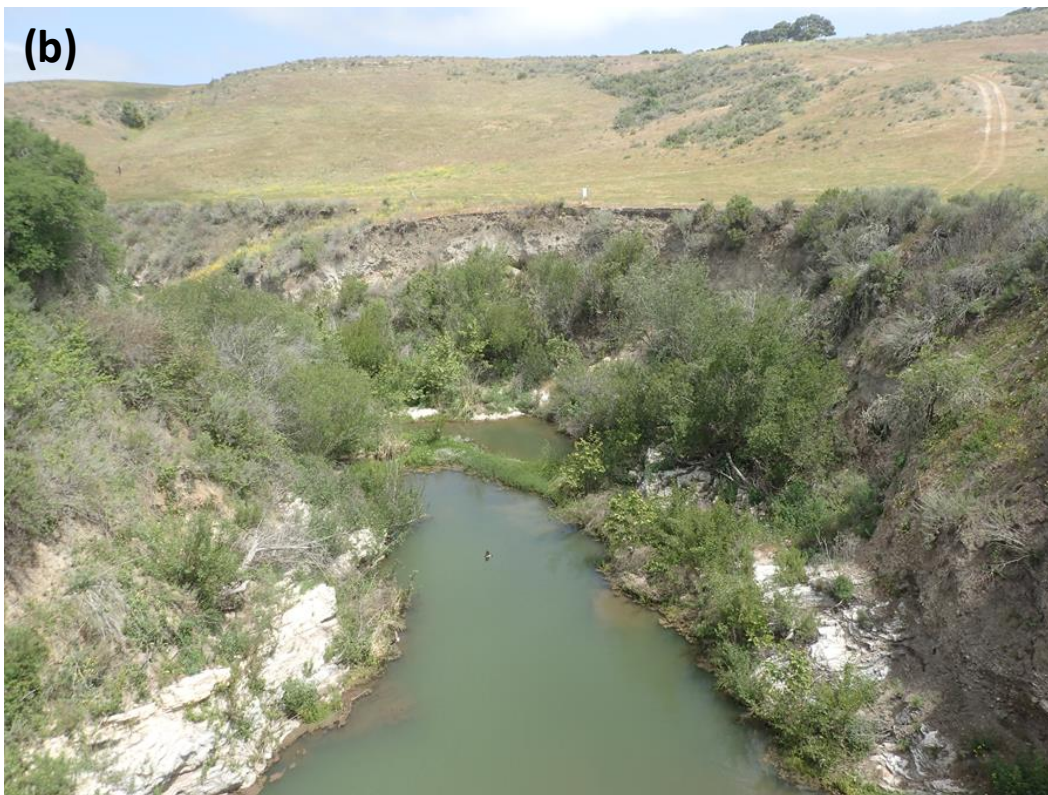
Figure 50: Photo point (T-39) collected at Salsipuedes Creek at Hwy 1 Bridge in May 2005 and (b) May 2018.

Figure 50: Photo point (T-39) collected at Salsipuedes Creek at Hwy 1 Bridge in May 2005 and (b) May 2018.

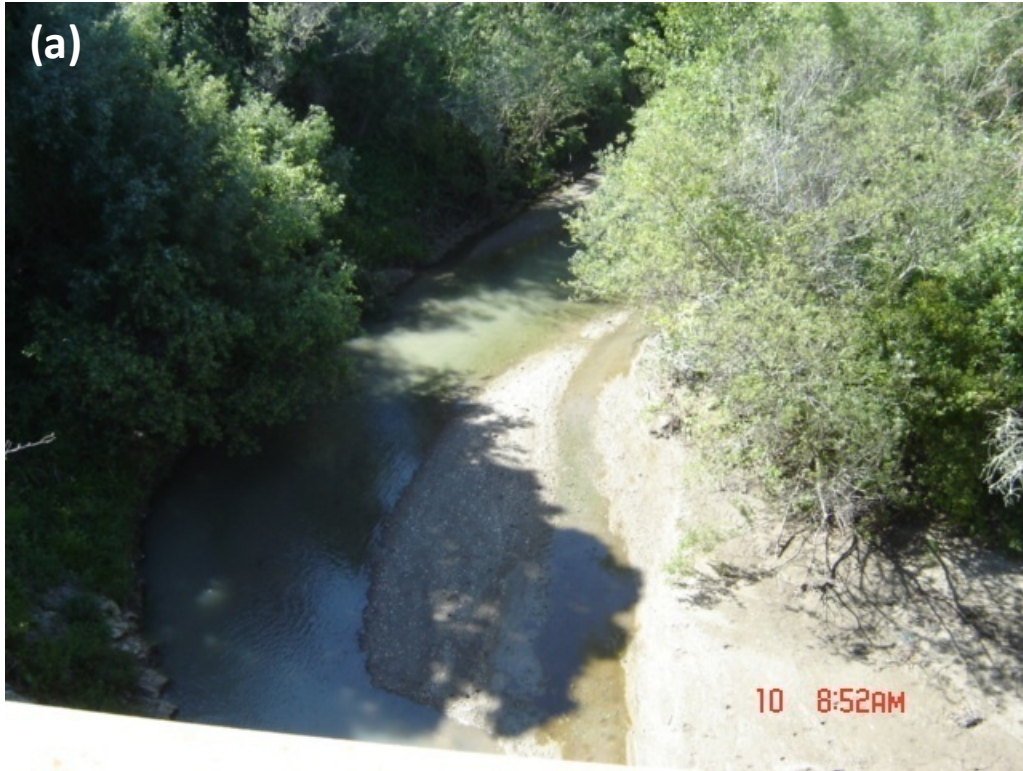
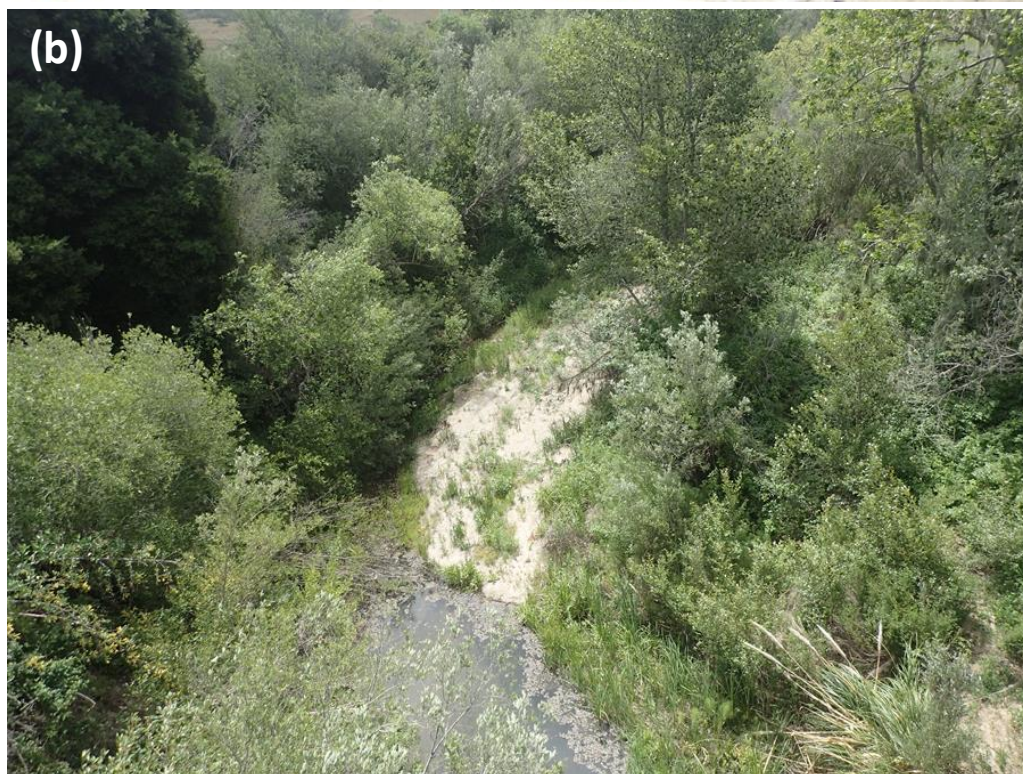
Figure 51: Photo point (T-42) collected at Salsipuedes Creek at Jalama Road Bridge in May 2005 and (b) May 2018.

Figure 51: Photo point (T-42) collected at Salsipuedes Creek at Jalama Road Bridge in May 2005 and (b) May 2018.

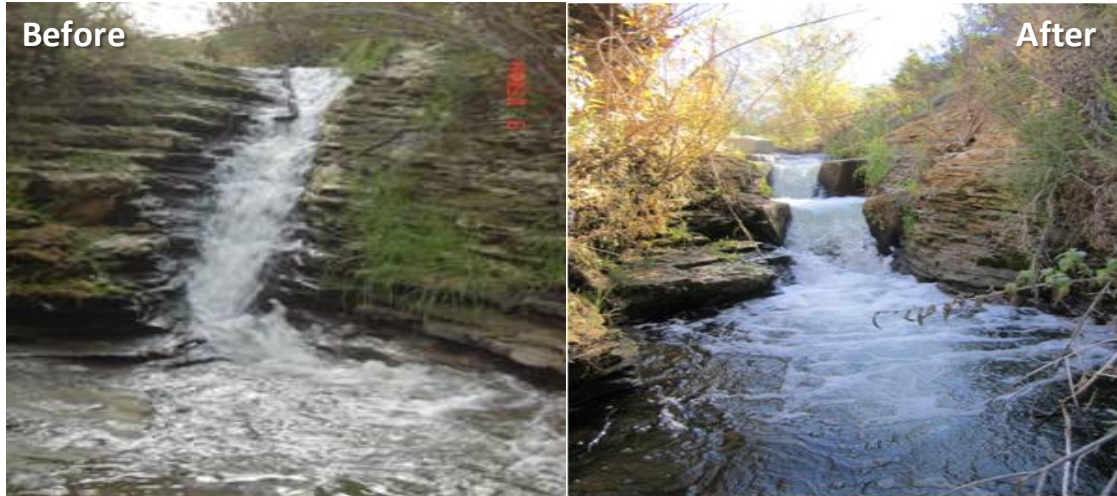
Figure 71: Fish passage and habitat restoration at Hilton Creek at the Cascade Chute Project that was completed in 2005.

Figure 71: Fish passage and habitat restoration at Hilton Creek at the Cascade Chute Project that was completed in 2005.

The HCWS has transformed Hilton Creek into a dense riparian zone where there is little thermal heating from the URP to the confluence with the LSYR mainstem (Figures 47-48). In 2005, completion of the Hilton Creek Cascade Chute Project doubled the available habitat for *O. mykiss* in the watered section of Hilton Creek (Figure 71) and releases from the URP provided for extensive riparian vegetation growth that has shaded and cooled the stream water. Due to critical drought conditions and no releases from the URP, though, the larger riparian trees between the URP and the LRP that need continuous water (i.e., alders and cottonwoods) have been stressed or have died, which has resulted in some thermal heating in that upper reach (Figure 72).

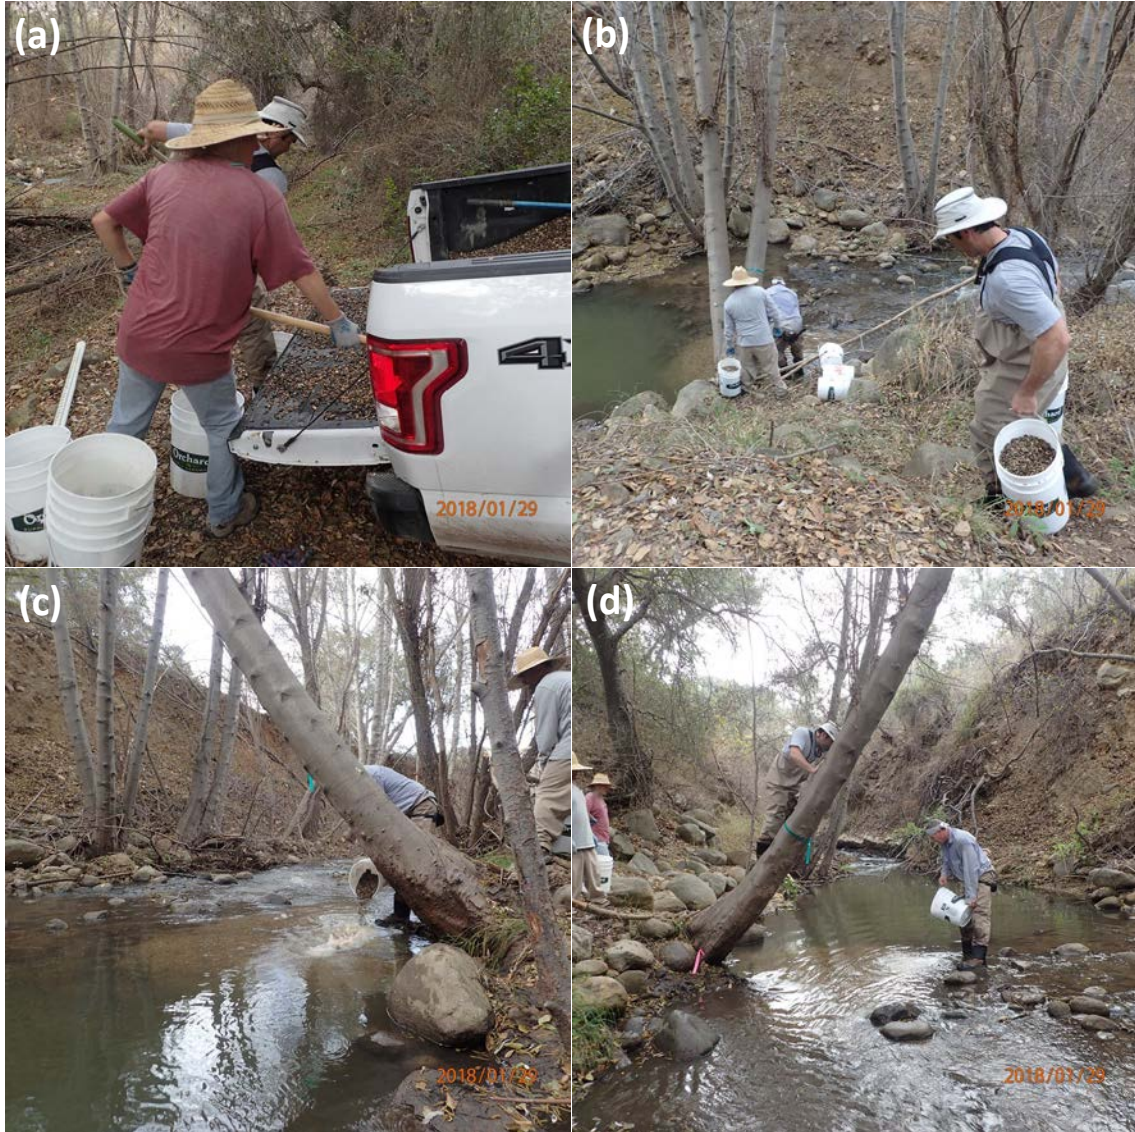
Figure 73: Gravel augmentation in Hilton Creek at the Spawning Pool (a) loading washed gravel into 5-gallon buckets and (b-d) hand placing gravels at the tailout of the habitat.

In collaboration with NMFS, Reclamation proposed to conduct a short-term 2-year gravel augmentation effort within Hilton Creek starting in 2018. All gravel augmentation, monitoring and reporting was implemented by the COMB-FD. A total of 5 gravel treatment sites were pre-selected for augmentation and all gravel had been placed at those locations by 1/30/18, prior to any spawning activities (Figure 73). Redd (spawning) surveys began soon after gravel augmentation had been completed and continued throughout the spawning season. Spawning occurred at an augmentation site less than 6 days following augmentation efforts. Three of the 5 gravel augmentation sites in Hilton Creek contained *O. mykiss* redds in 2018. Of the 8 total redds observed between February and May, 7 (or 87.5%) were associated with gravel augmentation sites. The only exception was an early spawning site that occurred just downstream of the LRP and prohibited gravel augmentation in that area. The overall results from this first year of gravel augmentation within the watered section of Hilton Creek suggest that the effort was beneficial towards achieving the objective of improving spawning habitat for the Hilton Creek *O. mykiss* population. A report was prepared and submitted to NMFS by Reclamation (COMB, 2018b).

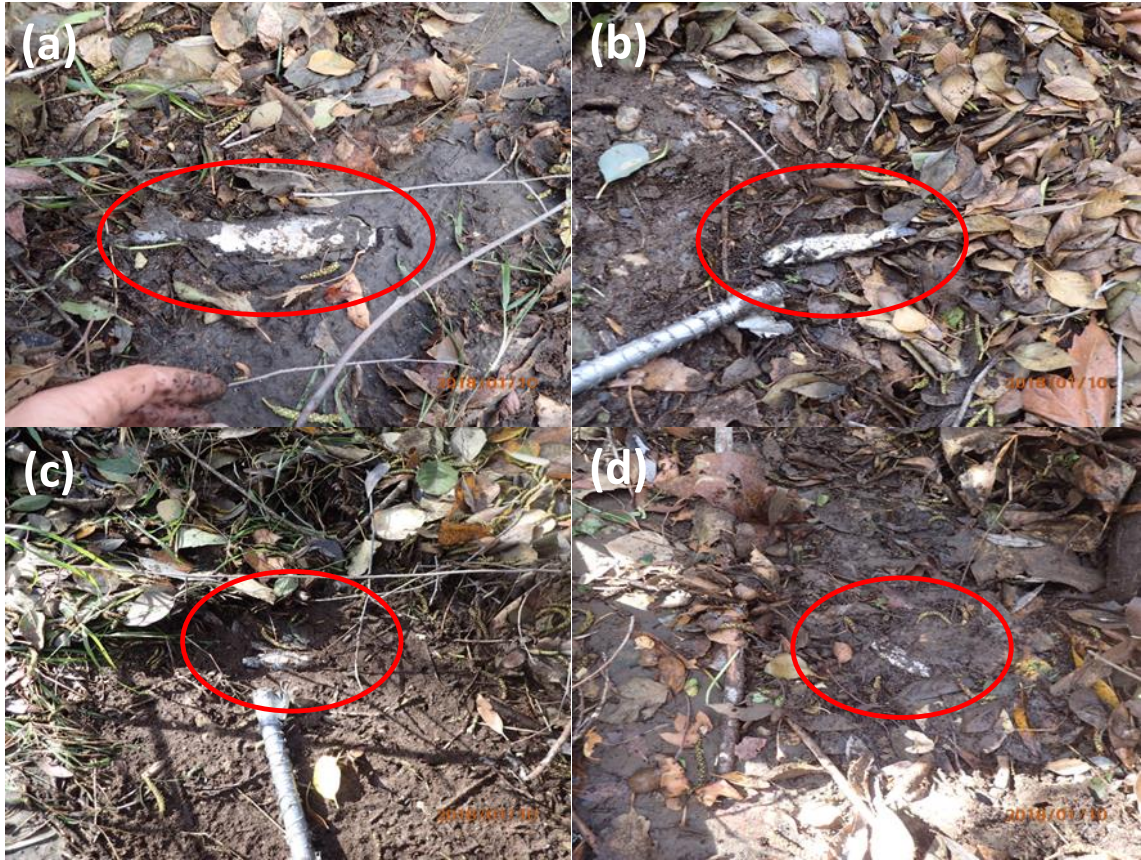
Figure 74: Found *O. mykiss* mortalities associated with the 1/8/18 stormflow event.(a-d) all located in the lower reaches of Hilton Creek and at the upper limits of the high flow event.

Figure 74: Found *O. mykiss* mortalities associated with the 1/8/18 stormflow event (a-d) all located in the lower reaches of Hilton Creek and at the upper limits of the high flow event.

The following day (1/10/18), members of the COMB-FD team returned to inspect the creek for any fish mortalities that may have been caused by the poor water quality. Seven dead *O. mykiss* were discovered, and on the following day (1/11/18) when the creek was thoroughly inspected by COMB-FD staff, six additional *O. mykiss* mortalities were found (Figure 74). In addition to the *O. mykiss* mortalities, one prickly sculpin (*Cottus asper*) mortality was discovered. Many of the deceased fish were found along the high water mark mixed in with leaf litter and fine allochthonous sediment laden materials. Based on the location and condition of the carcasses when found, those fish likely perished early on during the high flow event and floated downstream to be deposited along the high water mark.
