**2009 ANNUAL MONITORING REPORT
AND TREND ANALYSIS**
for
**THE BIOLOGICAL OPINION FOR THE OPERATION
AND MAINTENANCE OF THE CACHUMA PROJECT
ON THE SANTA YNEZ RIVER IN SANTA BARBARA
COUNTY, CALIFORNIA**

Prepared by:
CACHUMA OPERATION AND MAINTENANCE BOARD
for
U.S. DEPARTMENT OF THE INTERIOR
BUREAU OF RECLAMATION
SOUTH CENTRAL CALIFORNIA AREA OFFICE

FEBRUARY 29, 2012

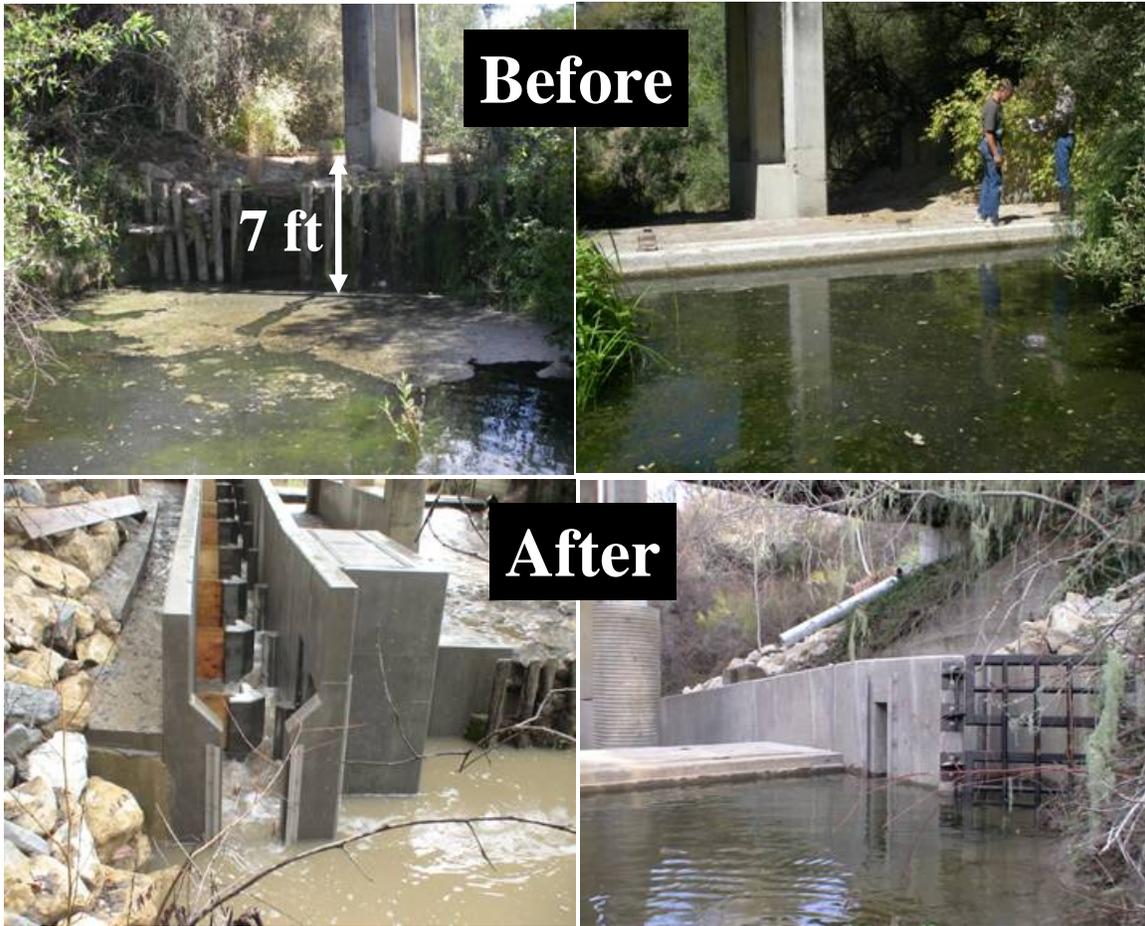
Figure 54: Fish passage and habitat restoration in the fall of 2008 at Rancho San Julian on El Jaro Creek.

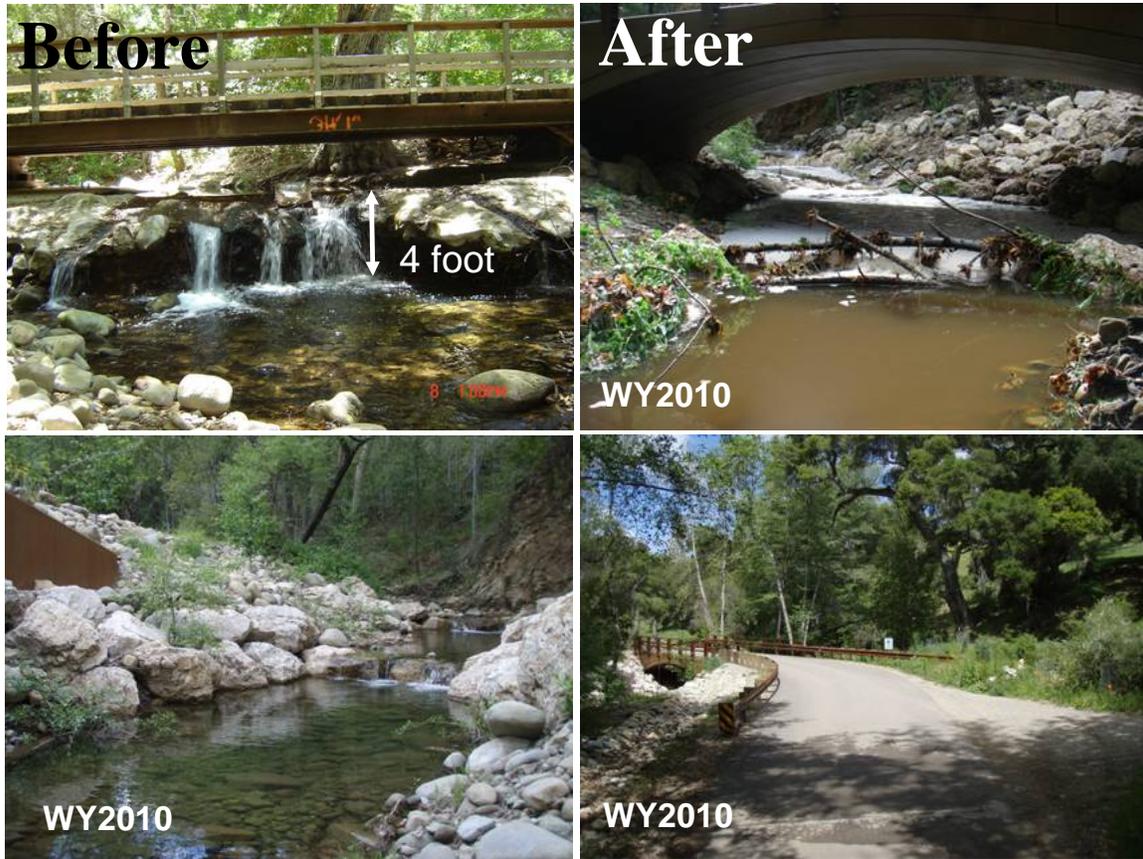
Figure 55: Fish passage and habitat restoration in the fall of 2008 at Refugio Road on Quiota Creek Crossing 6.
